# Analysis of Brownfield Cleanup Alternatives

480 S. 3rd Street  
Clinton, Clinton County, Iowa 52732

Terracon Project No. 07207086; Task 22/32.4

**Re: Analysis of Brownfield Cleanup Alternatives**  
Clinton YMCA - 480 S. 3rd Street  
Clinton, Clinton County, Iowa 52732  
Terracon Project No. 07207086 T22/32.4  
Brownfields Assessment Grant: BF97782001

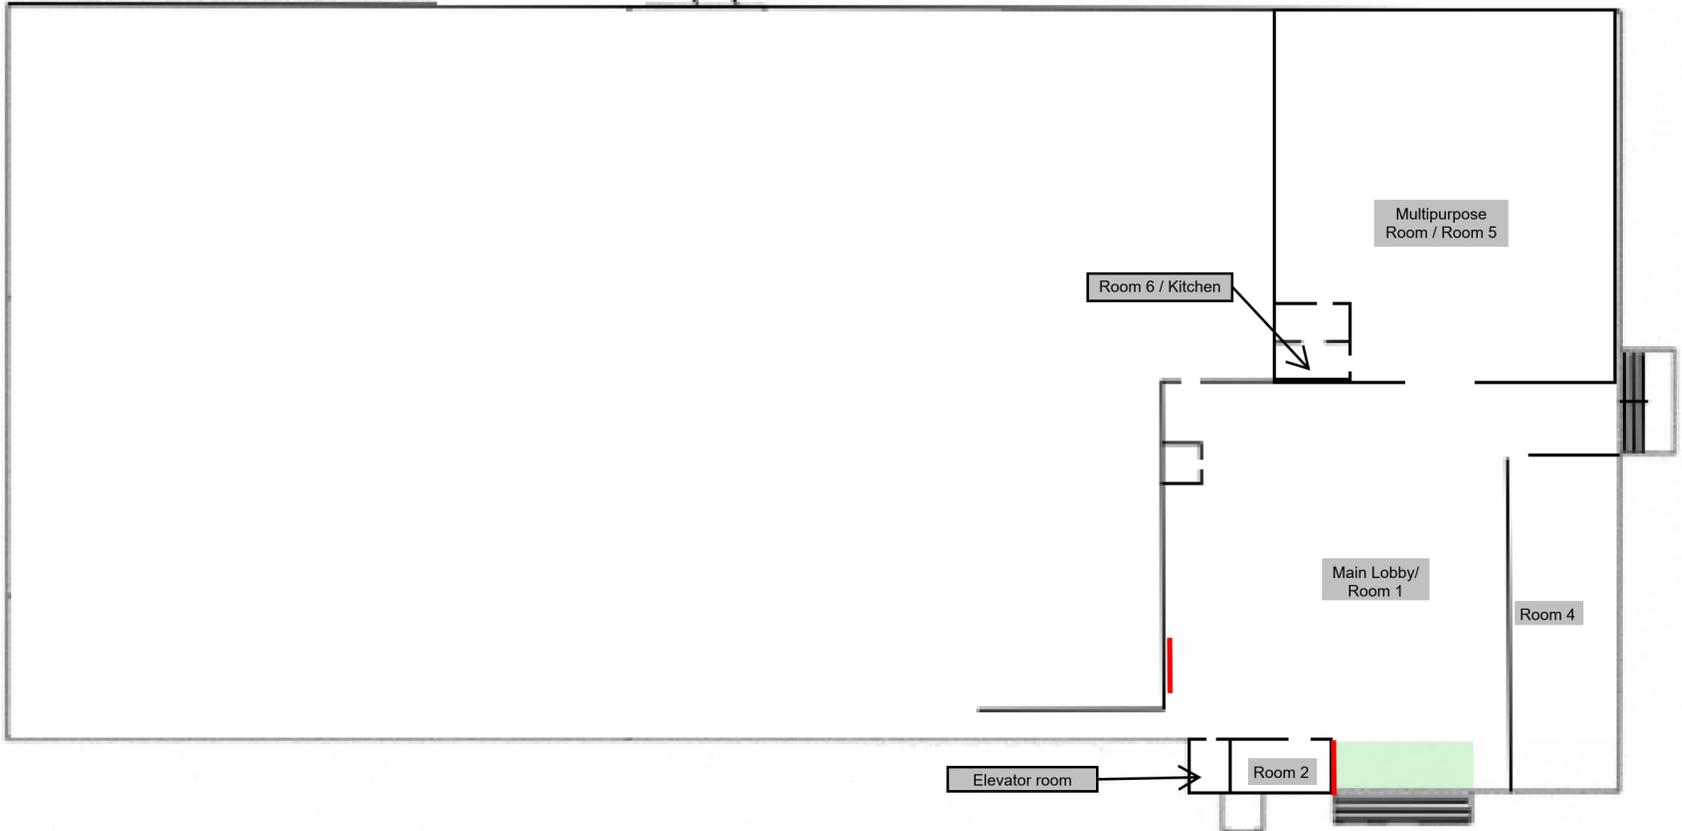
Approximate location/assumed extent of LBP on plaster/drywall in entryway/main lobby area

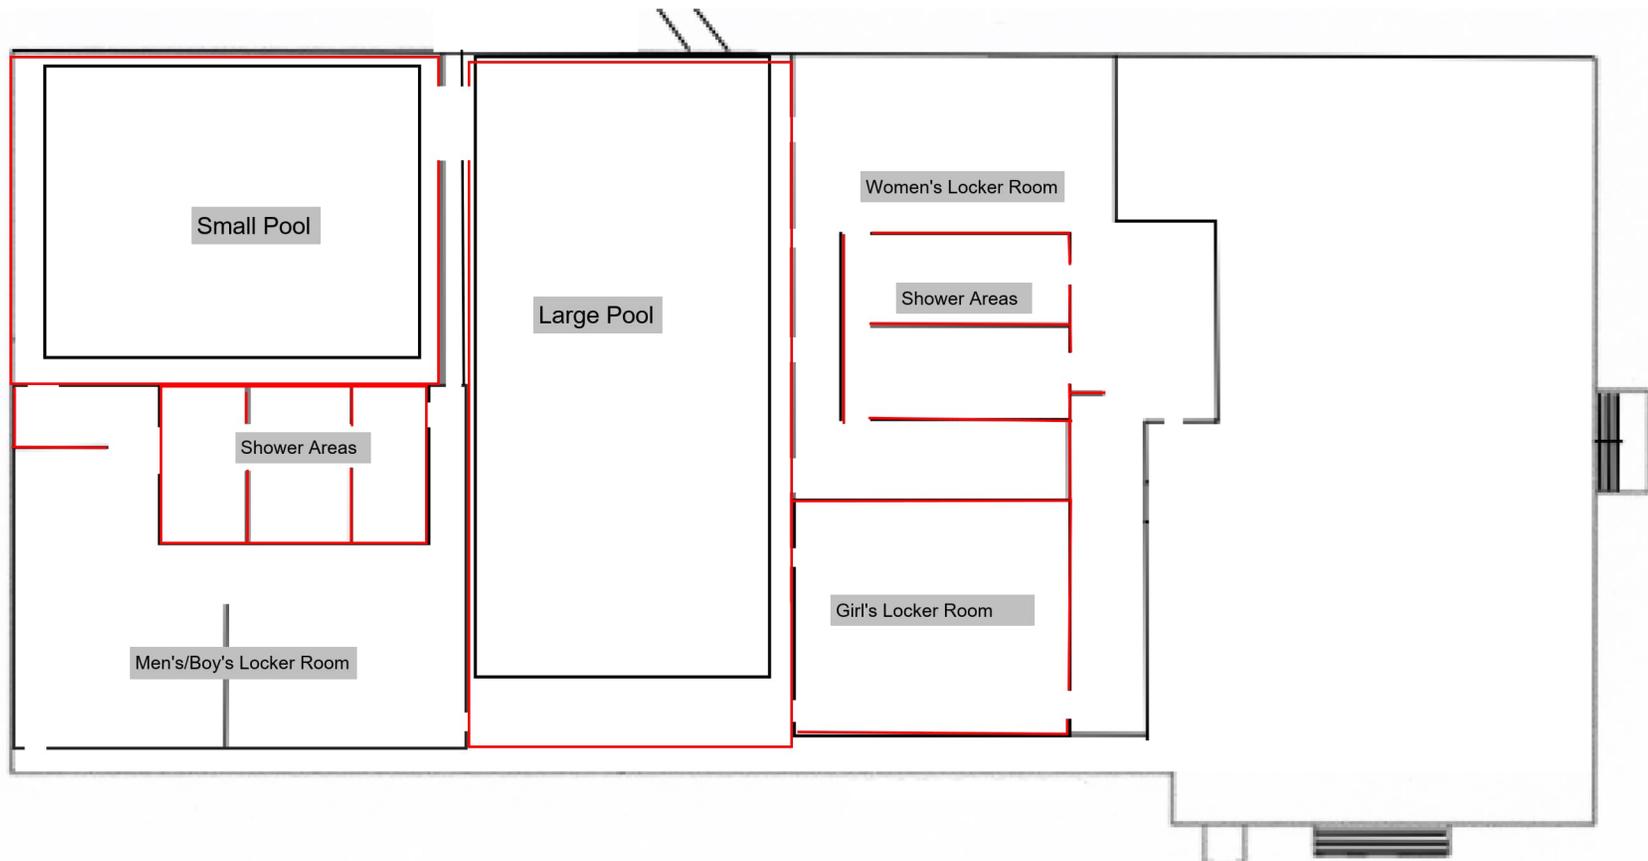
Approximate extent/location of LBP glazing on ceramic block walls. Block walls extend floor to ceiling throughout the majority of the locker room areas, and generally include pipe chases as well behind the shower areas

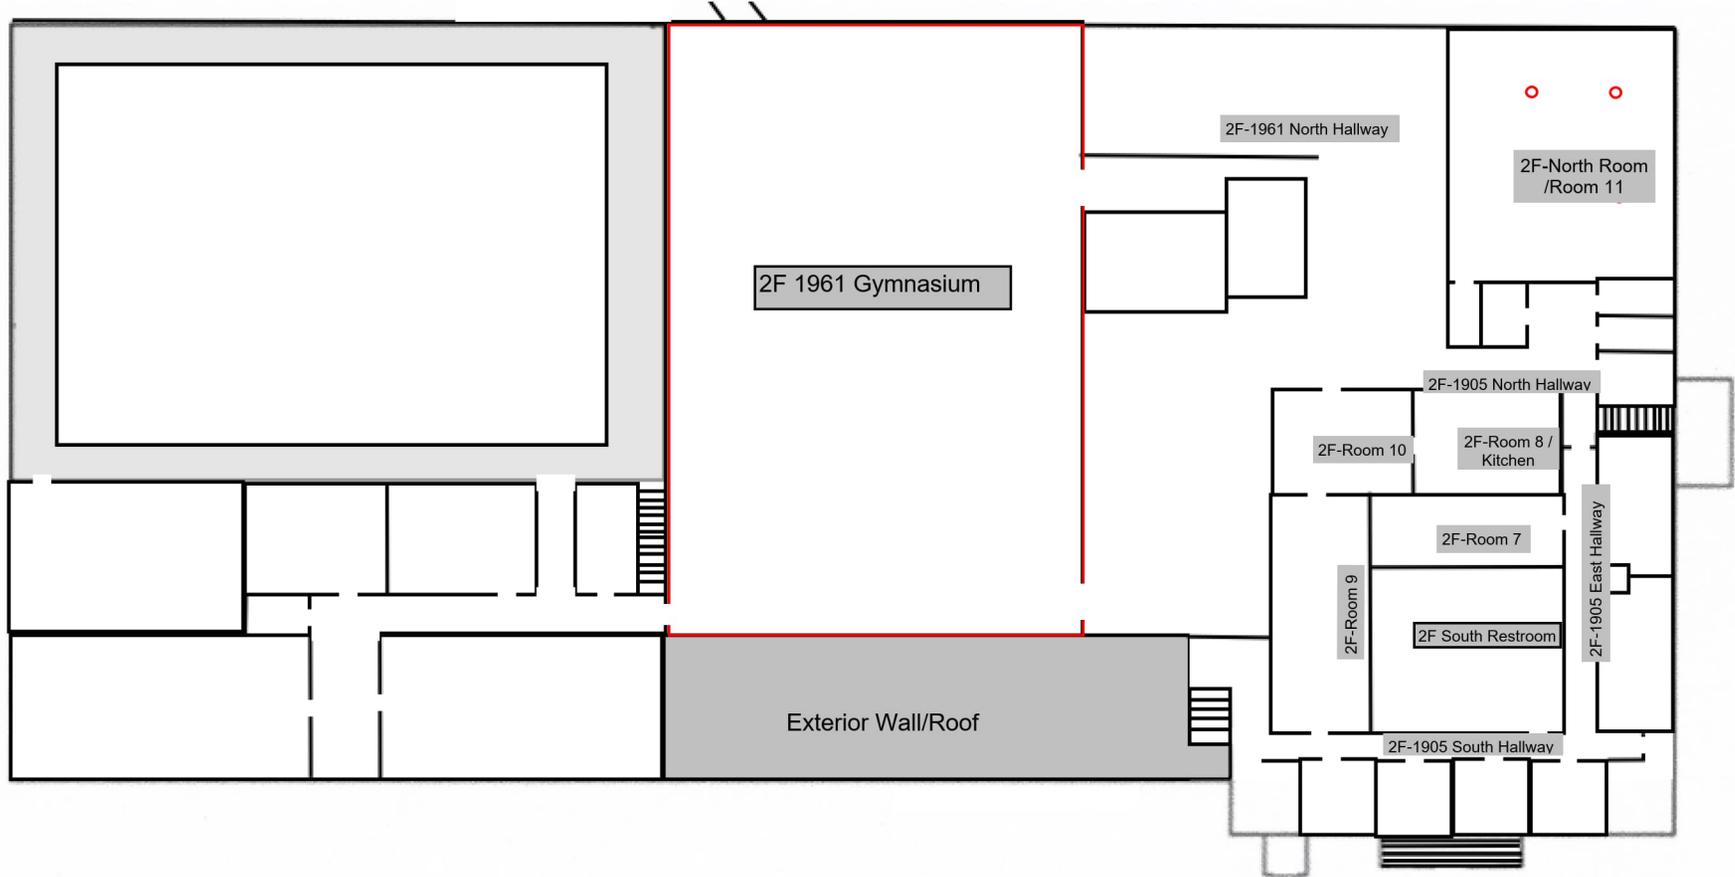
Extent of LBP glazing on ceramic block walls in gymnasium; block walls extend approximately 6 feet up from the floor.

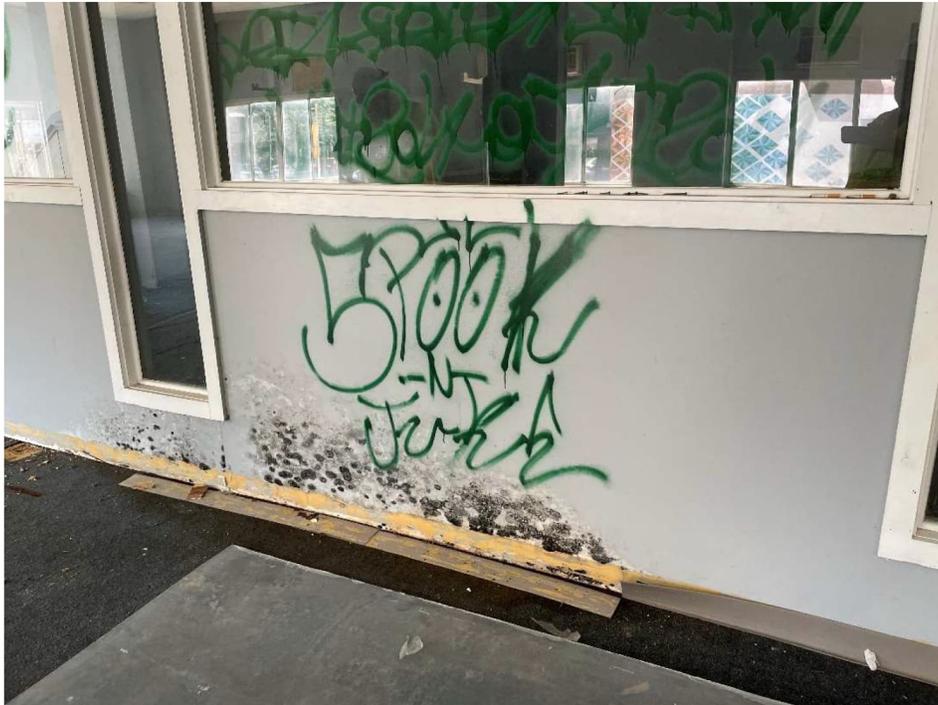
**Photo 8:** View of observed microbial growth along the north portion of the west wall in Room 4, first floor

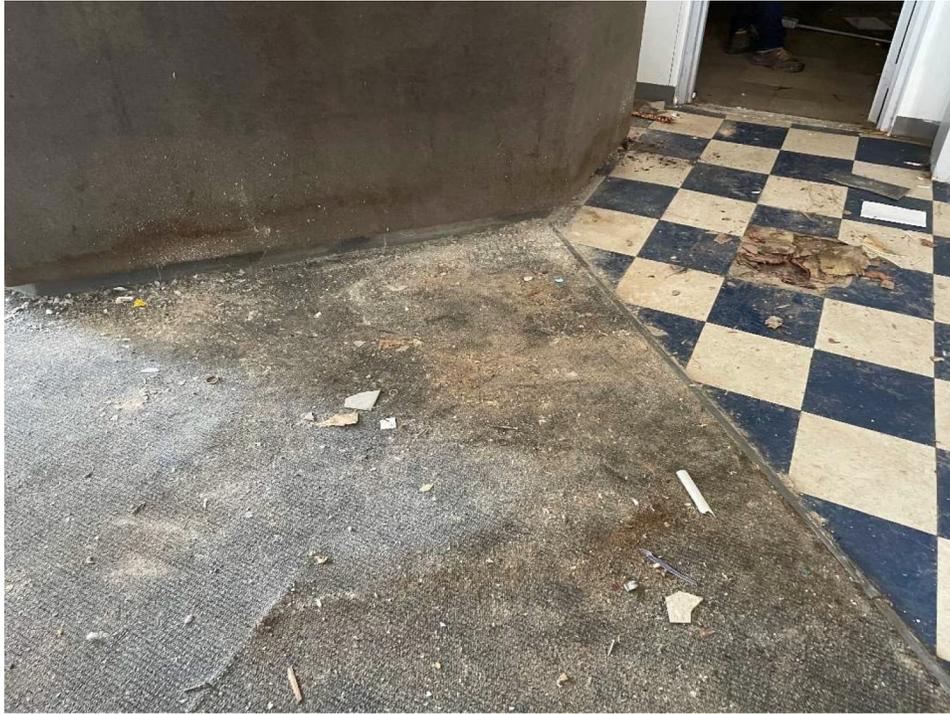
**Photo 9:** View of water stained flooring on first floor near Room 3/behind the counter

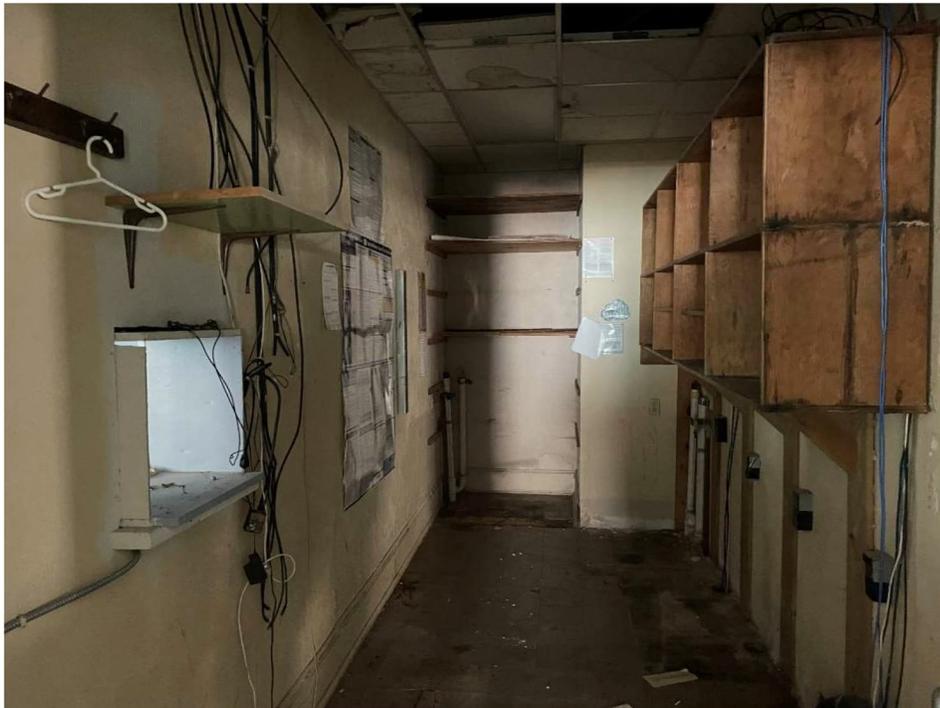
**Photo 10:** View of Room 3 on first floor with water stained ceiling and floor tiles

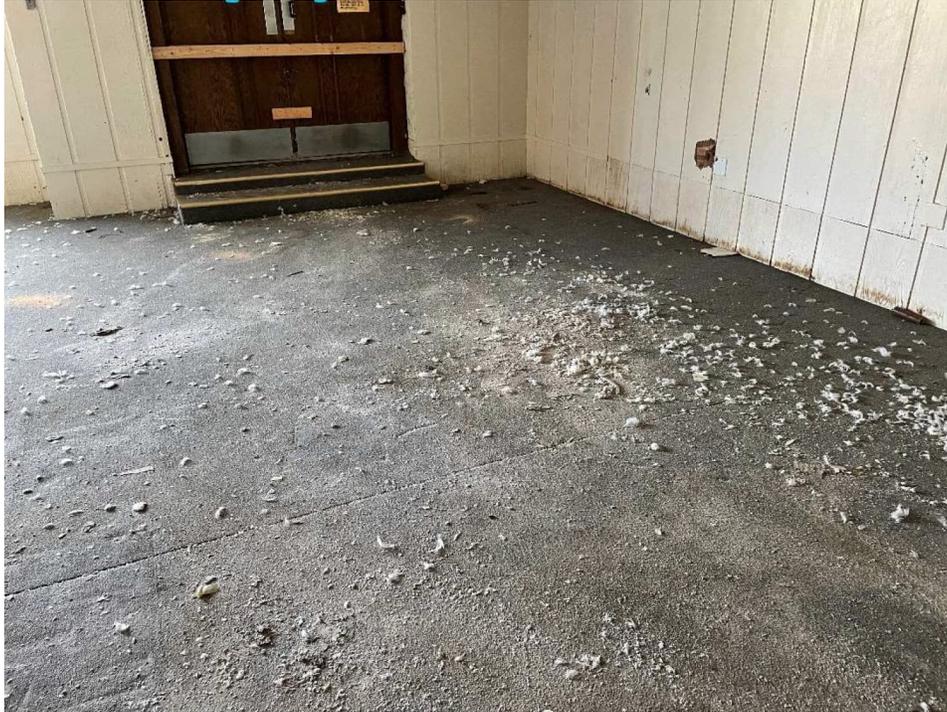
**Photo 11:** View near southeast corner of Room 5 on first floor with water damaged flooring and water staining on wood paneling

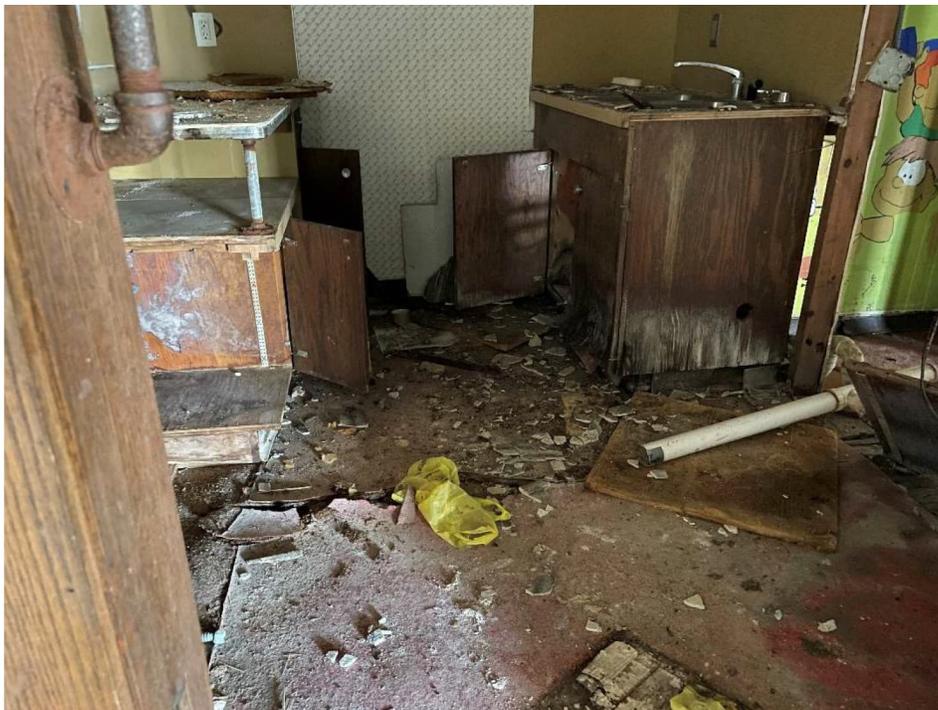
**Photo 12:** View of Room 6 on the first floor with water damaged materials and delaminated plaster on floor in room

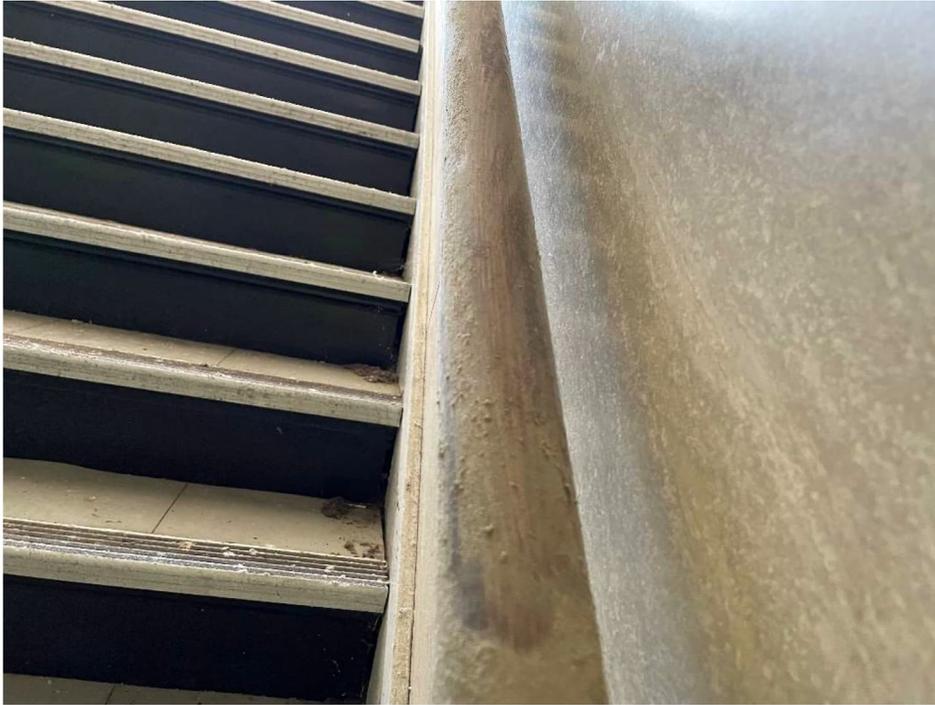
**Photo 13:** View of handrail leading from first floor to second floor with water damage and suspect microbial growth

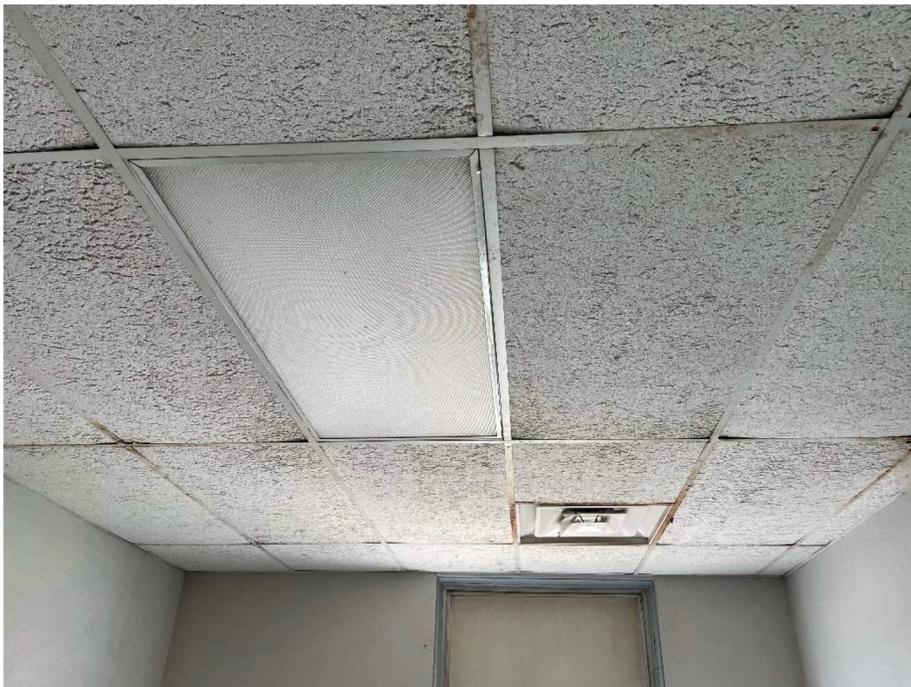
**Photo 14:** View of moisture-impacted ceiling tiles and ruset ceiling tile grid inside Unit 201 on second floor

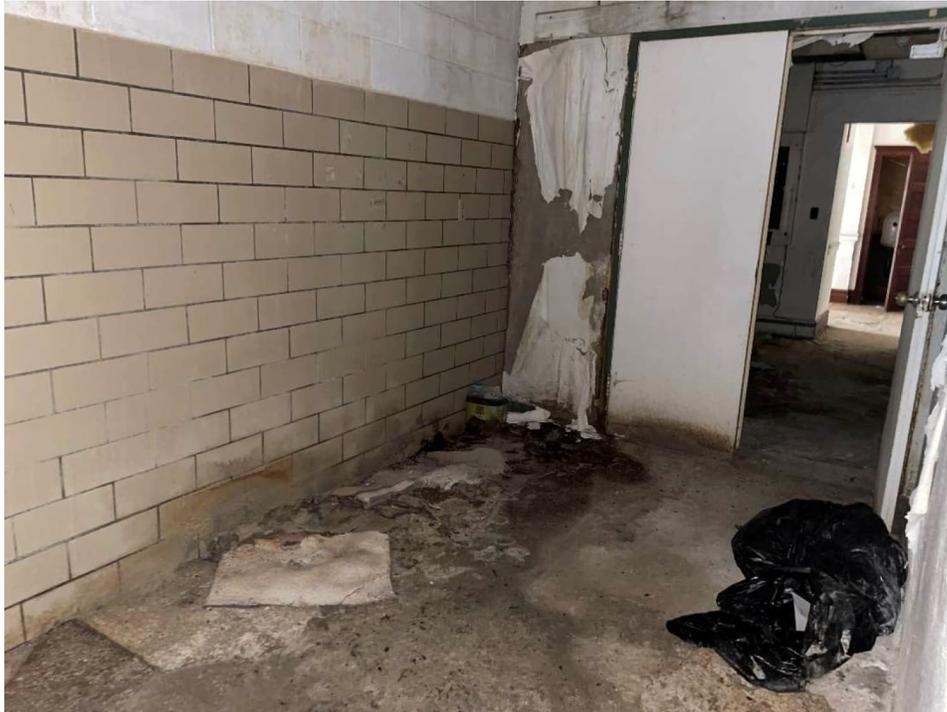
**Photo 15:** View of second floor north hallway showing significant water damage and staining to various materials

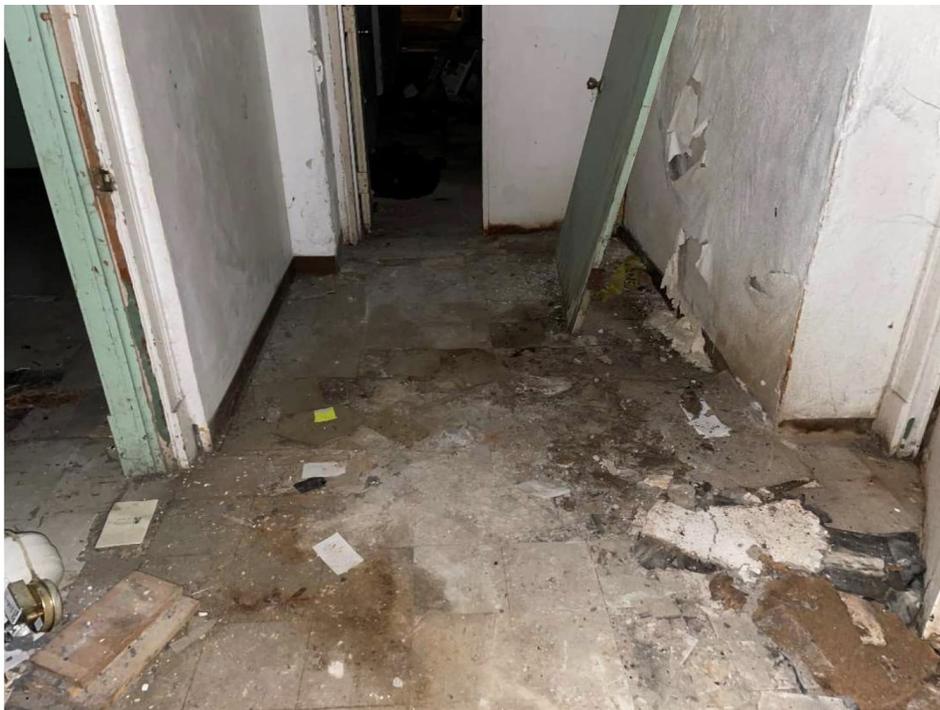
**Photo 16:** Alternate view of second floor north hallway area near Room 10 and significant water damaged materials

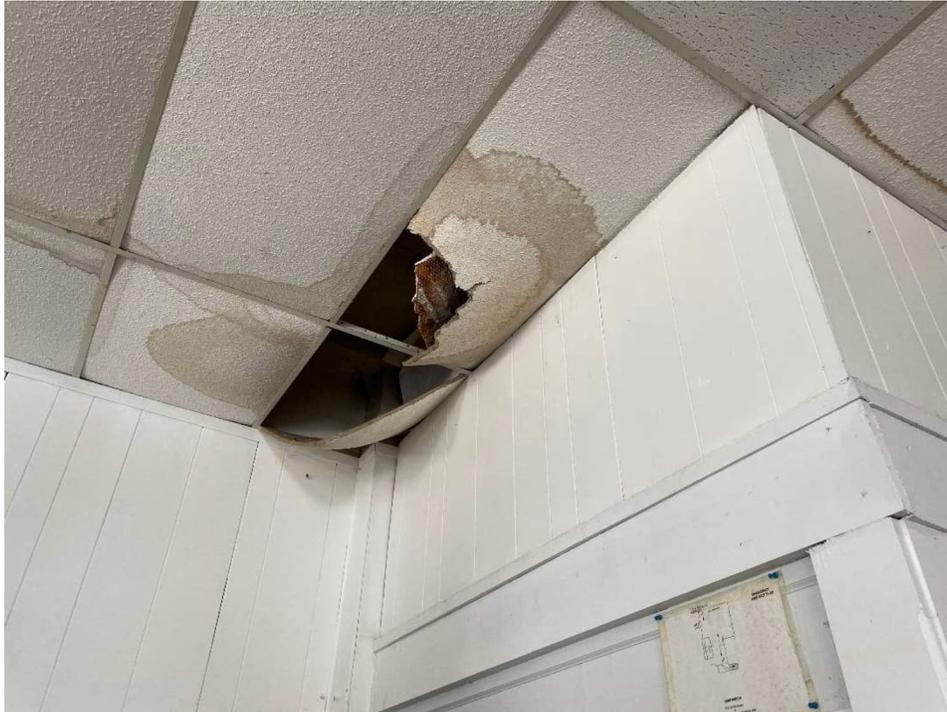
**Photo 17:** View of water damaged ceiling tiles at southwest corner of Room 11 on second floor

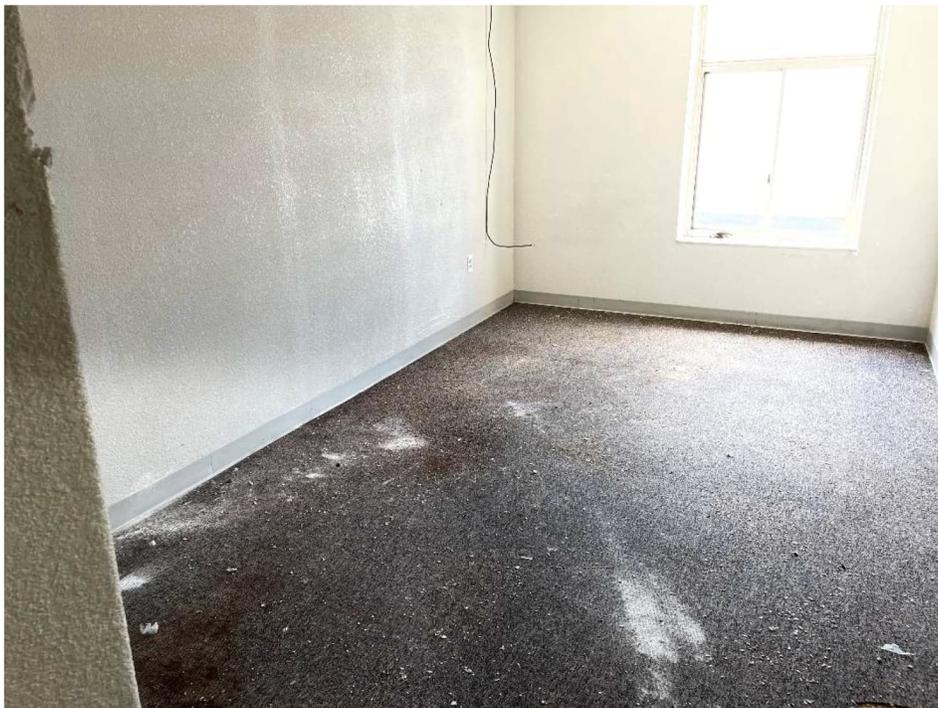
**Photo 18** View of water damaged flooring in Unit 323 on third floor

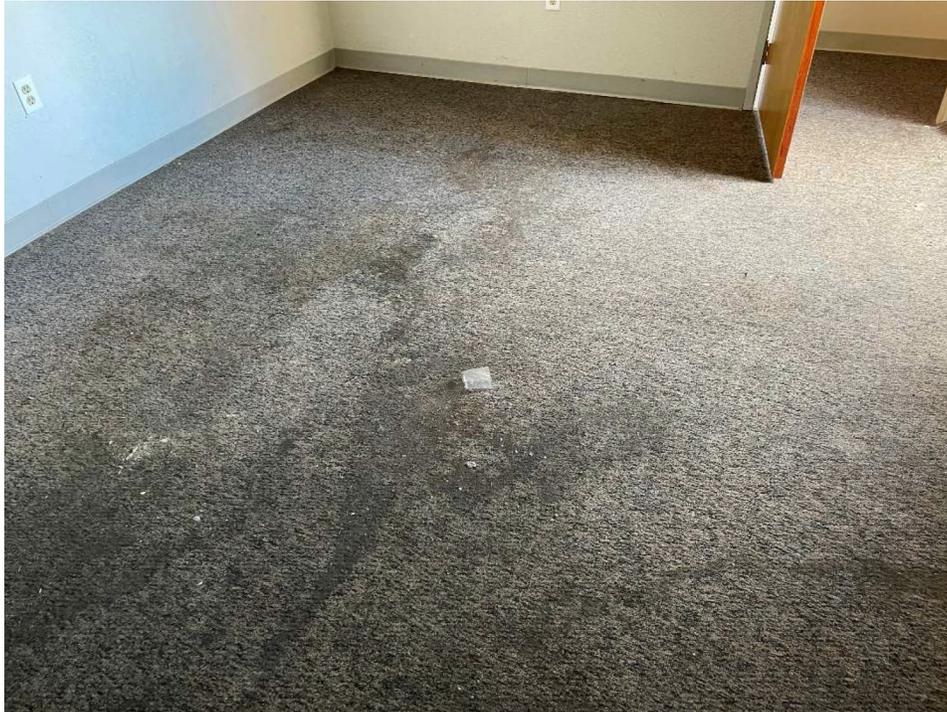
**Photo 19:** View of water damaged flooring in Unit 318 on third floor

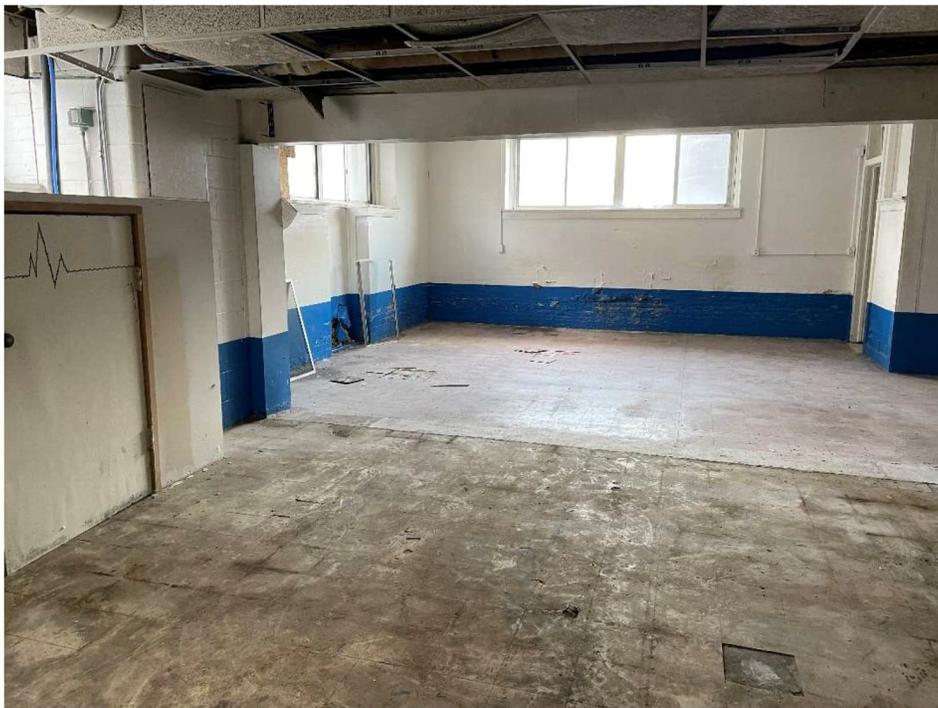
**Photo 20:** View of significant moisture damage on south wall of basement

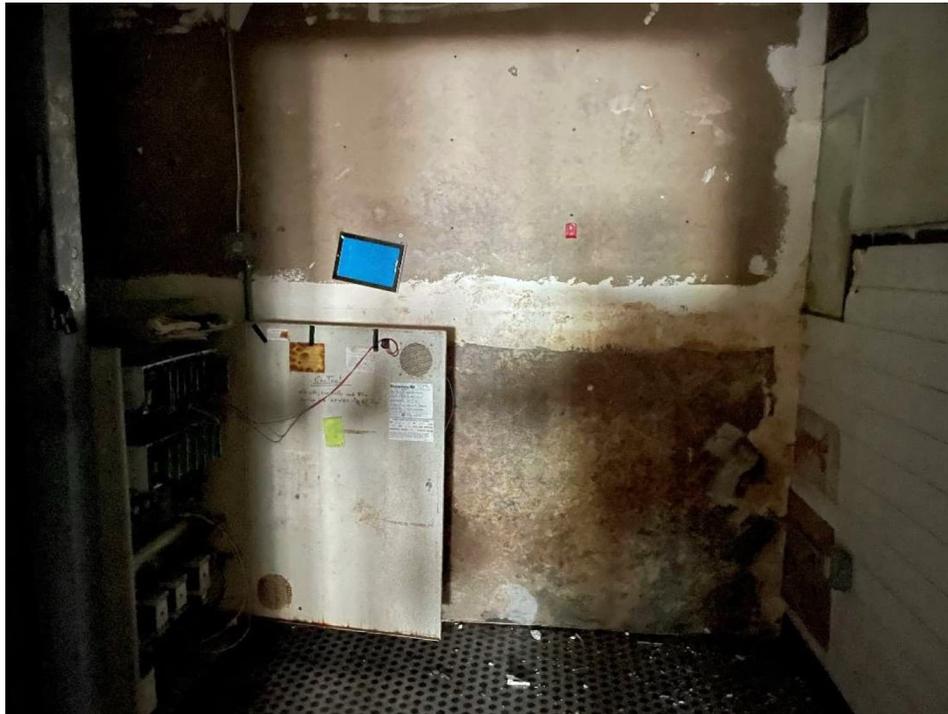
**Photo 21:** View of significant water damage in Room B8 in the basement

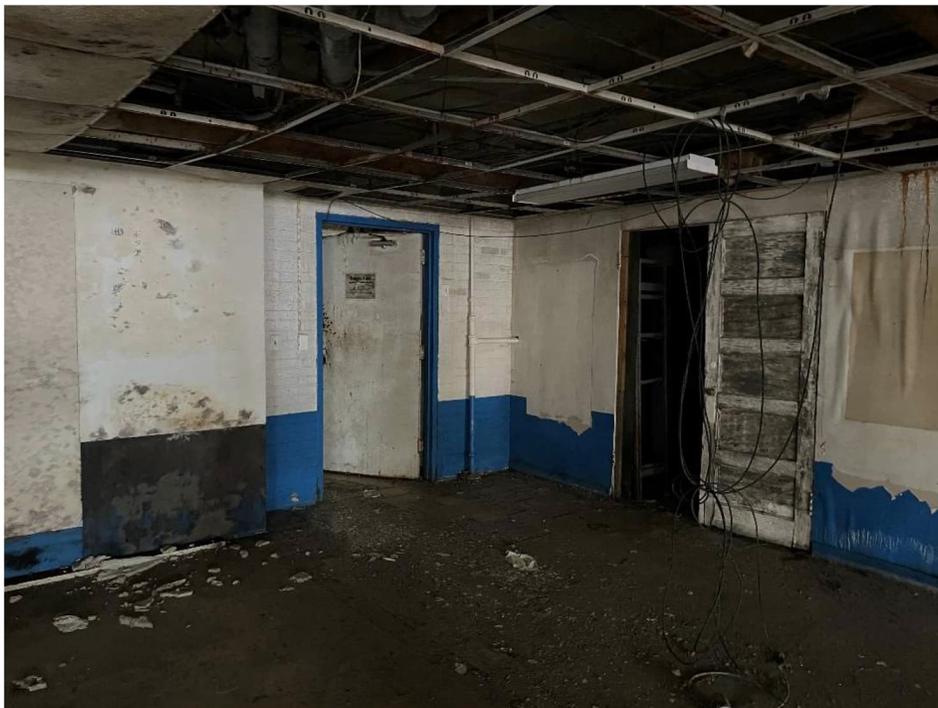
**Photo 22:** View of water damage and suspect microbial growth in northwest portion of basement

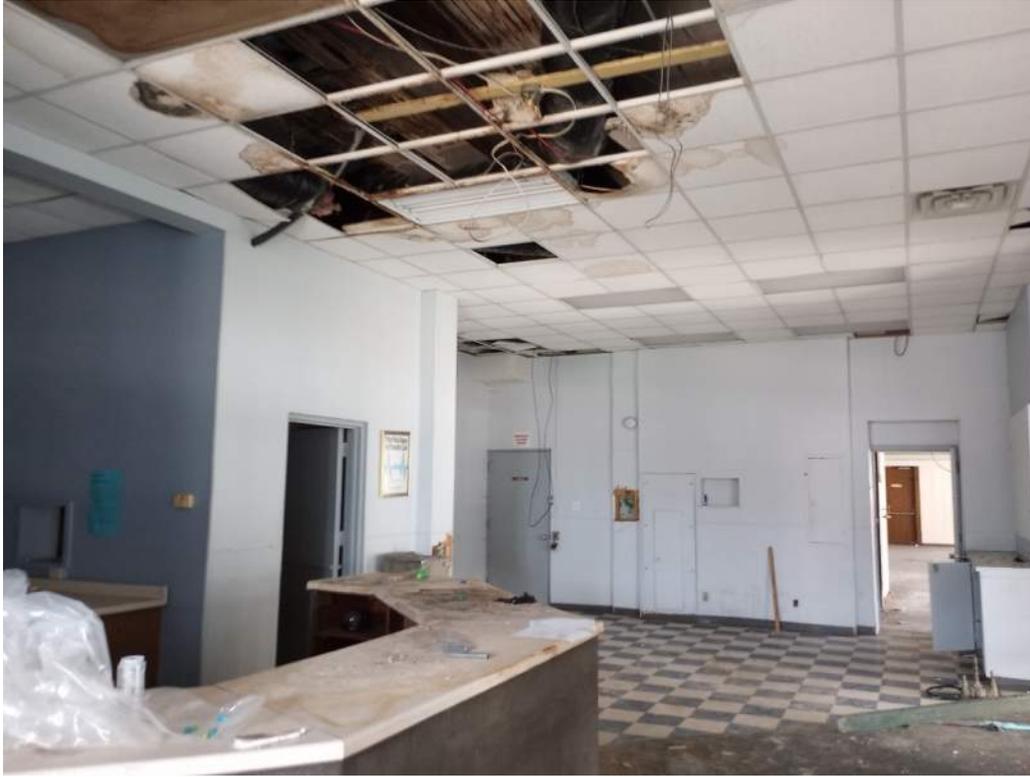
The wood framing in the structure has not been badly damaged over the years and is in good condition. The lack of water in the structure has kept this building from rotting over time, even while it was unoccupied. The basement did have some water/ mold but it appear that the structure held up and should not need to have much done in the form of renovation to the structure. In the opinion of Select Structural Engineering, this building is salvageable. Picture below show the structure and give an indication of condition.

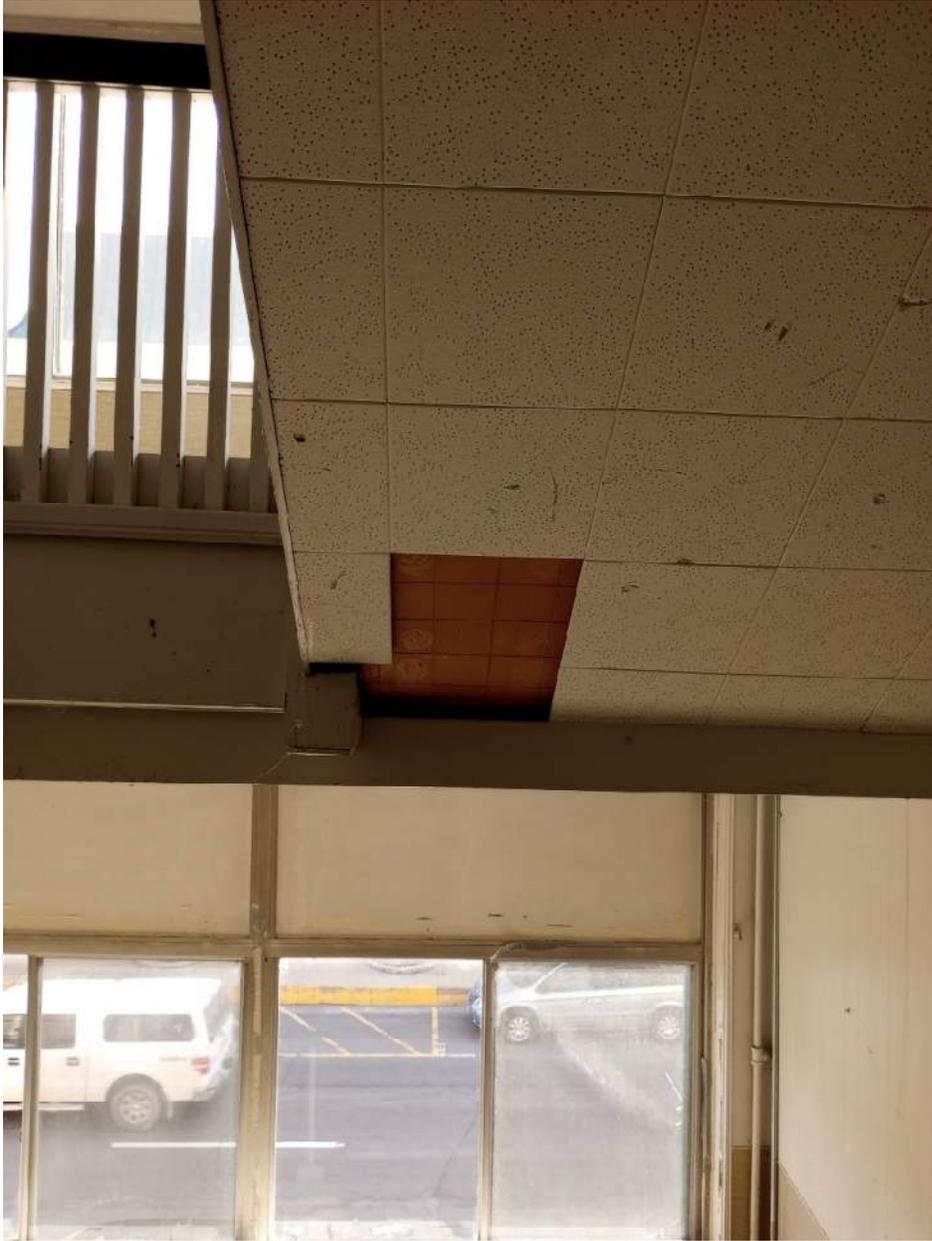
Non Structural Tile – Potential Asbestos Abatement

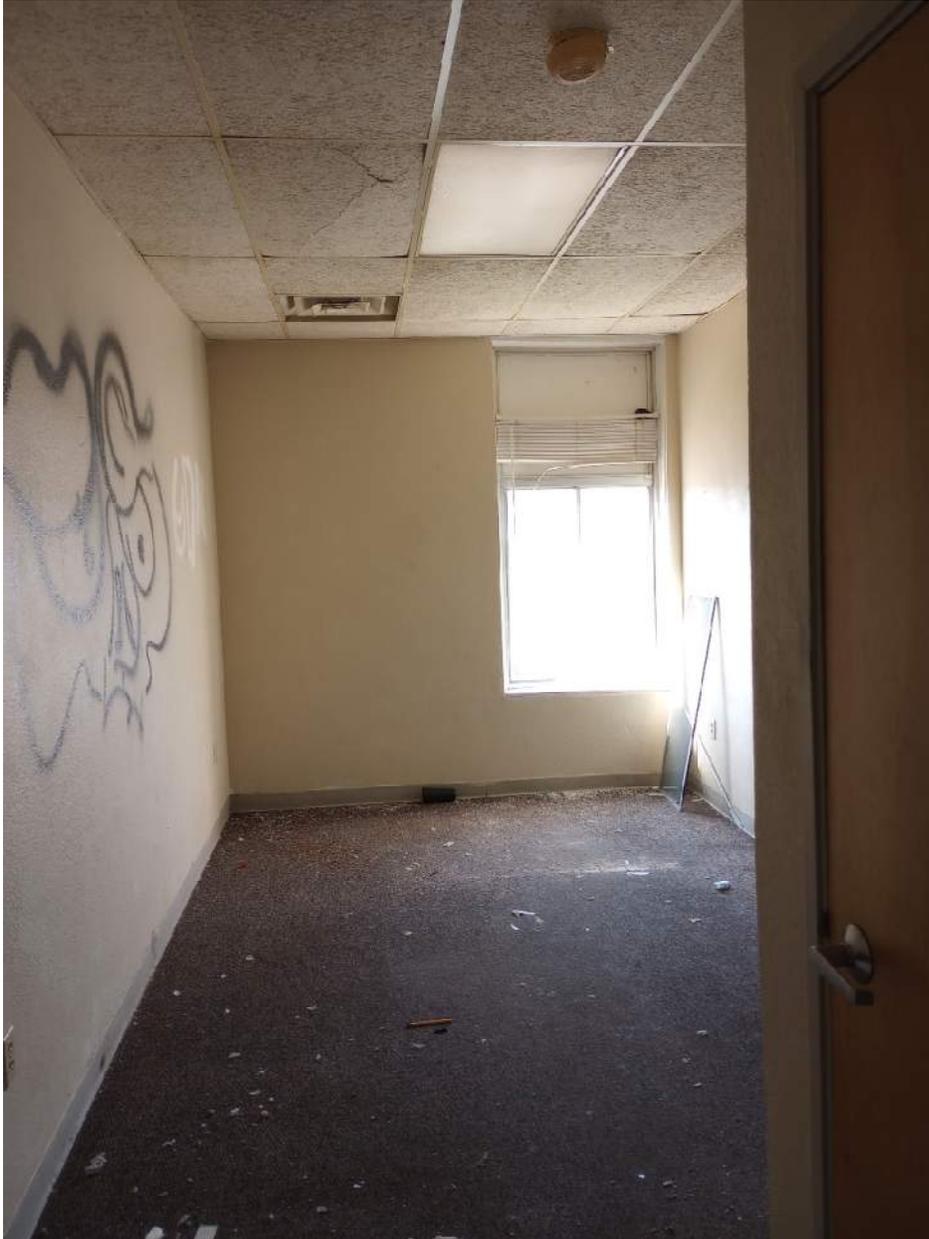
Upper Floor Dorm in Good Condition of Building A

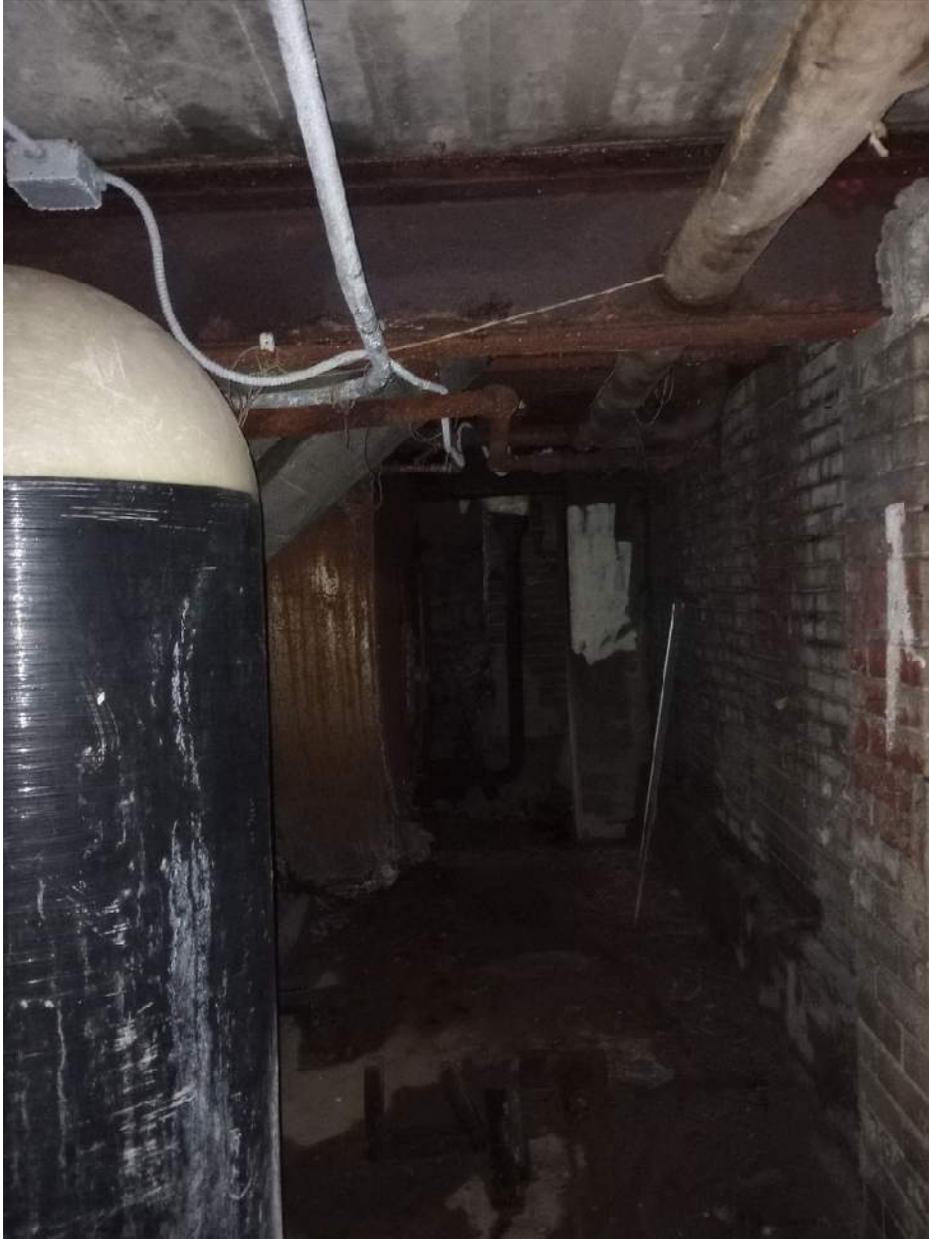
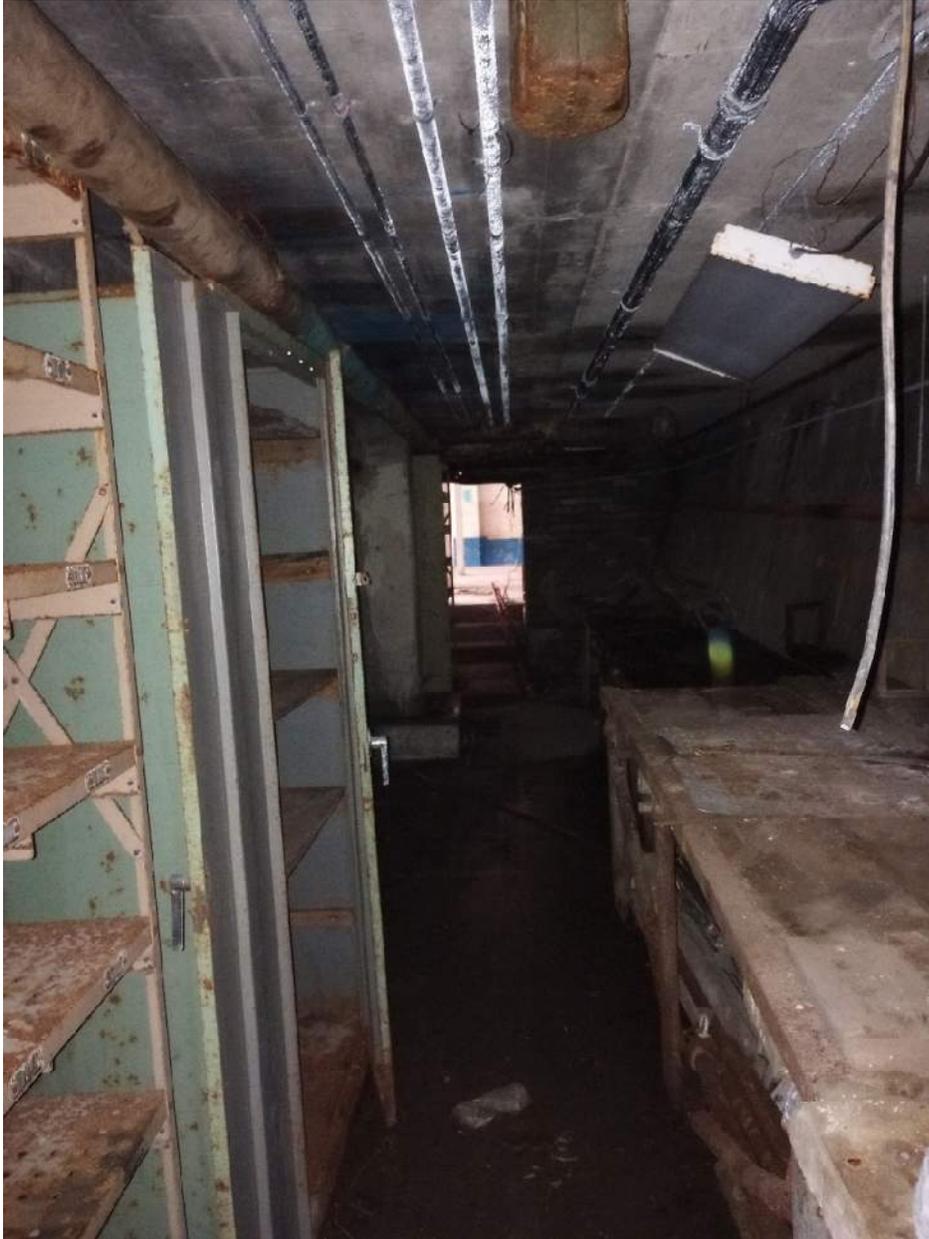
It is the opinion of Select Structural Engineering that this Building is not salvageable. The roof of this building was not successful at keeping water out and the level of moisture in the building envelope was/is significant. The structural framing such as the steel is a complete loss and will not be certified by any licensed structural engineer. This is in addition to the mold and potential asbestos which presents a significant risk to occupants including contractors who would need to work inside the building.

Boiler Room in The Basement of Building B1
