# Phase I Environmental Site Assessment (Rev-1)

ECIA Brownfields Assessment Services

211 & 213 East Broadway Street

Stanwood, Cedar County, IA

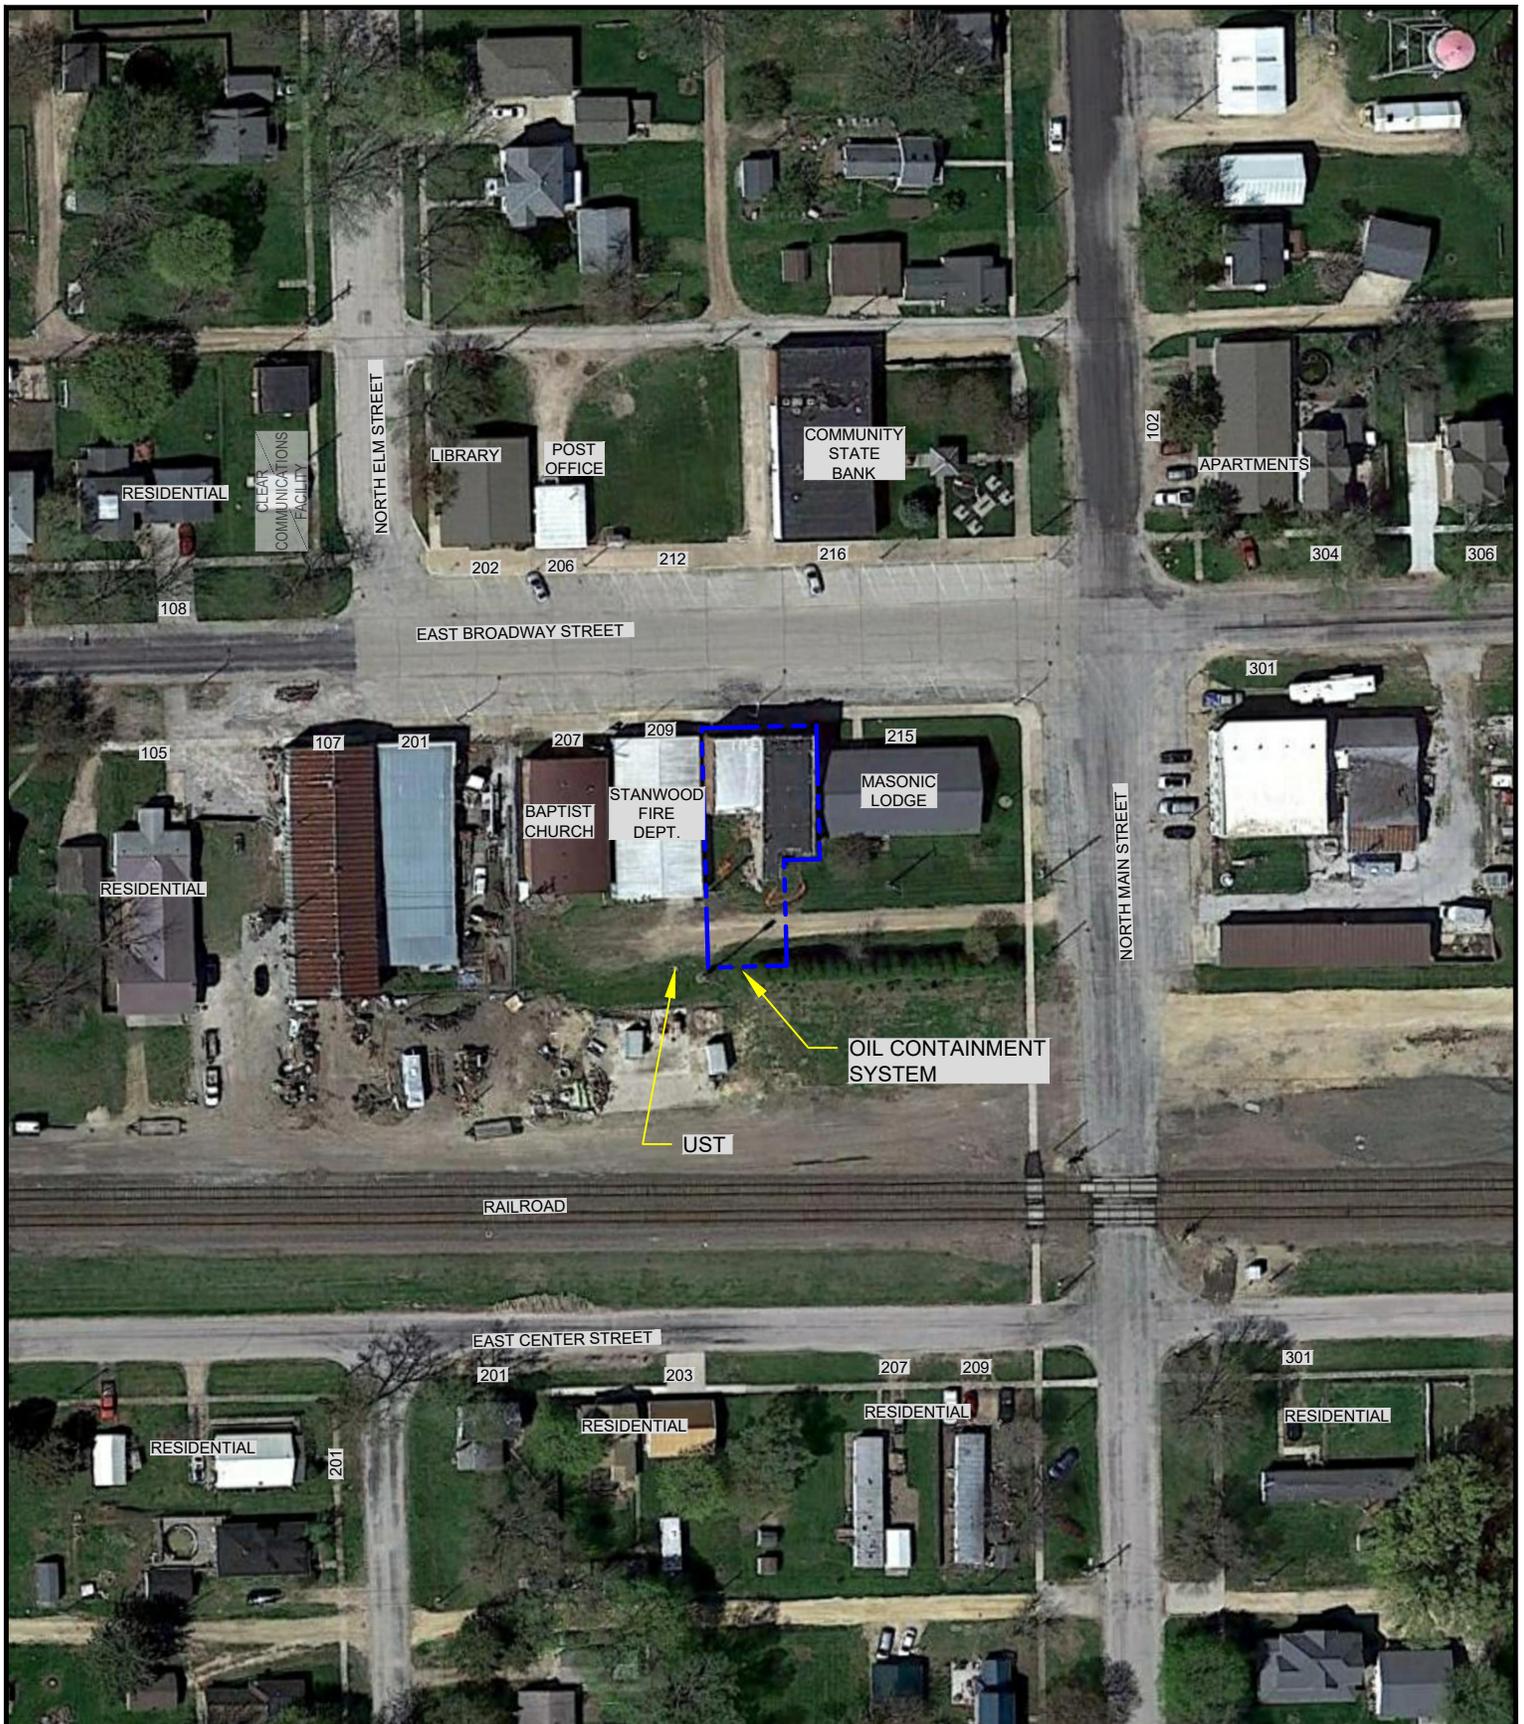
SITE DIAGRAM	EXHIBIT
PHASE I ENVIRONMENTAL SITE ASSESSMENT ECIA BROWNFIELDS 211 & 213 EAST BROADWAY STREET STANWOOD, CEDAR COUNTY, IOWA	2

AERIAL PHOTO FROM GOOGLE EARTH

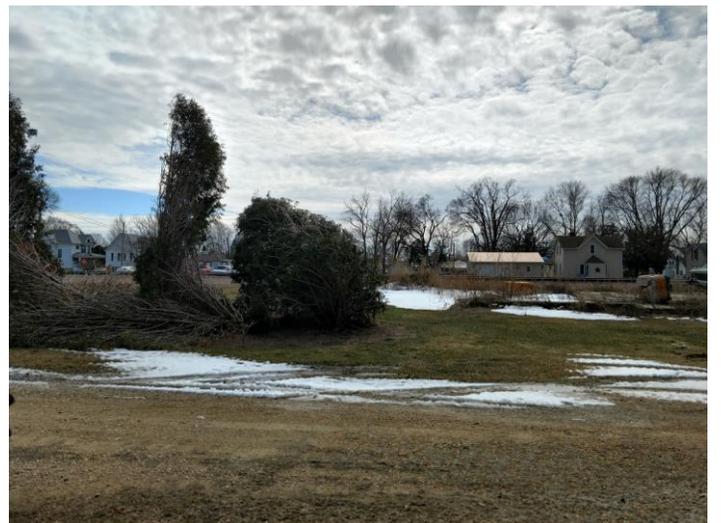
The historical review did identify an oil containment system (observed ASTs in aerial photos) located on the adjoining property to south of the site in the 1915 Sanborn map and the aerial photos through 1980. Based on our review of available property records, aerial photographs and the Sanborn map, it is unclear where the southern property boundary of the subject site is located. Consequently, based on the topographic gradient and uncertainty of property boundaries the oil containment system does represent a REC to the site.

**Photo #4** View of the vacant property adjoining to the south.

Based on the scope of services, limitations, and conclusions of this assessment, Terracon recommends conducting additional investigation to evaluate subsurface conditions associated with the identified RECs.

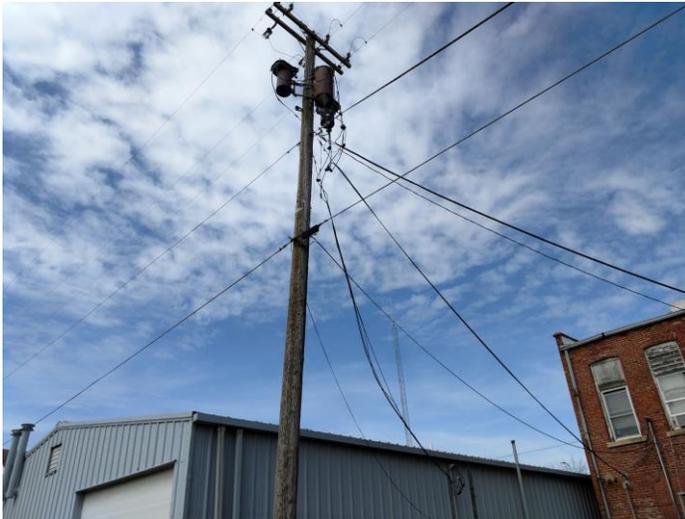
During the site reconnaissance, three (3) pole-mounted transformers, owned and serviced by Alliant Energy, were observed along the south side of the site building; however, information with regard to PCB content of the transformer fluids was not observed. Some transformers contain mineral oil which may contain PCBs.

**Photo #7** View of pole mounted transformers along the south side of the site.

Alliant Energy maintains responsibility for the transformers, and if the transformers were “PCB contaminated,” Alliant Energy is not required to replace the transformer fluids until a release is identified. However, evidence of current or prior releases was not observed in the vicinity of the electrical equipment during the site reconnaissance. The presence of the pole-mounted transformer at the site is not considered a REC to the site at this time.

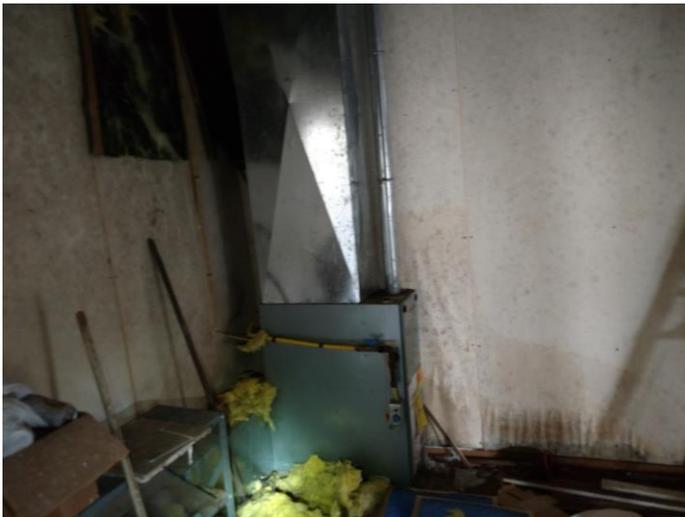
The building is heated by a natural gas furnace and is cooled with an electric air conditioning system.

**Photo #9** View of first floor heating system (building 213).

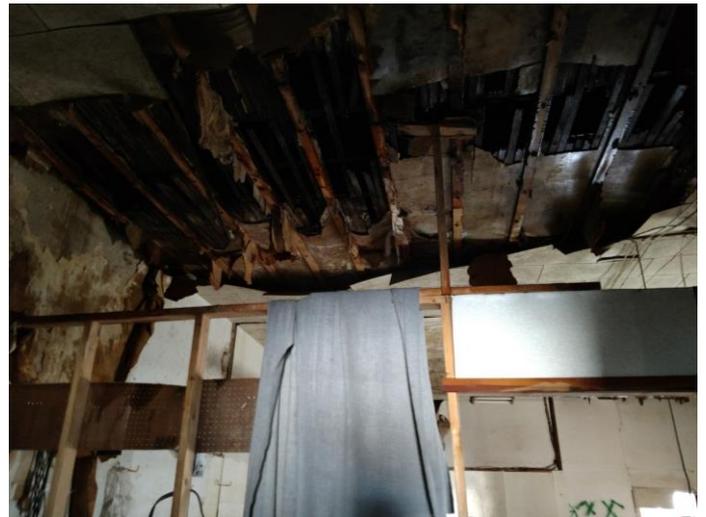
**Photo #10** View of first floor water damaged ceilings (building 213).

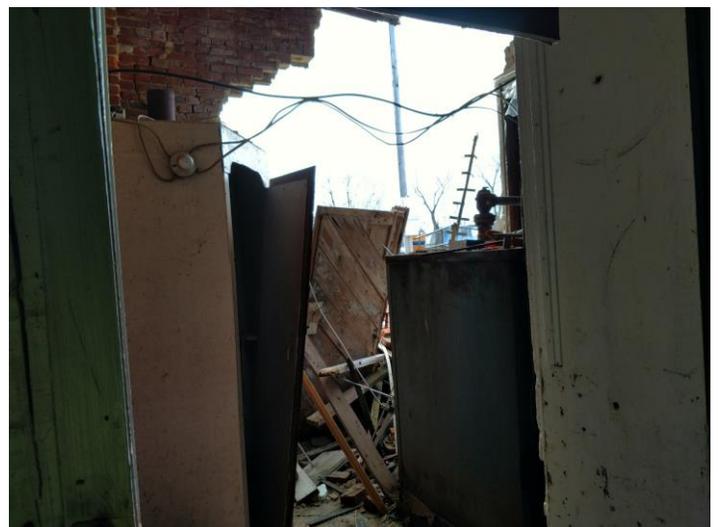
**Photo #12** View of first floor structural damage (building 213).

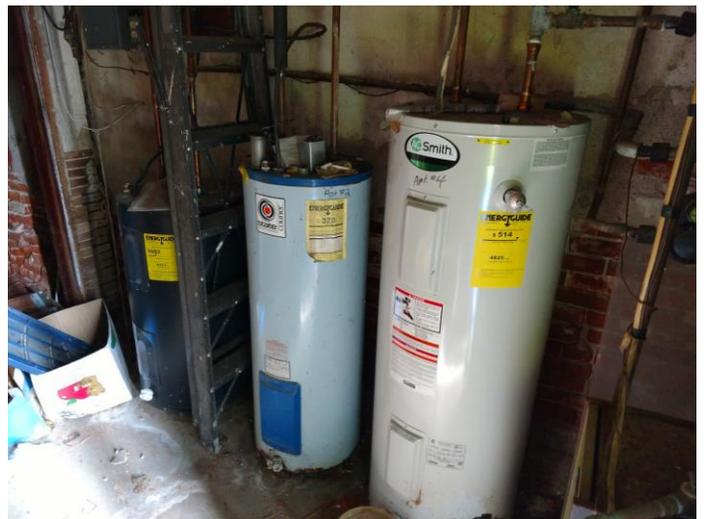
**Photo #16** View of hot water heaters (building 211).

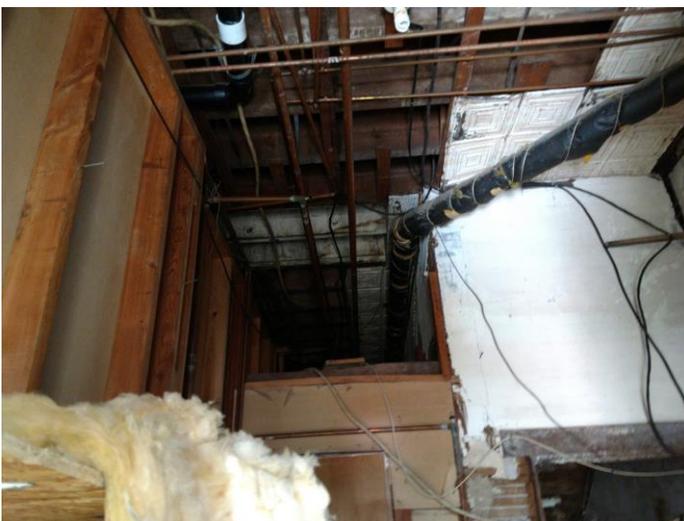
**Photo #17** View of first floor water damaged ceilings (building 211).
