# Analysis of Brownfield Cleanup Alternatives

480 S. 3rd Street  
Clinton, Clinton County, Iowa 52732

Terracon Project No. 07207086; Task 22/32.4

**Re: Analysis of Brownfield Cleanup Alternatives**  
Clinton YMCA - 480 S. 3rd Street  
Clinton, Clinton County, Iowa 52732  
Terracon Project No. 07207086 T22/32.4  
Brownfields Assessment Grant: BF97782001

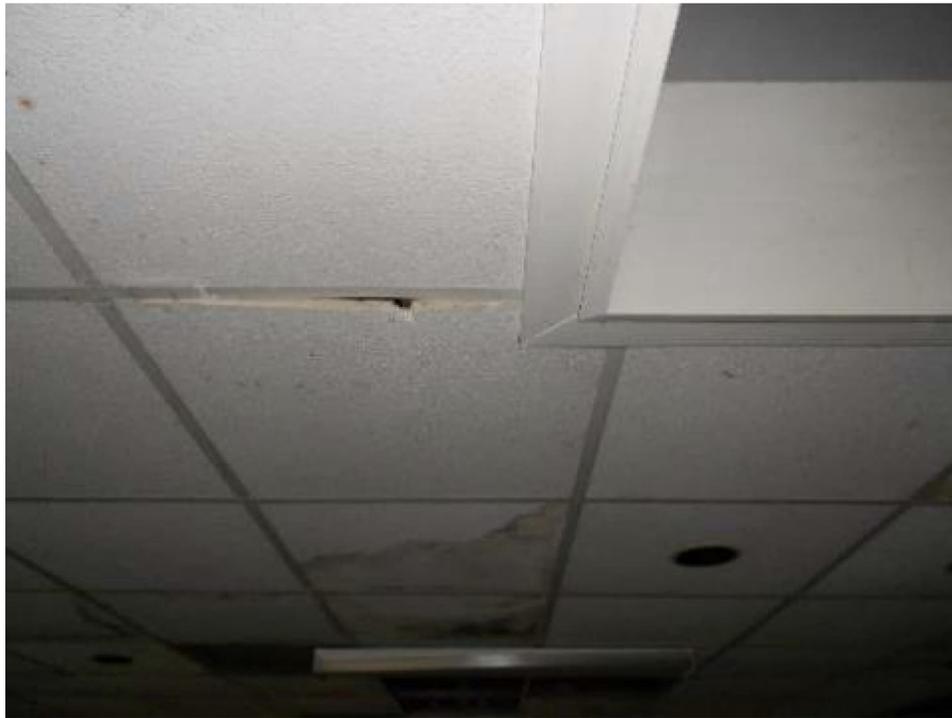
**Photo 1:** View of 1905 Bldg. 1<sup>st</sup> floor, north room 2' x 2' ceiling tile (NC-01).

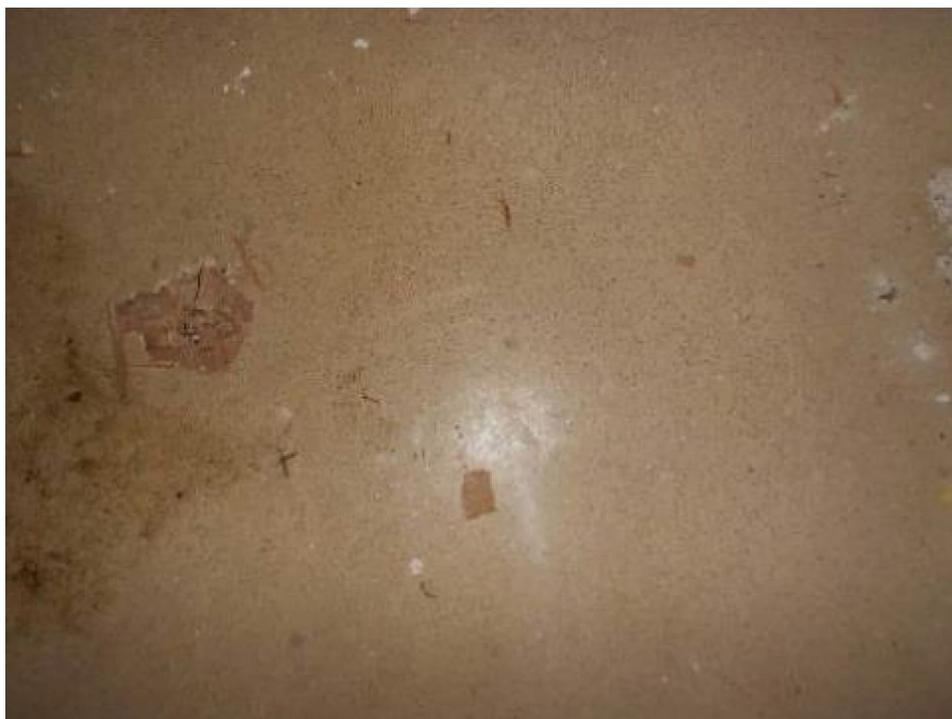
**Photo 2:** View of 1905 Bldg. 2<sup>nd</sup> floor, 9" x 9" floor tile, south restroom, beneath vinyl flooring (NC-04).

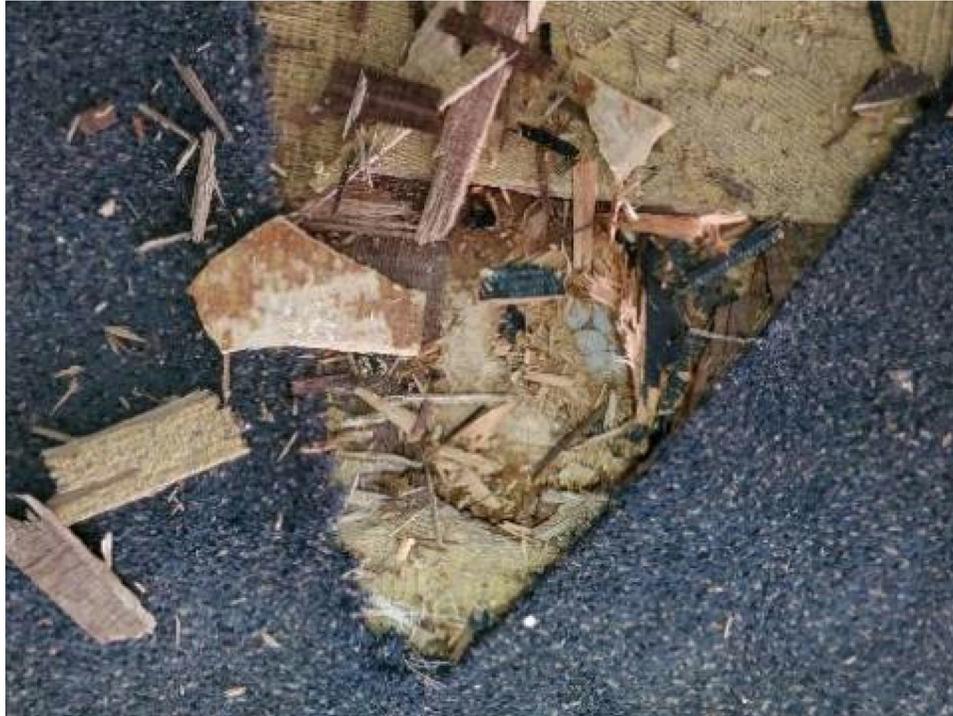
**Photo 3:** View of 1905 Bldg. 1st floor, 9" x 9" floor tile in main lobby, beneath underlayment (NC-16).

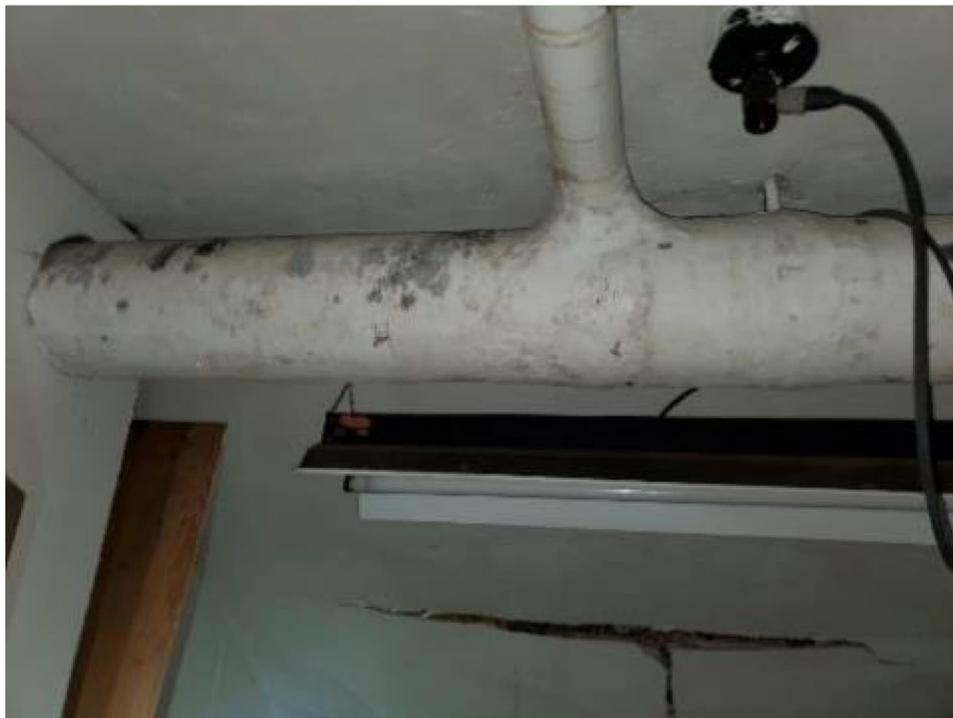
**Photo 4:** View of 1905 Bldg. Mag. Pipe insulation, basement landing of east stairwell (PC1-01).

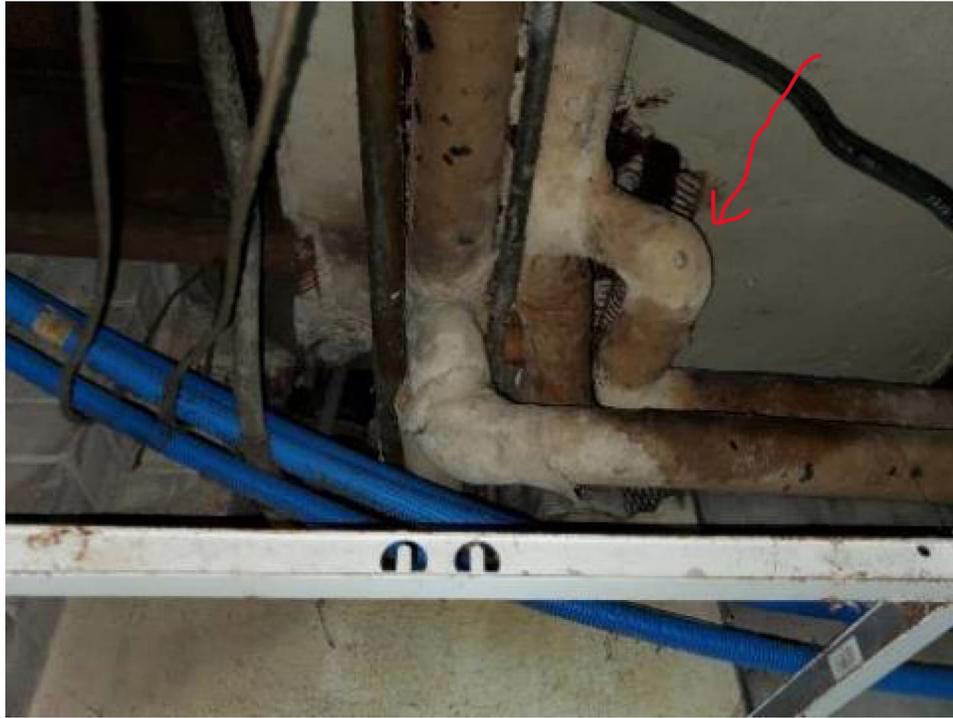
**Photo 5:** View of 1905 Bldg. basement, mudded joint fitting with canvas wrap (PC2-04).

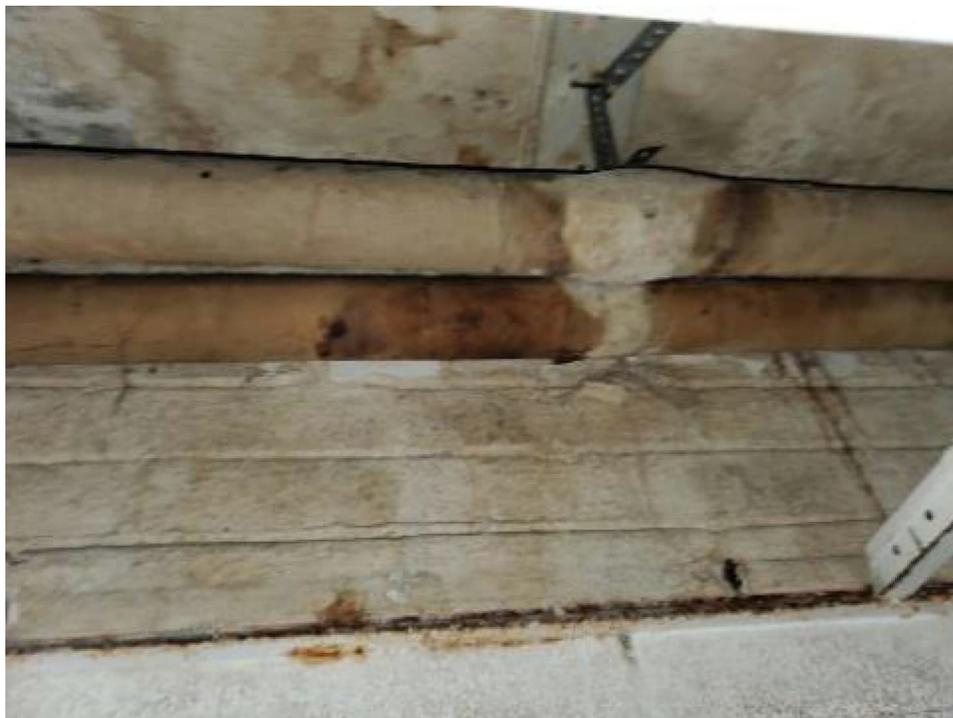
**Photo 6:** View of 1905 Bldg. basement, mudded joint fitting w/ canvas wrap on fiberglass pipe (PC3-07).

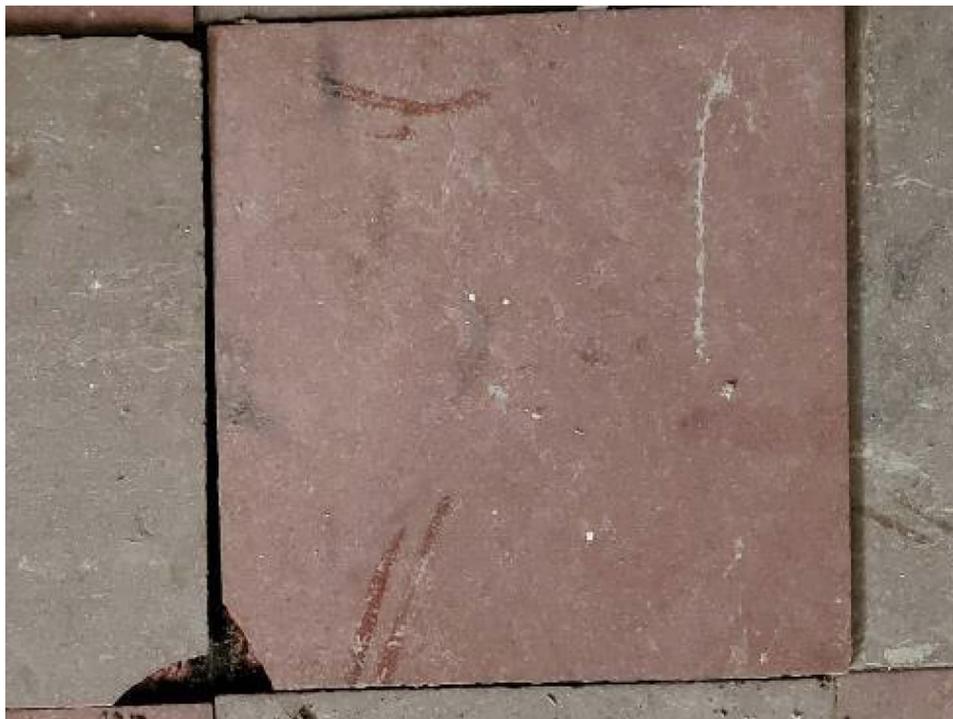
**Photo 8:** View of 1905 Bldg. basement, 9" x 9" floor tile and mastic, southeast room, corner (PC5-13).

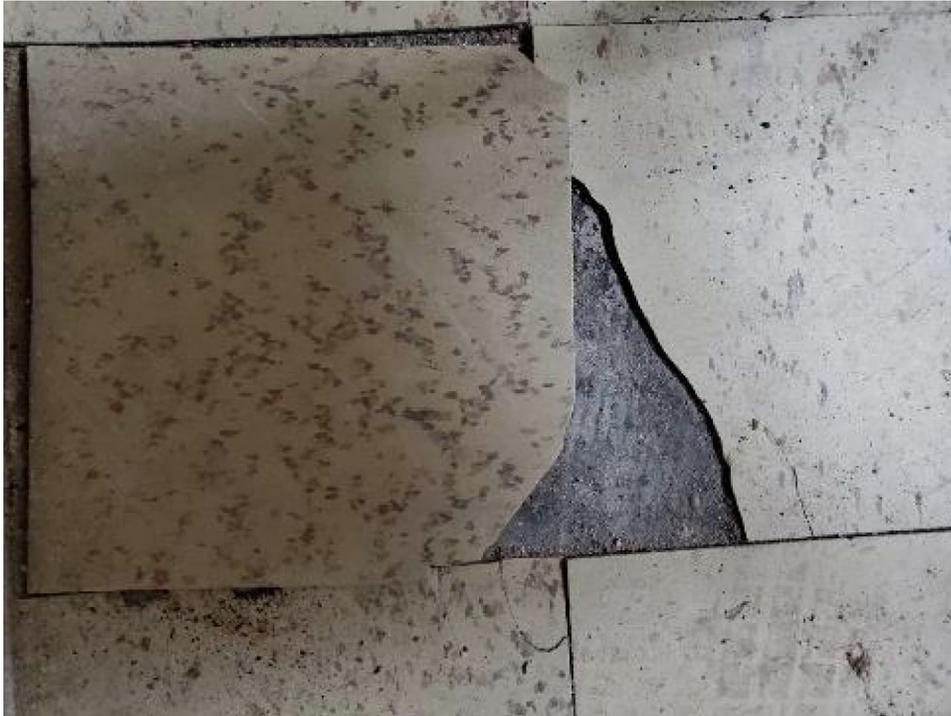
**Photo 9:** View of 1905 Bldg. 1<sup>st</sup> floor, southeast room, 9" x 9" floor tile, (PC6-16).

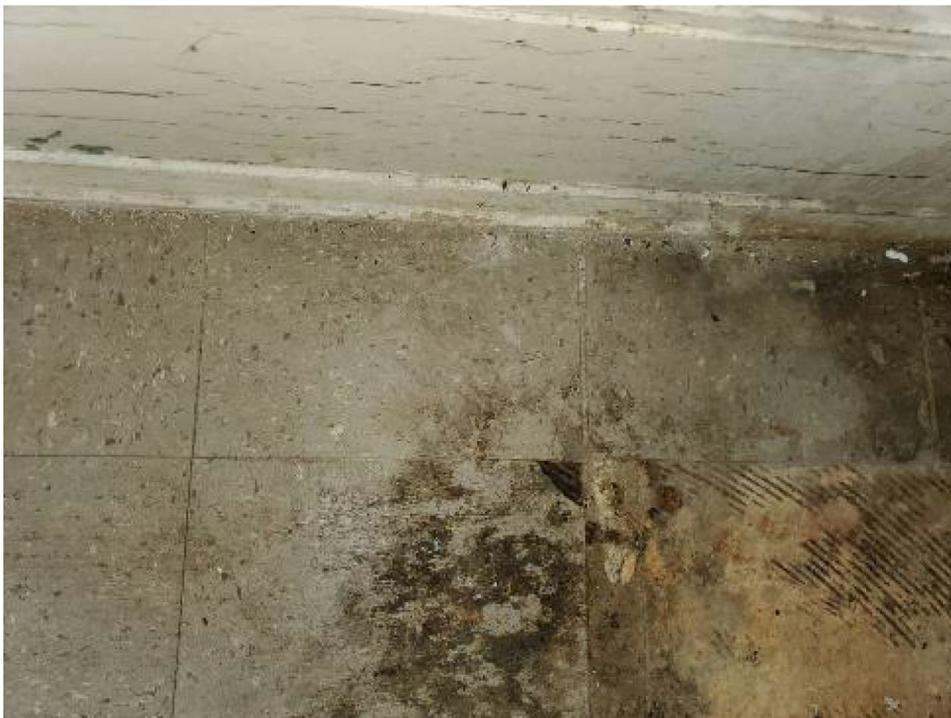
**Photo 10:** View of 1905 Bldg. 1<sup>st</sup> floor, storage room, 9" x 9" floor tile (PC7-19).

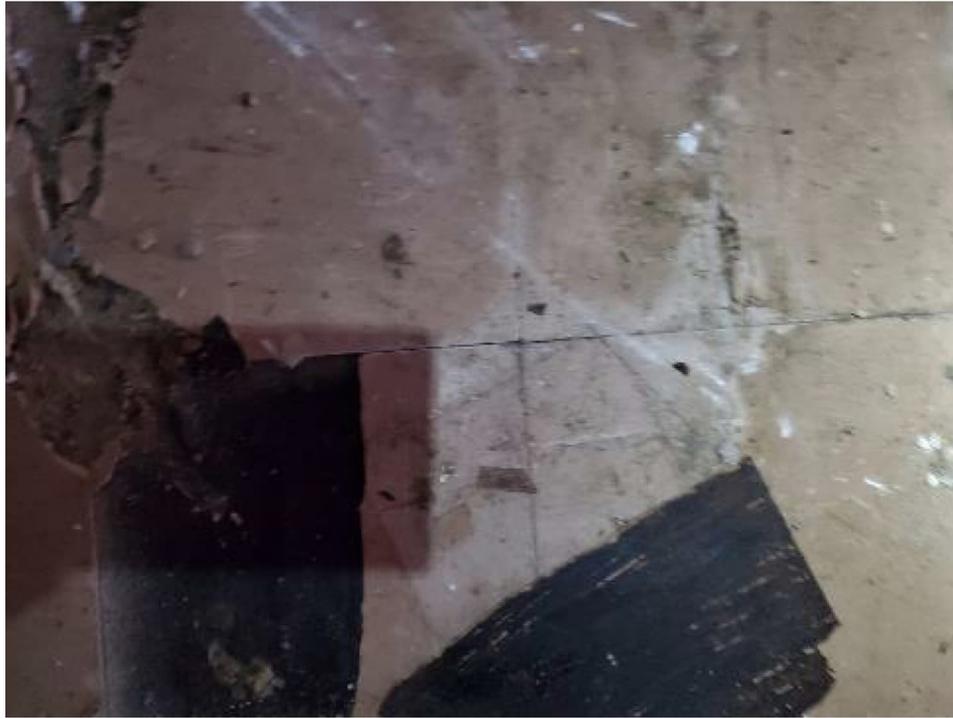
**Photo 11:** View of 1905 Bldg. 2<sup>nd</sup> floor, near the restrooms, 9" x 9" floor tile & mastic (PC8-22).

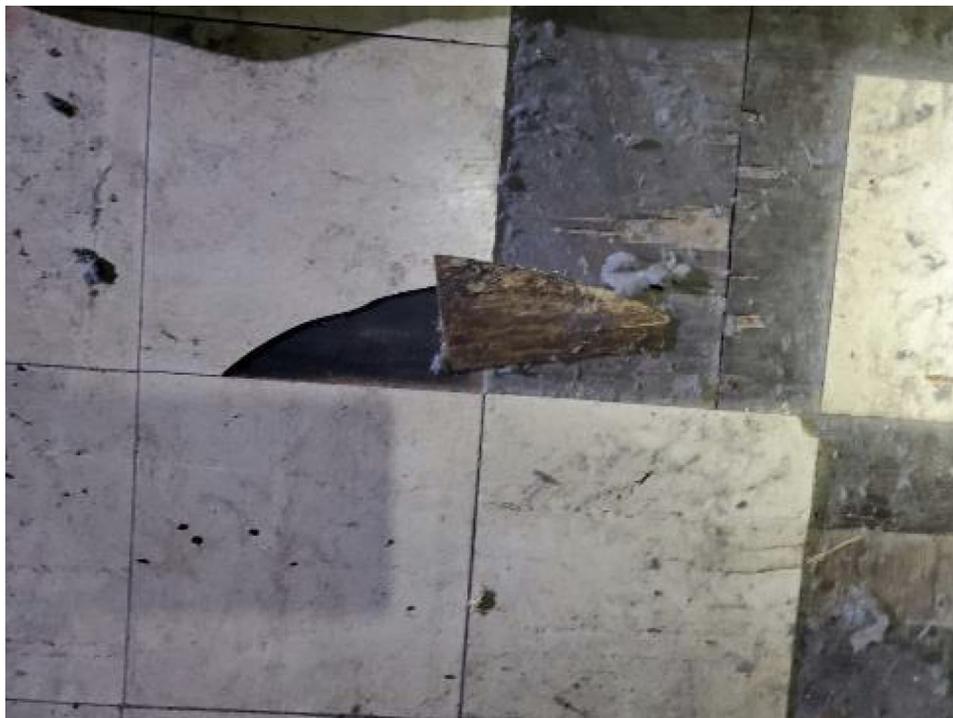
**Photo 12:** View of 1905 Bldg. 2<sup>nd</sup> floor, kitchen area, 9" x 9" floor tile (PC9-25).

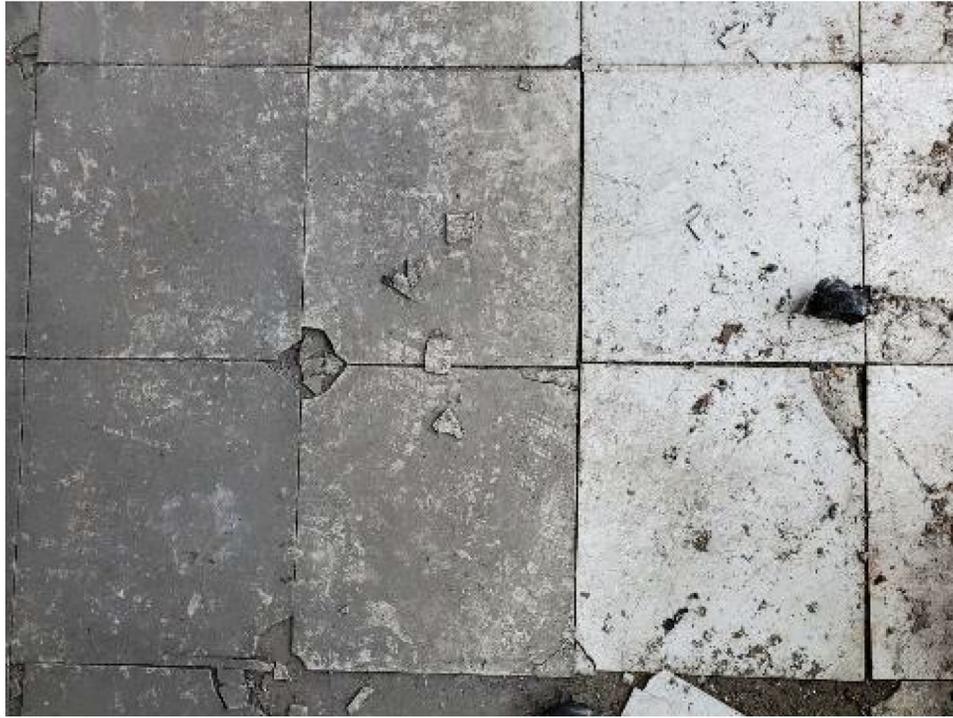
**Photo 13:** View of Bldg. 1961 1<sup>st</sup> floor, main lobby, 12" x 12" floor tile & mastic (PC13-37).

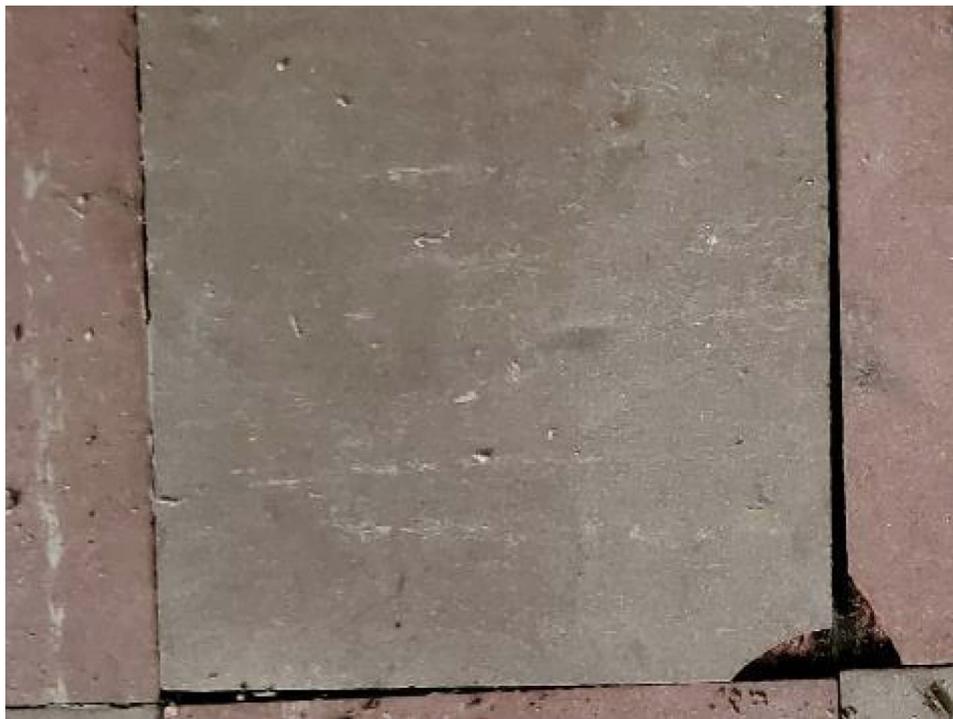
**Photo 14:** View of 1905 Bldg. basement, 9" x 9" floor tile & mastic, southeast room, corner (PC14-40).

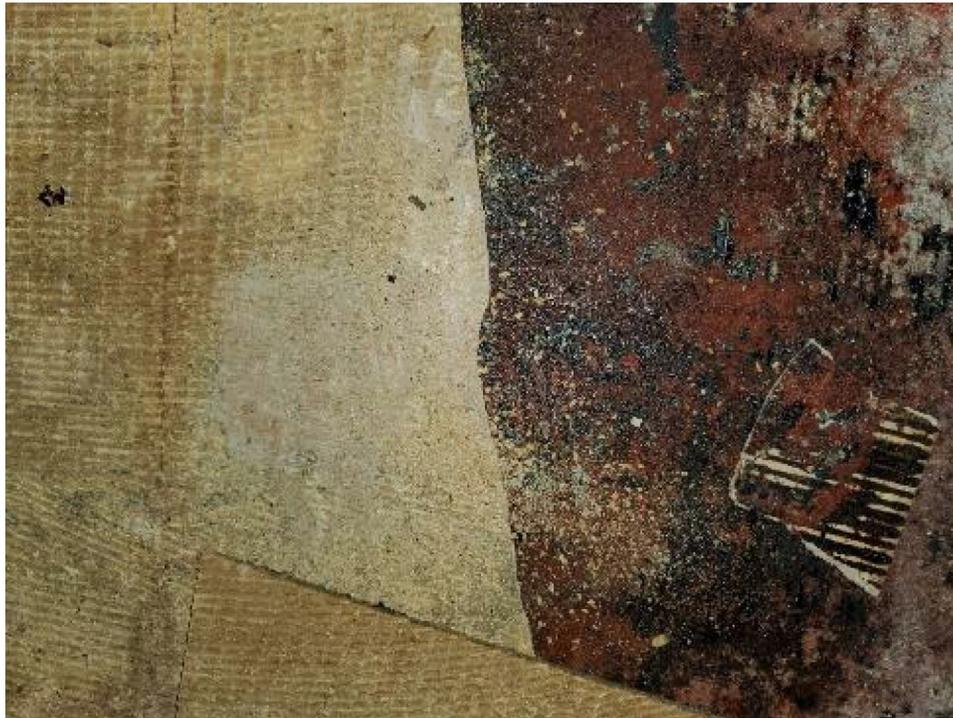
**Photo 15:** View of 1905 Bldg. basement, 9" x 9" floor tile, southeast room (PC15-43).

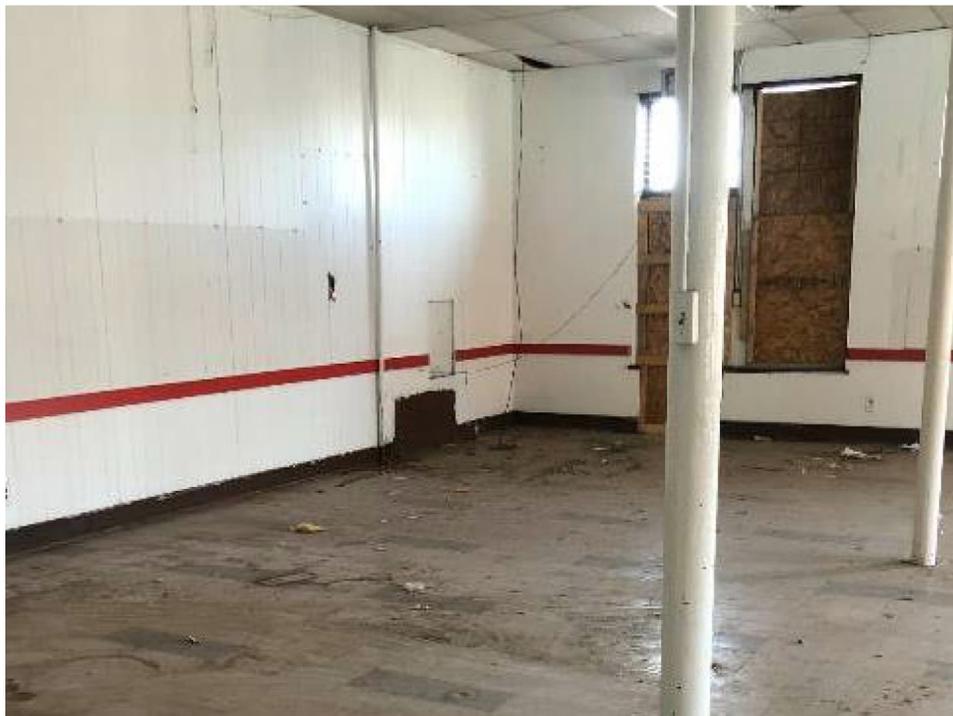
**Photo 16:** View of 1905 Bldg. 2<sup>nd</sup> floor north room, black caulk behind paneling walls (HA-1).

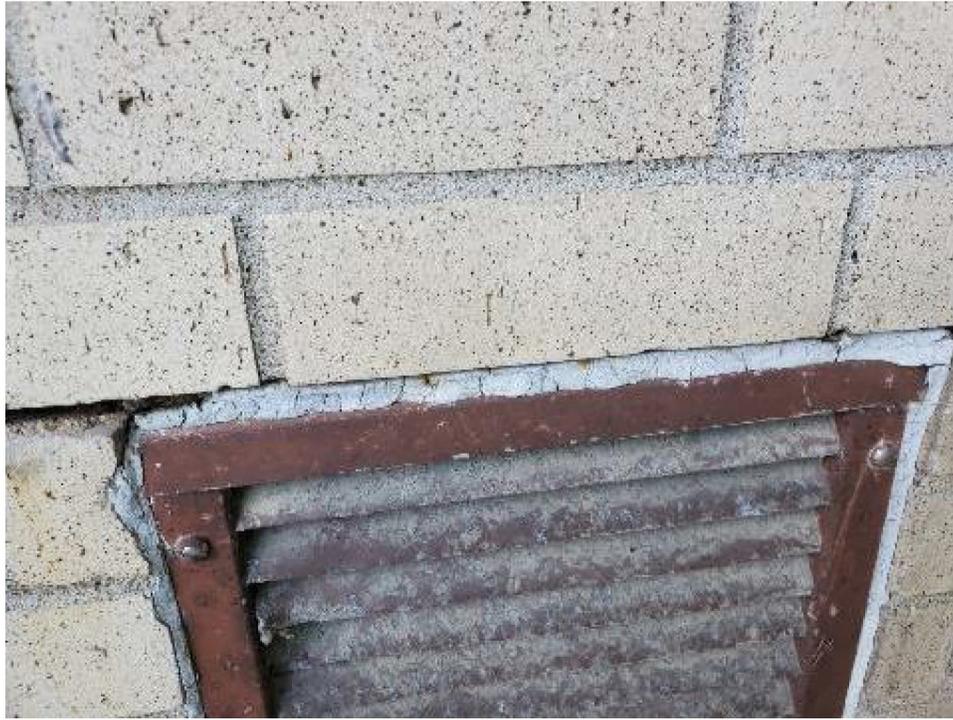
**Photo 16:** View of 1961 Bldg. exterior north wall, gray caulk on building exhaust (HA-15).

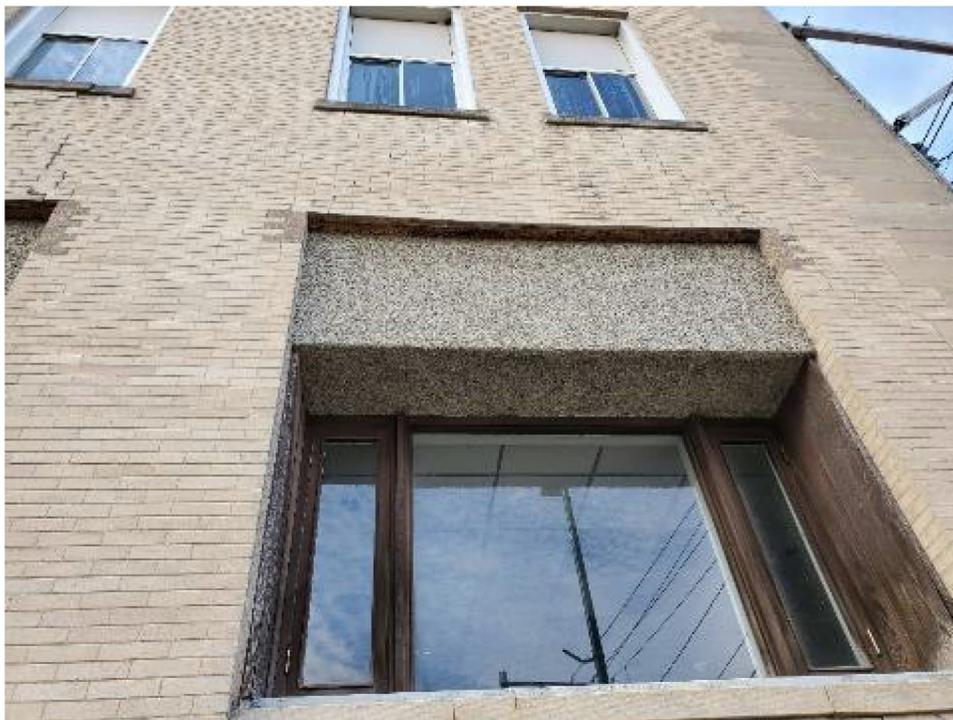
**Photo 16:** View of 1905 Bldg. exterior window caulk around window frames, gray (HA-15).

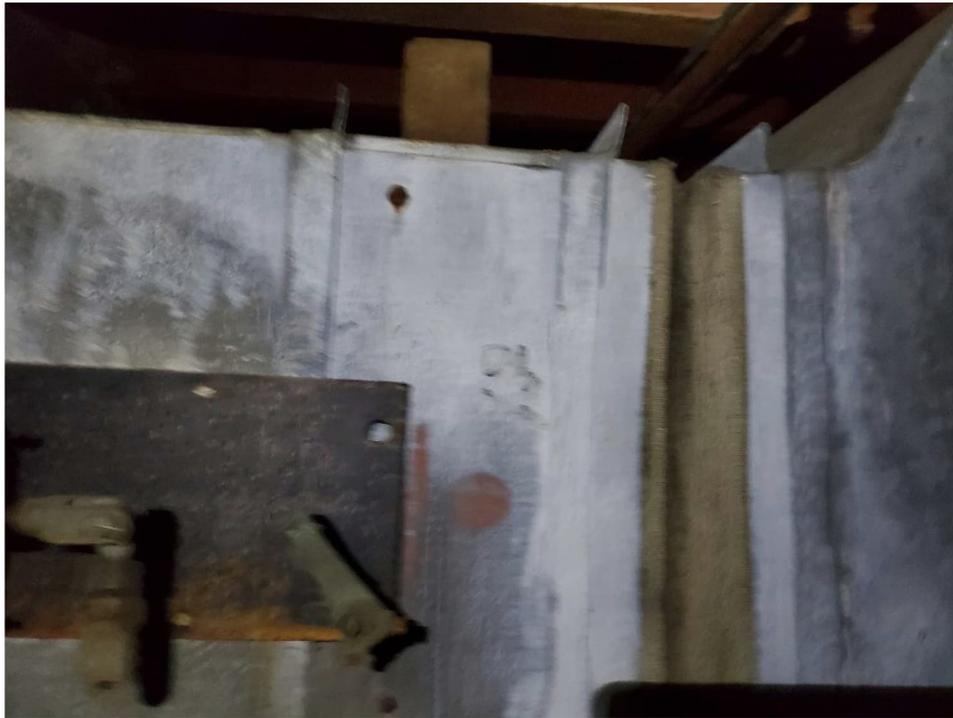
**Photo 17:** View of 1961 mezzanine mechanical room vibration cloth, white (HA-17).

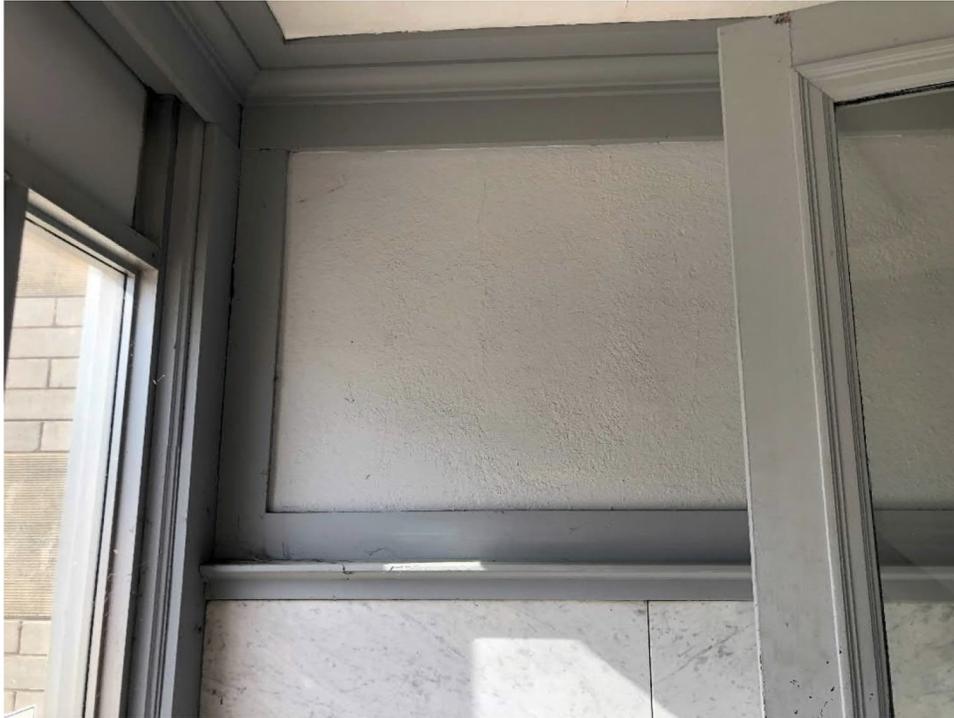
**Photo 1:** View of LBP plaster in main entrance area of building

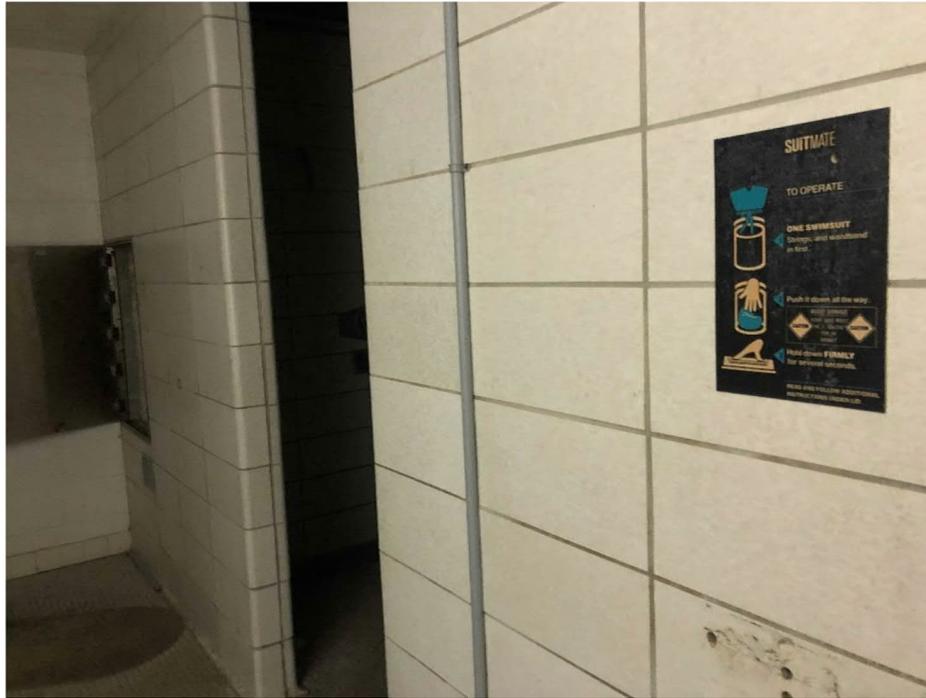
**Photo 3:** View of LBP on glazed ceramic block in locker rooms

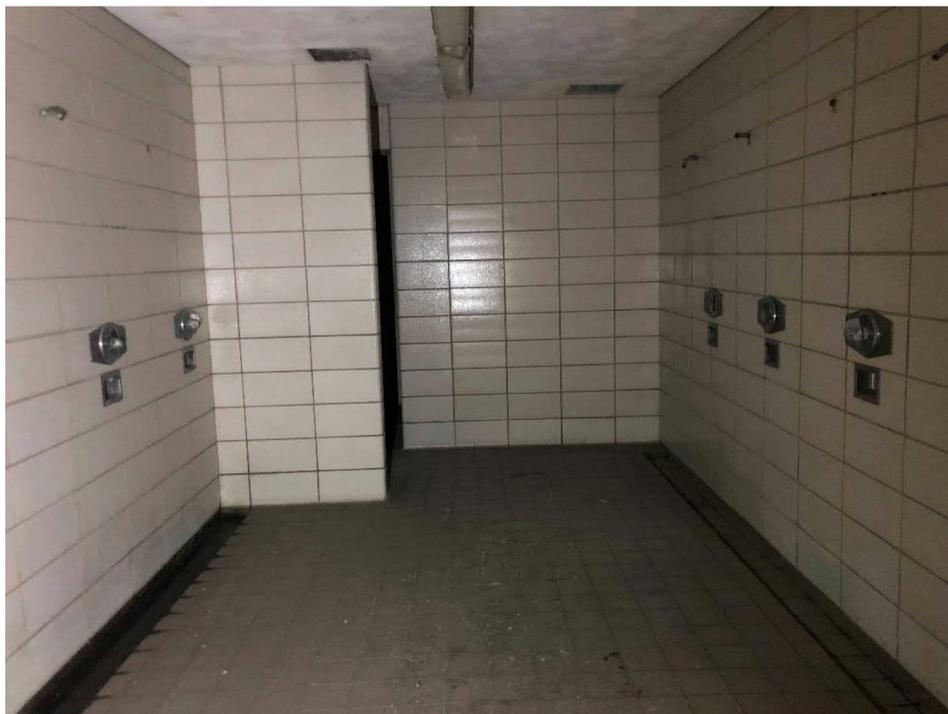
**Photo 4:** View of LBP on glazed ceramic block in locker rooms

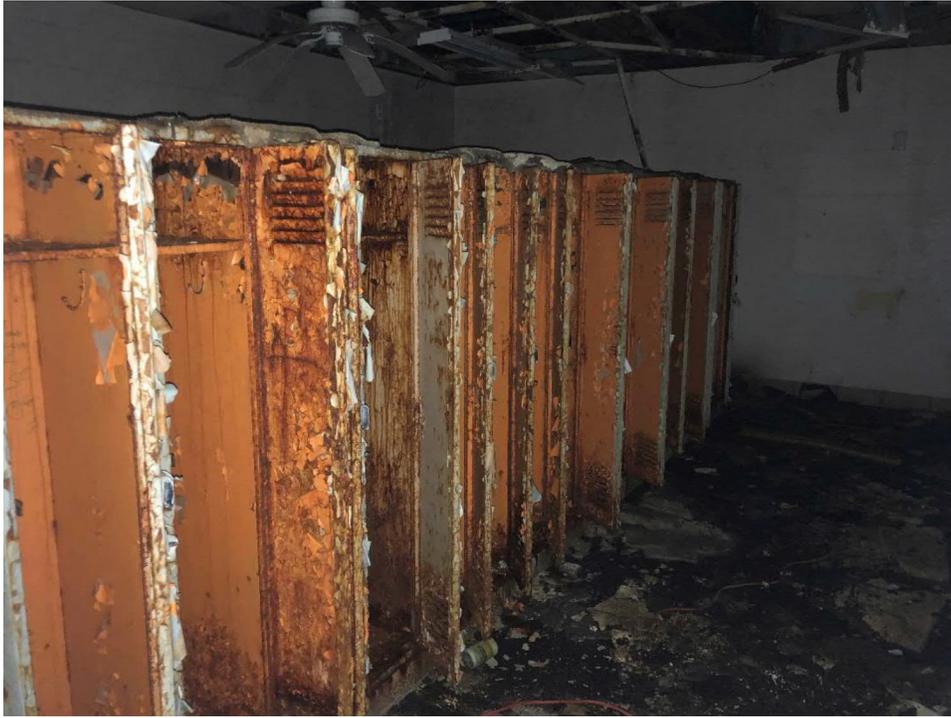
**Photo 5:** View of LBP on lockers

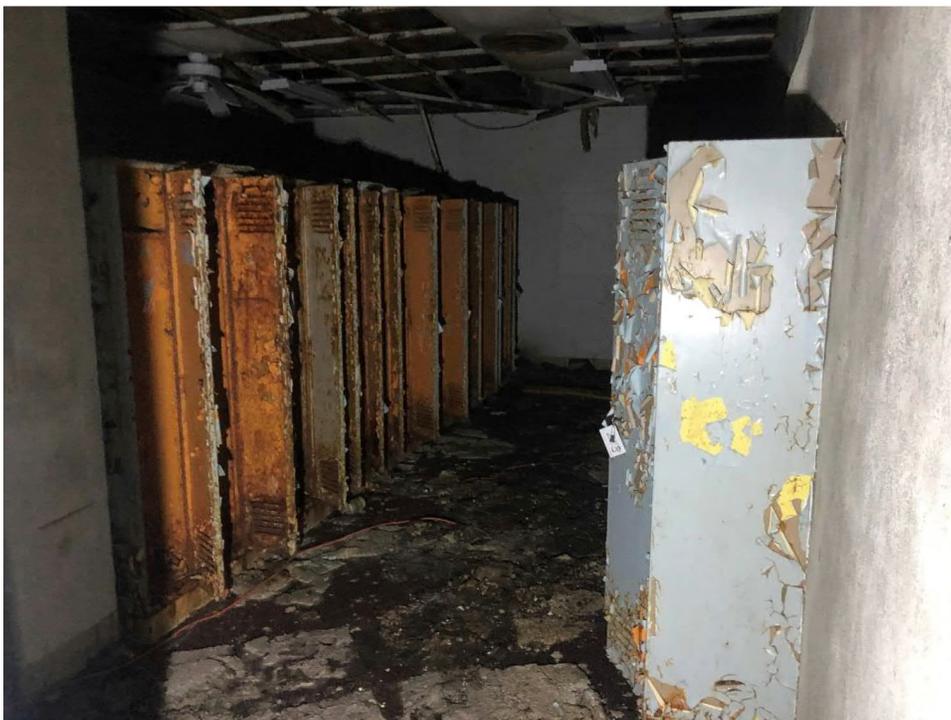
**Photo 6:** View of LBP on lockers

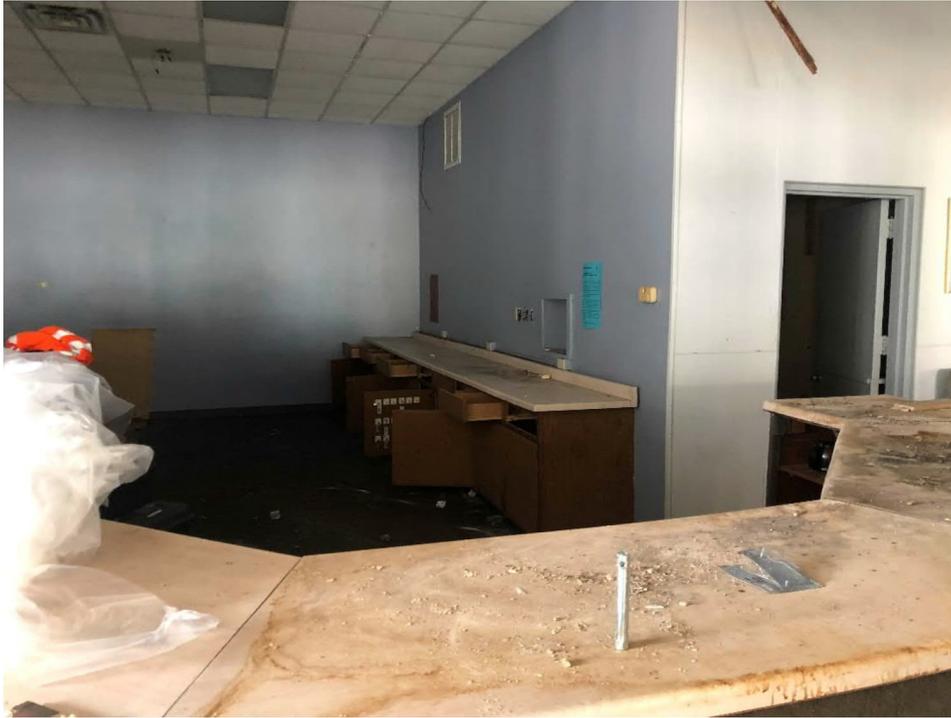
**Photo 7:** View of LBP on west wall of main lobby/entrance area

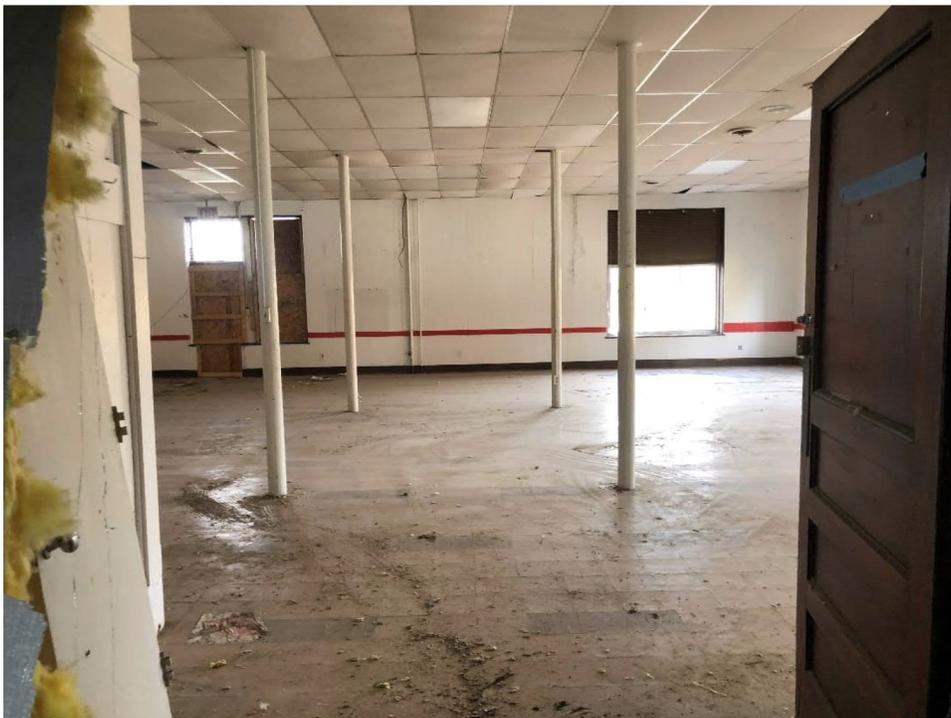
**Photo 8:** View of LBP on support poles in small gym

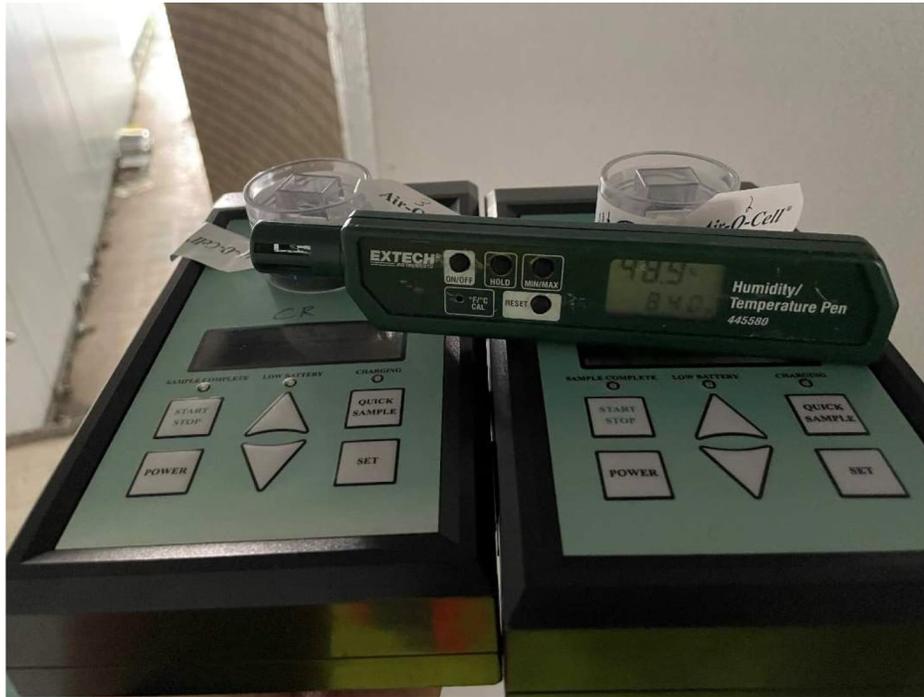
Photo 1: View of spore trap samples 2 and 3 on first floor

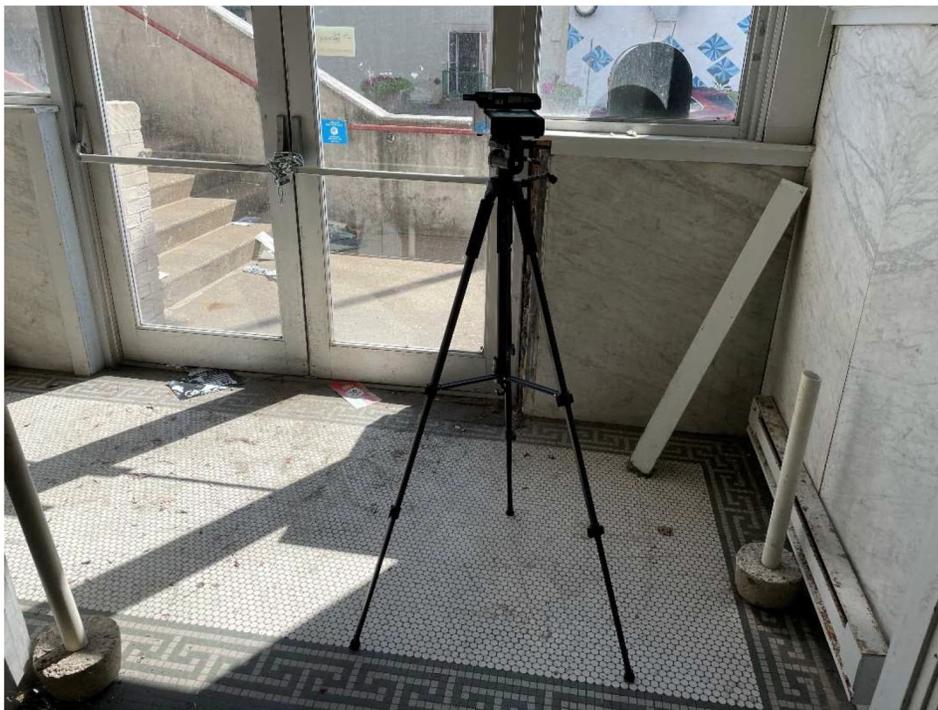
Photo 2: Area of view of spore trap sample number 6 in stairwell leading to basement

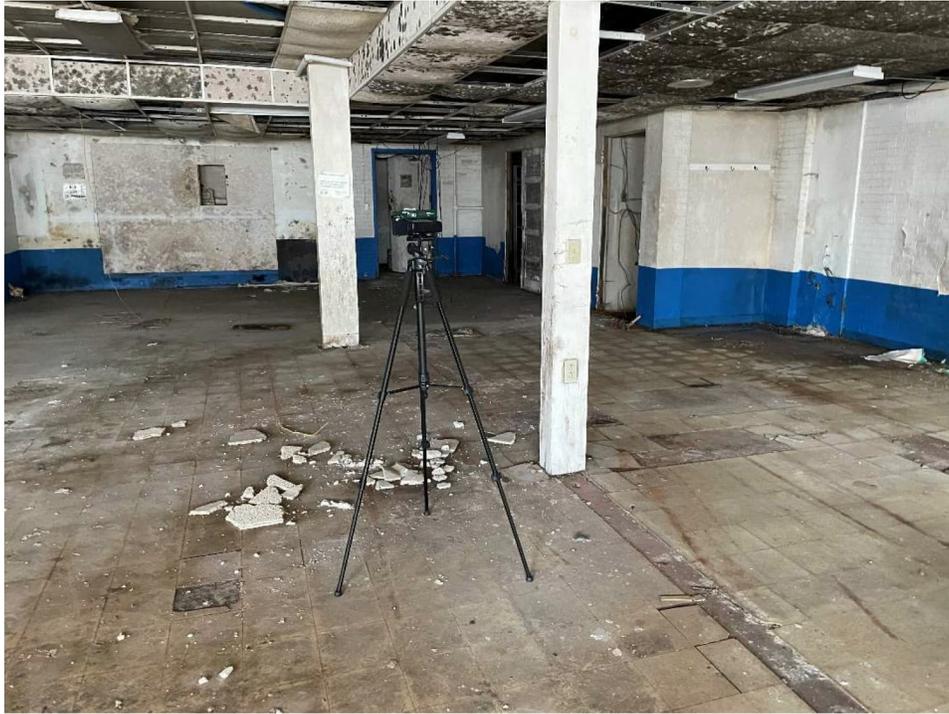
**Photo 3:** General view of spore trap sample number 8 in approximate center of basement

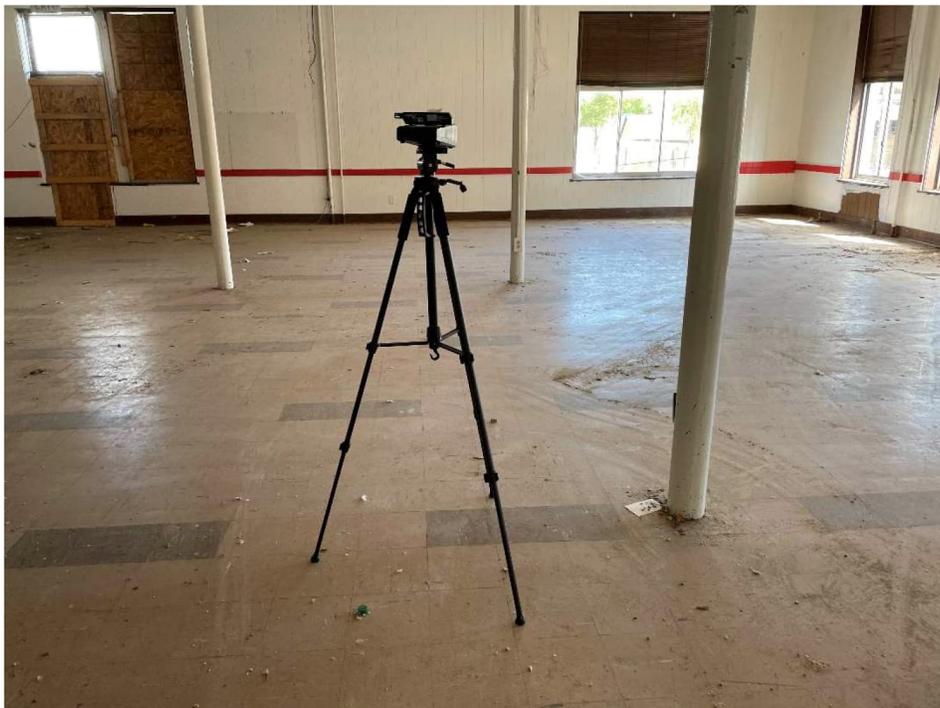
**Photo 4:** General view of spore trap sample number 15 in Room 11 on second floor

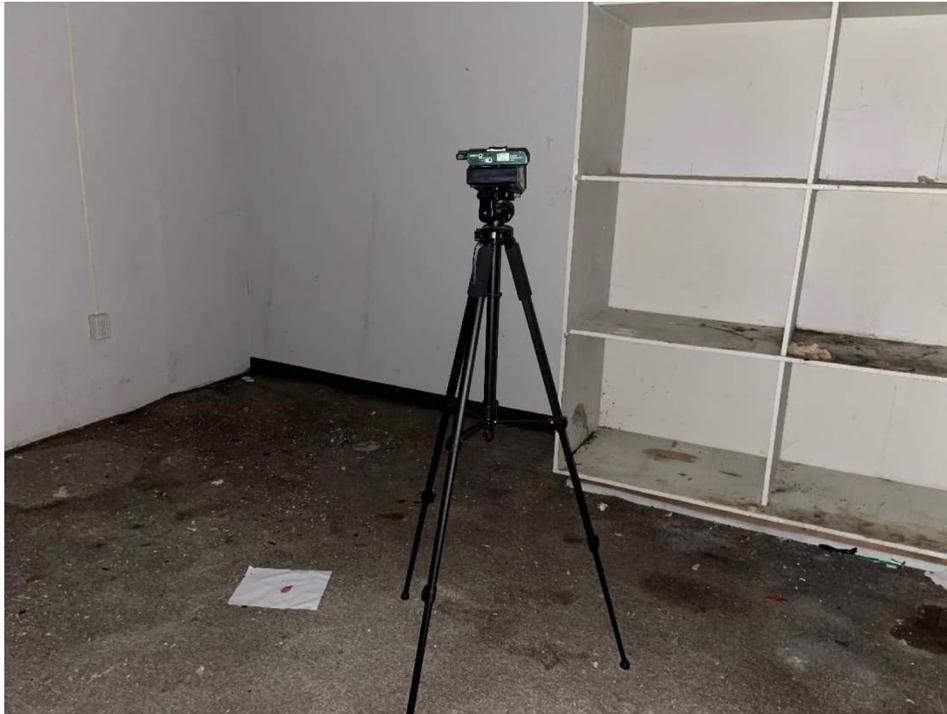
**Photo 5:** General view of spore trap sample number 18 in Room 10 on second floor

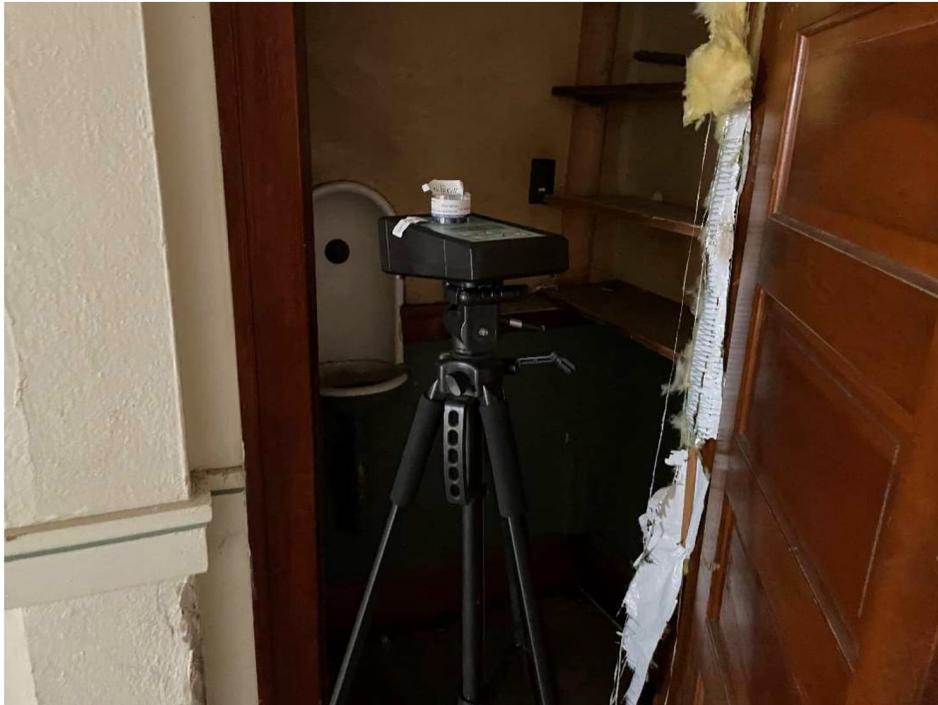
**Photo 6:** General view of spore trap sample number 25 in North Restroom on second floor

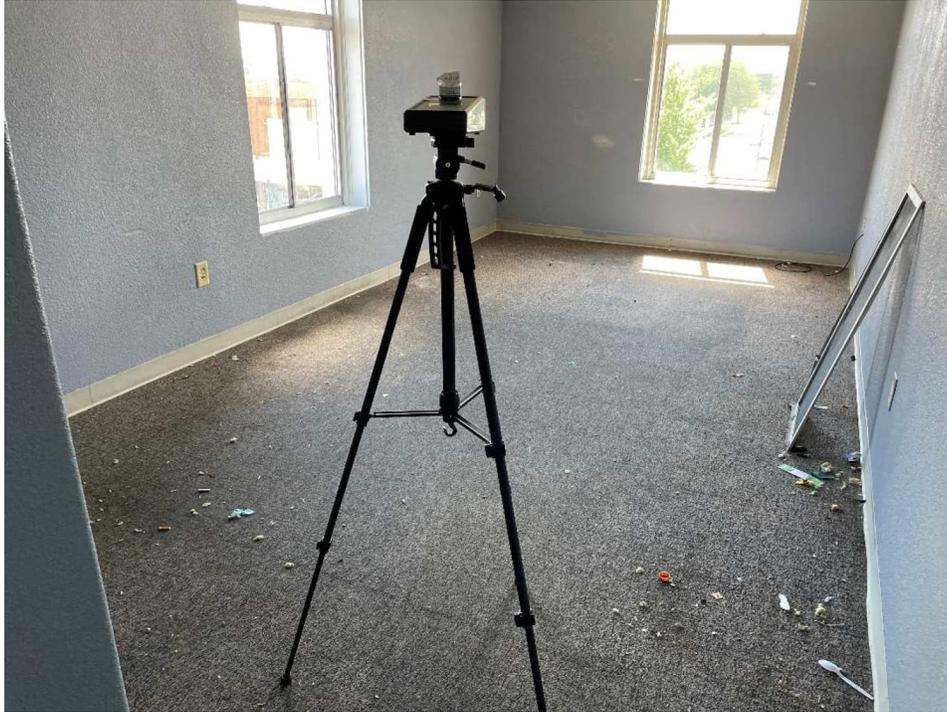
**Photo 7:** General view of spore trap sampe number 33 in Unit 313 on third floor
