# Analysis of Brownfield Cleanup Alternatives

480 S. 3rd Street  
Clinton, Clinton County, Iowa 52732

Terracon Project No. 07207086; Task 22/32.4

**Re: Analysis of Brownfield Cleanup Alternatives**  
Clinton YMCA - 480 S. 3rd Street  
Clinton, Clinton County, Iowa 52732  
Terracon Project No. 07207086 T22/32.4  
Brownfields Assessment Grant: BF97782001

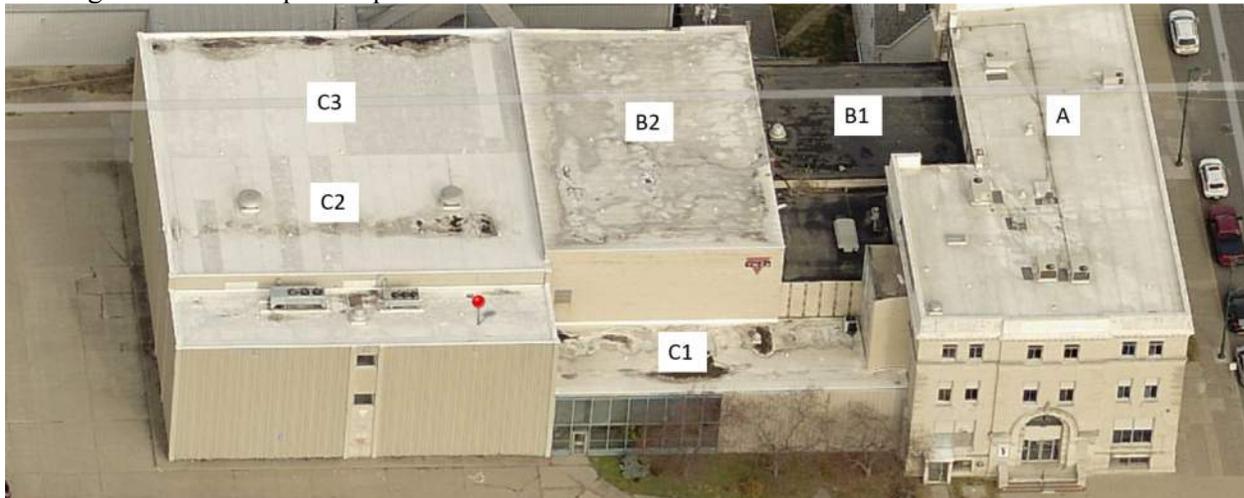
Building A as designated below is the original building on the site. It is a wood frame structure with some steel beams/columns at large opening and in the basement. The exterior is a brick façade which is in relatively good condition except for some lateral cracking due to settlement. The Basement in this building is made out of precast panels in some areas and a steel skeleton in others.

The wood framing in the structure has not been badly damaged over the years and is in good condition. The lack of water in the structure has kept this building from rotting over time, even while it was unoccupied. The basement did have some water/ mold but it appear that the structure held up and should not need to have much done in the form of renovation to the structure. In the opinion of Select Structural Engineering, this building is salvageable. Picture below show the structure and give an indication of condition.

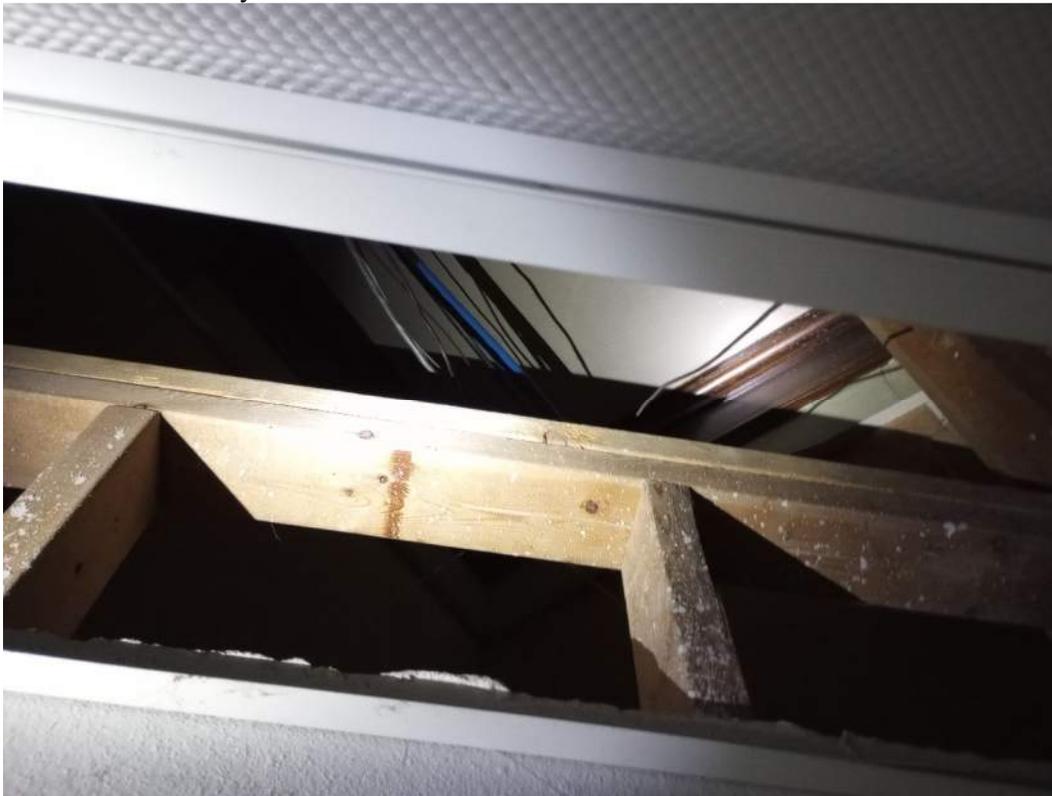
Wood Framed Lobby Area

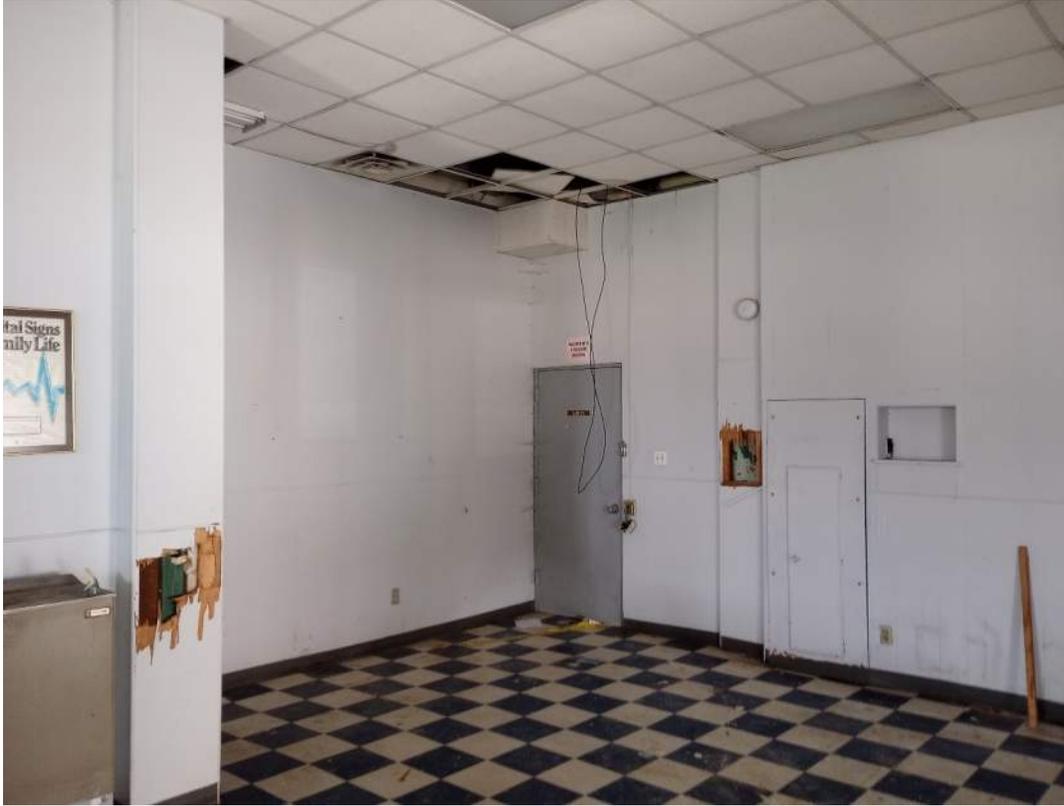
Wood Framed Lobby Area/Entrance to Locker Area

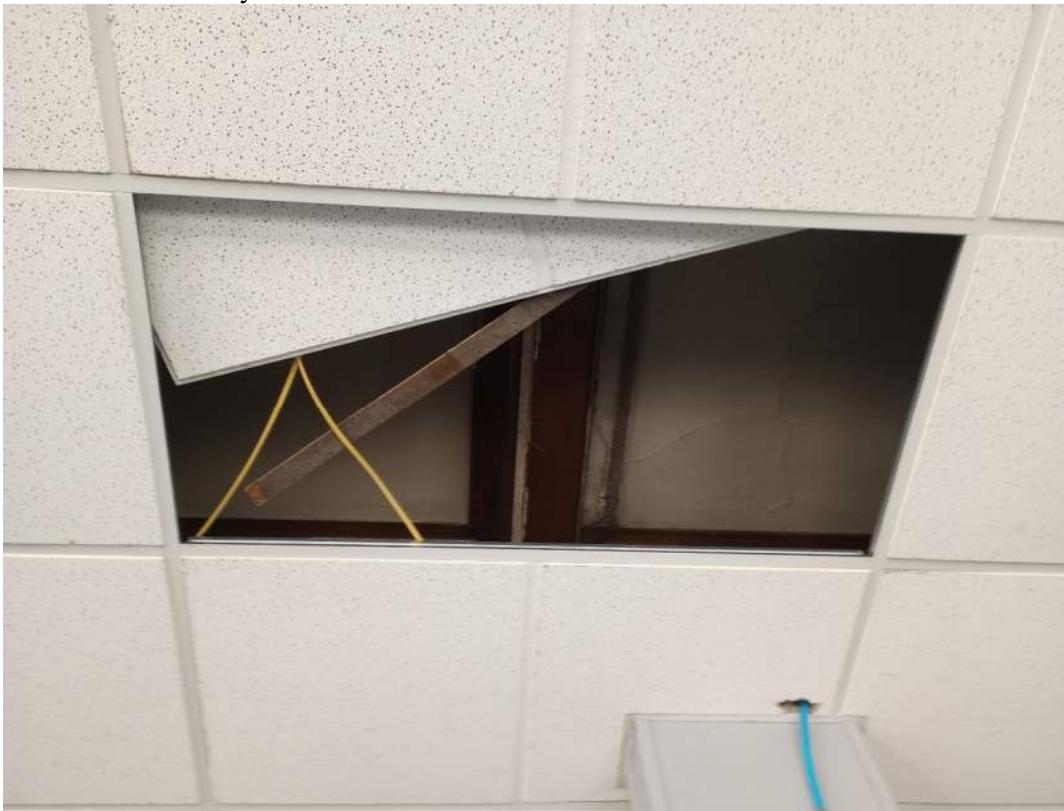
Steel Structure in Lobby Area

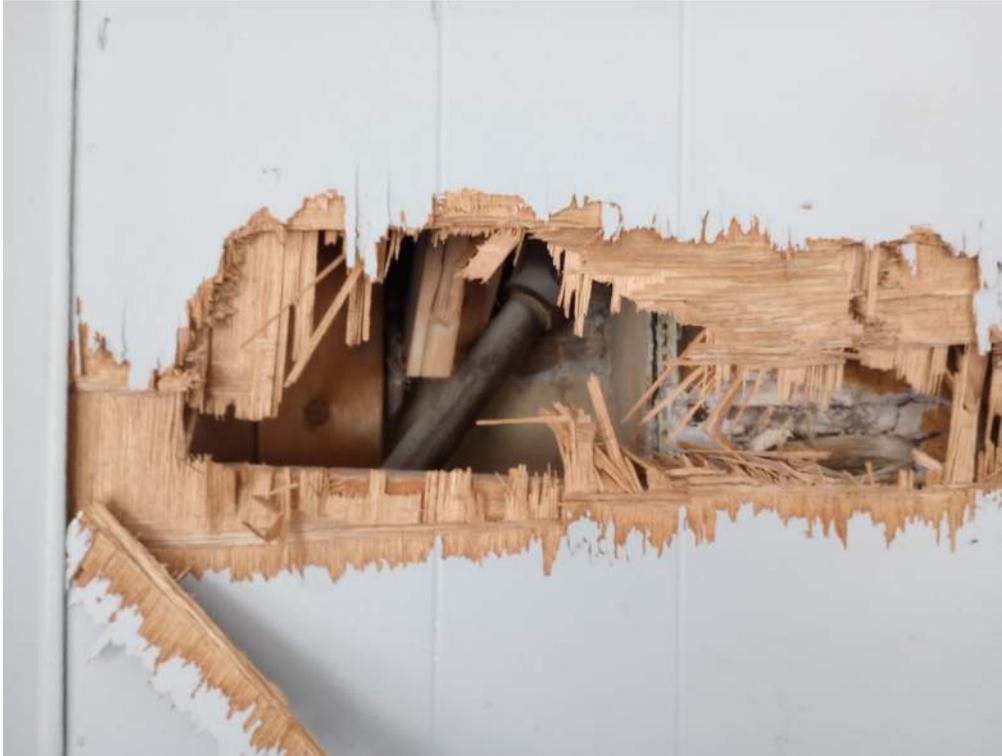
Wood Framed Construction In Lobby Area

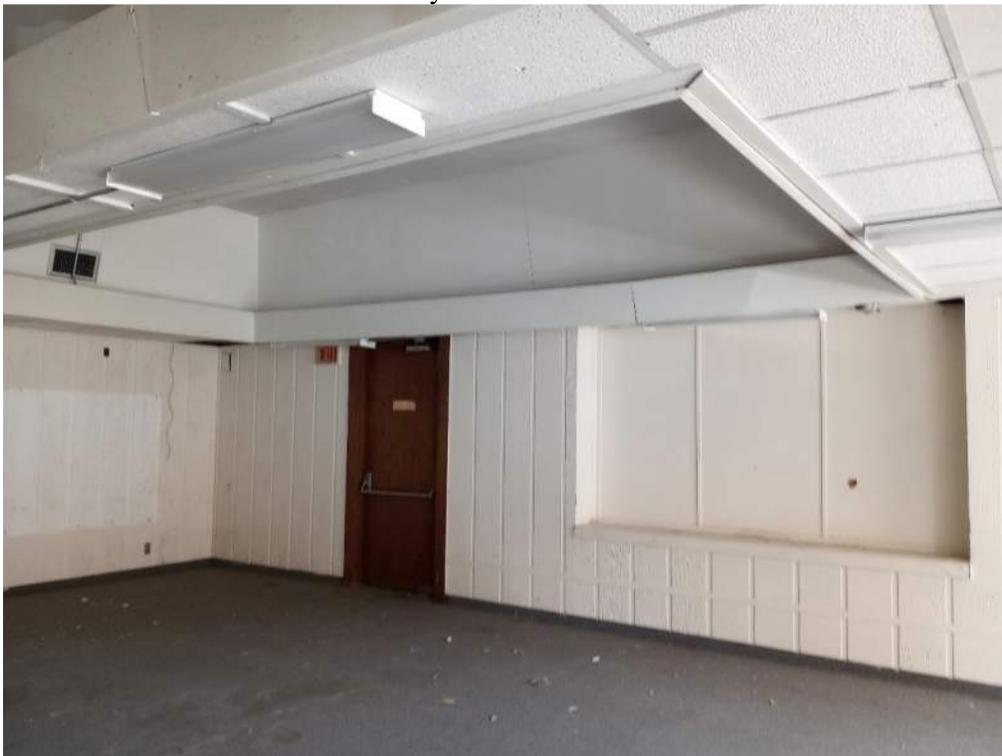
Wood and Steel framed Construction in Basement Under Dormitories

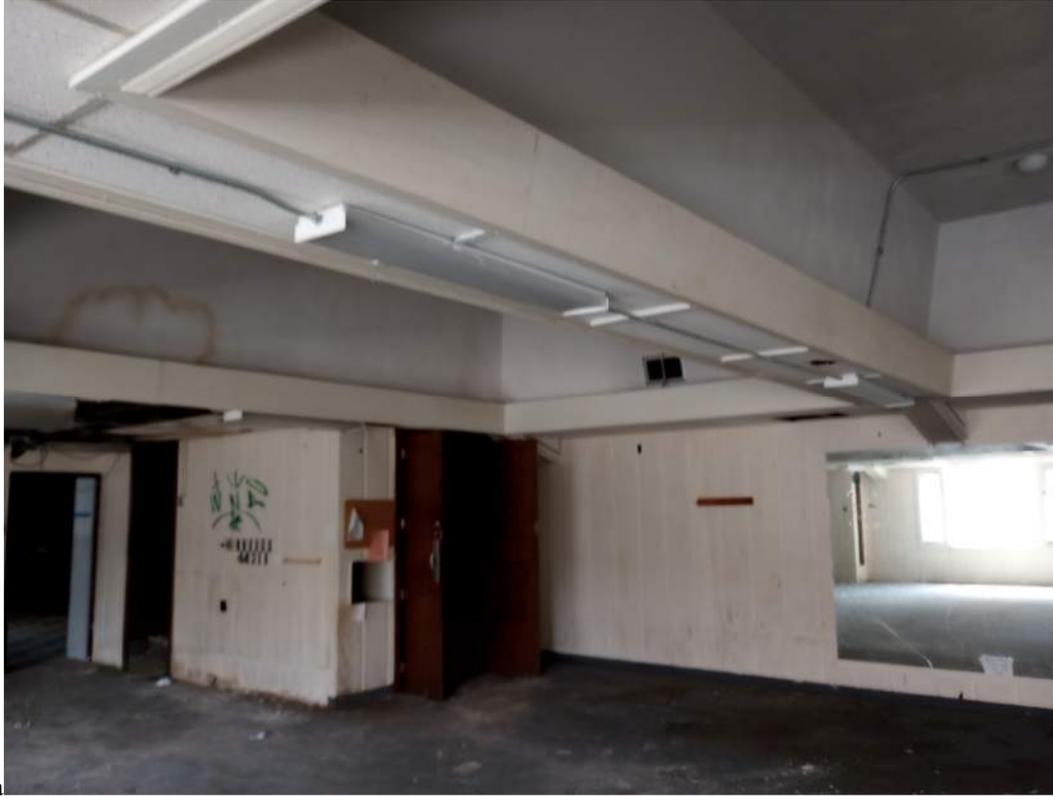
a  
Wood and Steel framed Construction in Basement Under Dormitories

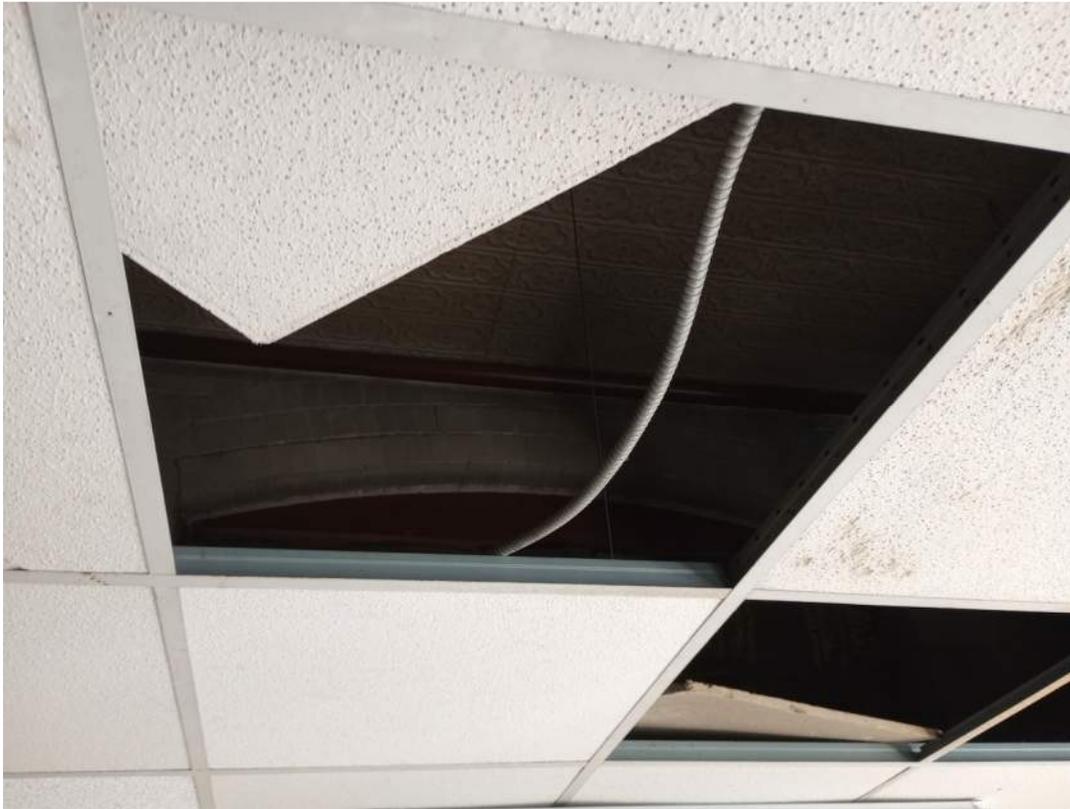
Wood and Steel framed Construction in Basement Under Dormitories

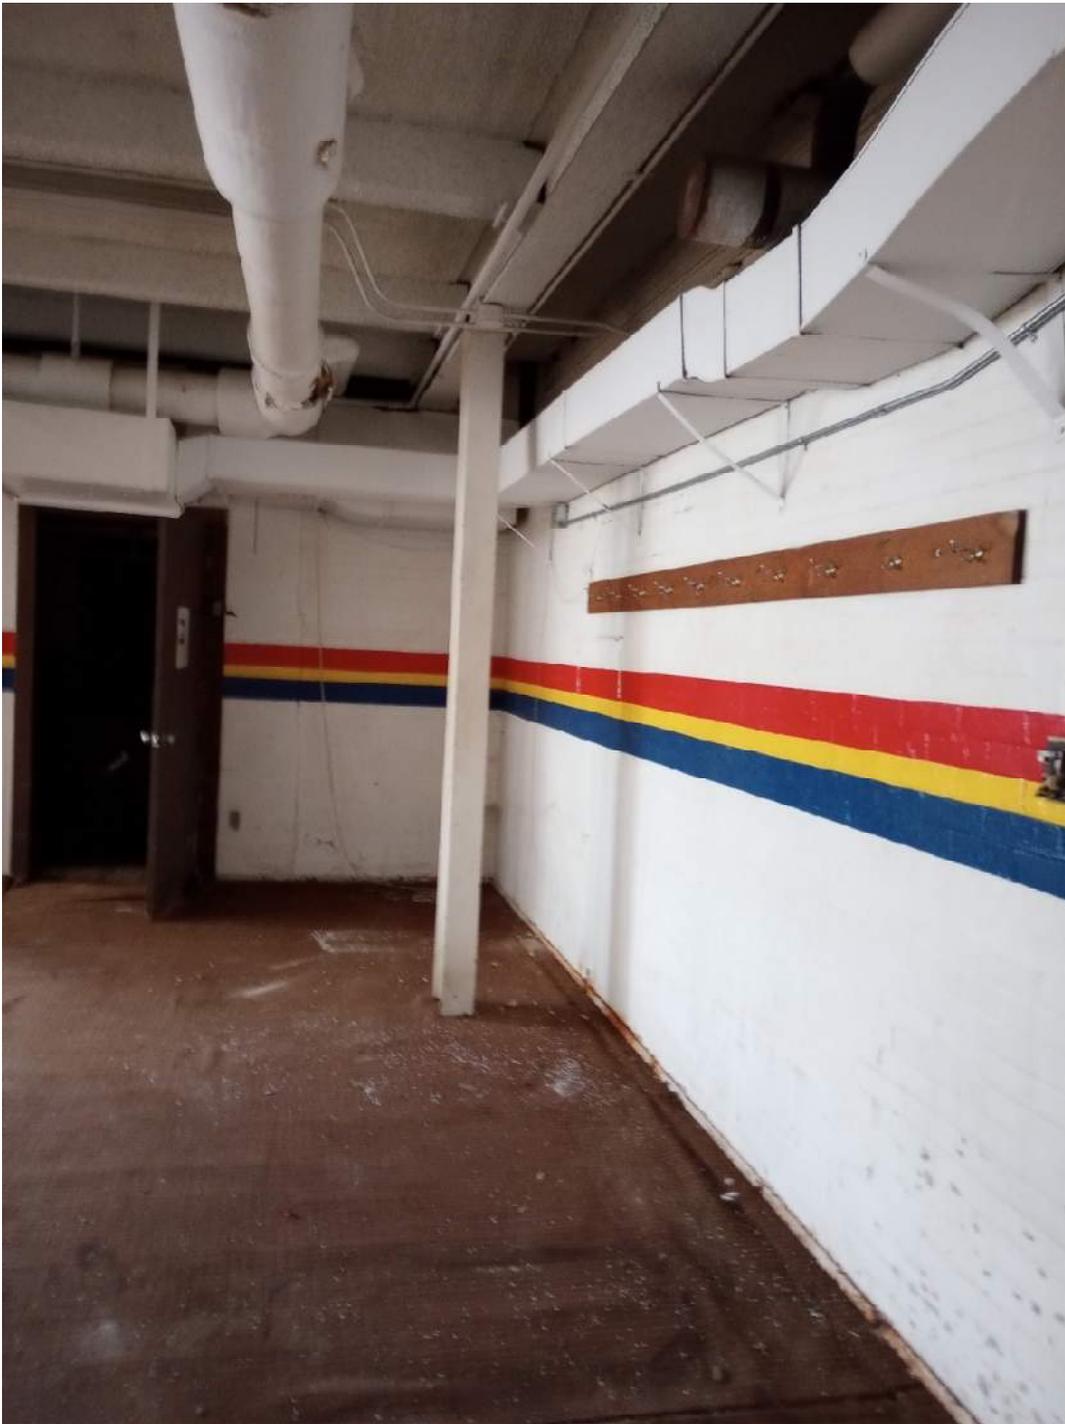
Wood and Steel framed Construction in Basement Under Lobby

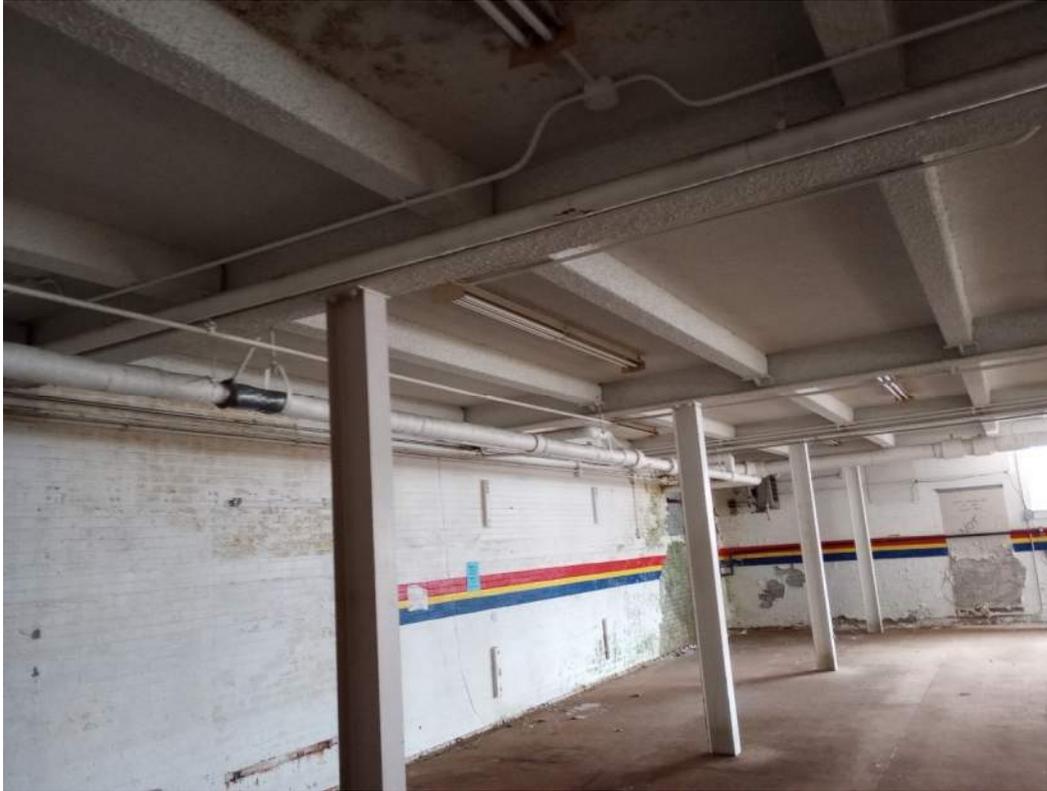
Wood and Steel framed Construction in Basement Under Lobby

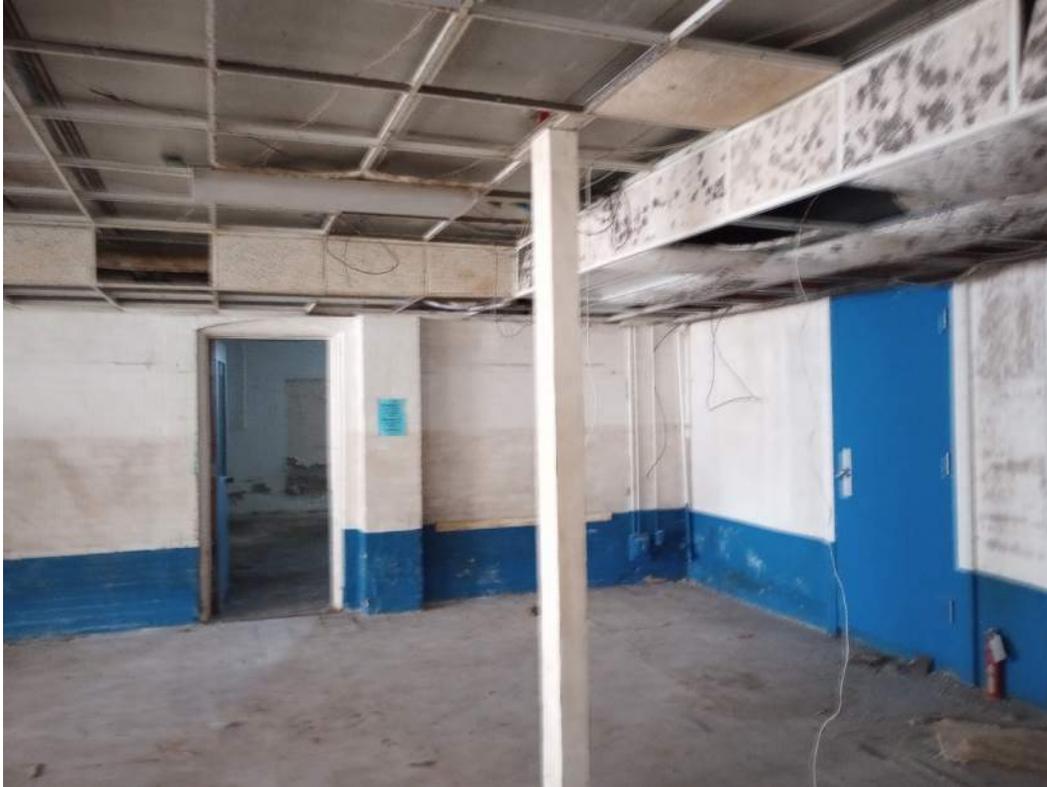
Precast Floors Under Lobby in Building A

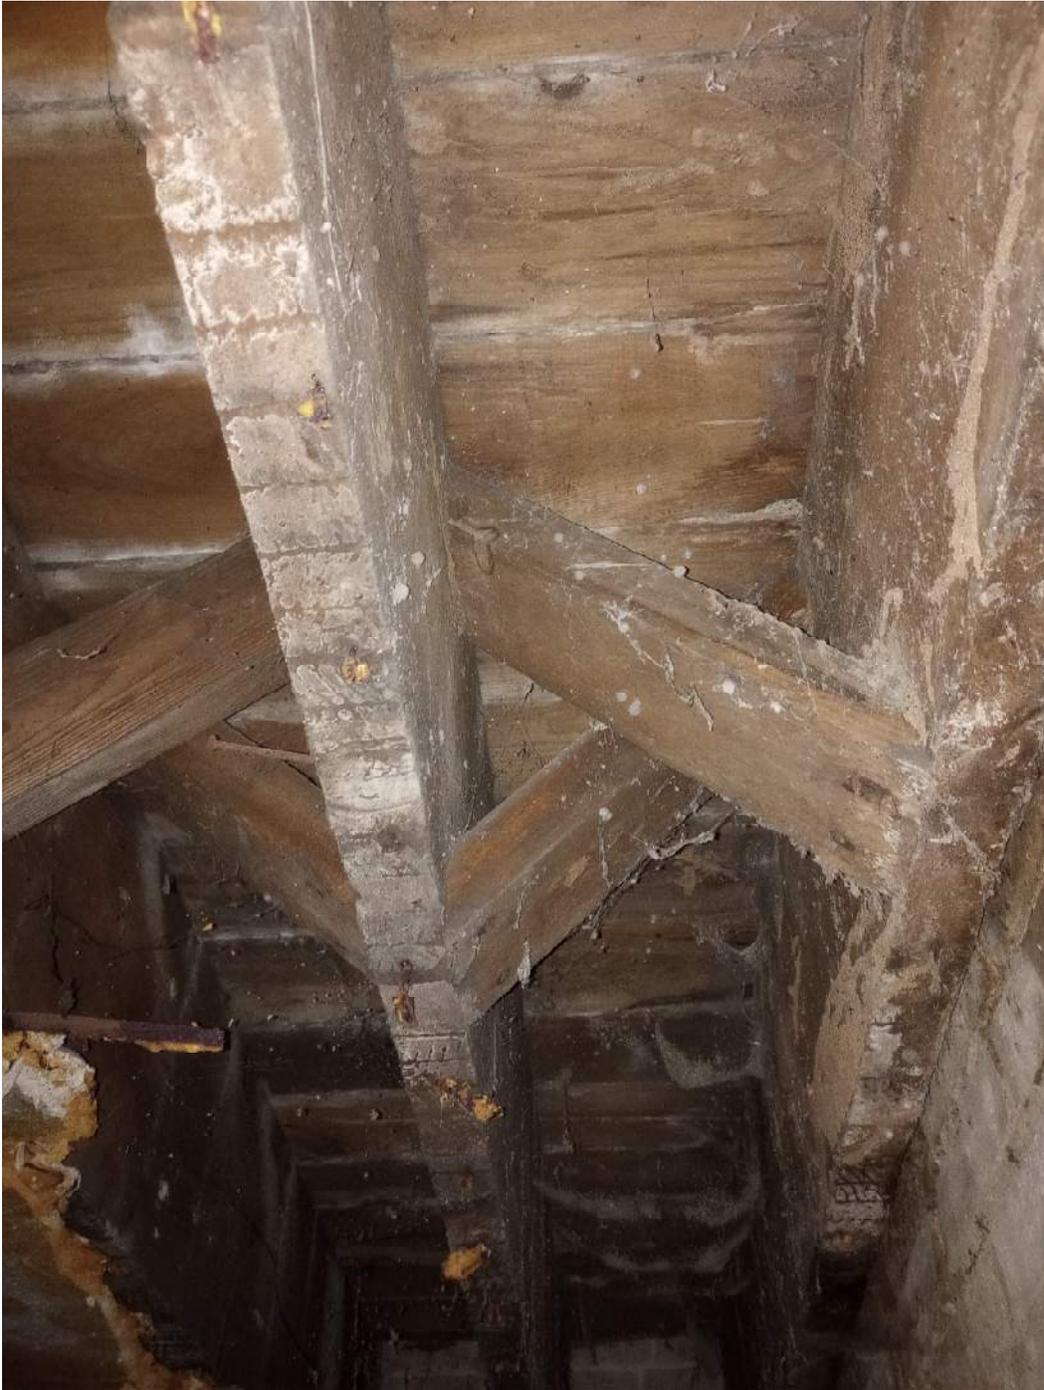
Uncompromised Wood Structure in the Floor Cavity of Building A

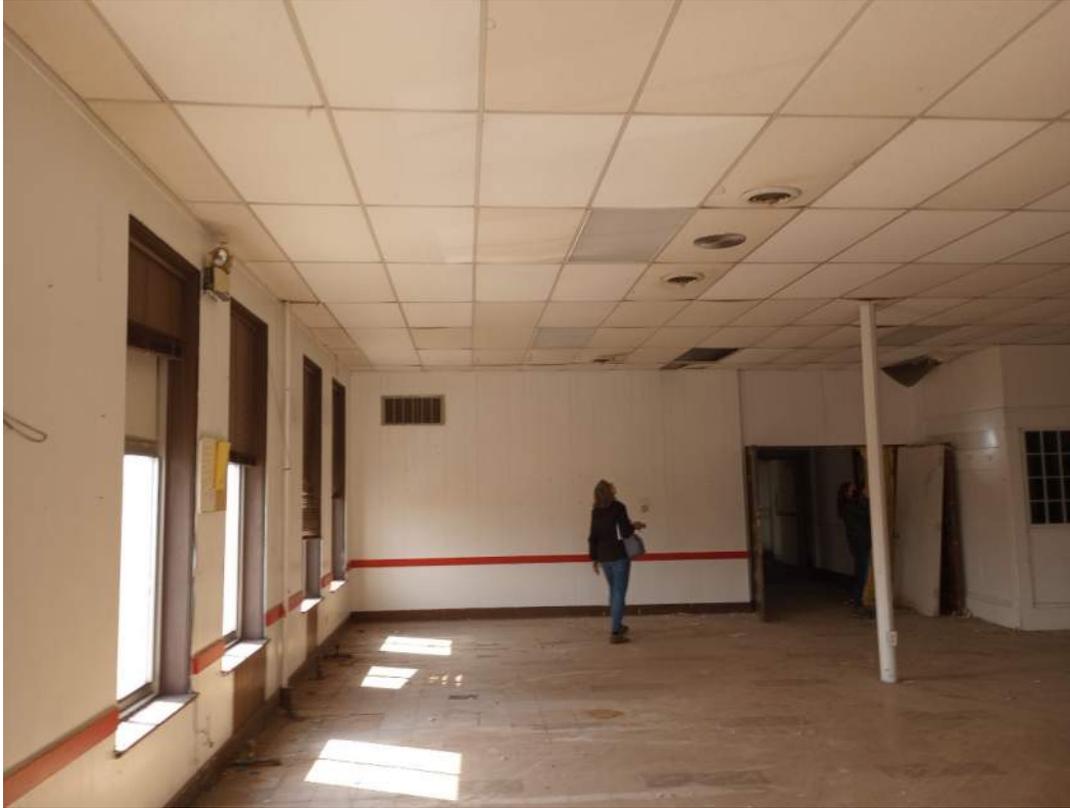
Uncompromised Wood and Steel Framing in Second Story of Building A

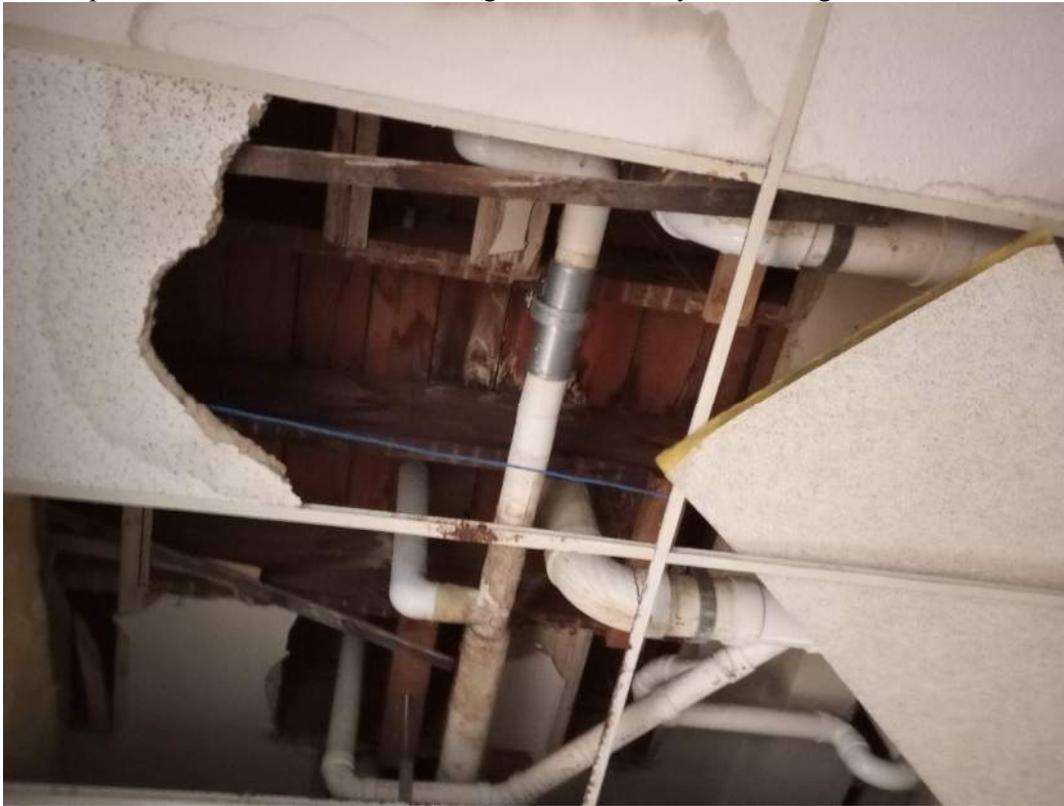
Uncompromised Wood and Steel Framing in Second Story of Building A

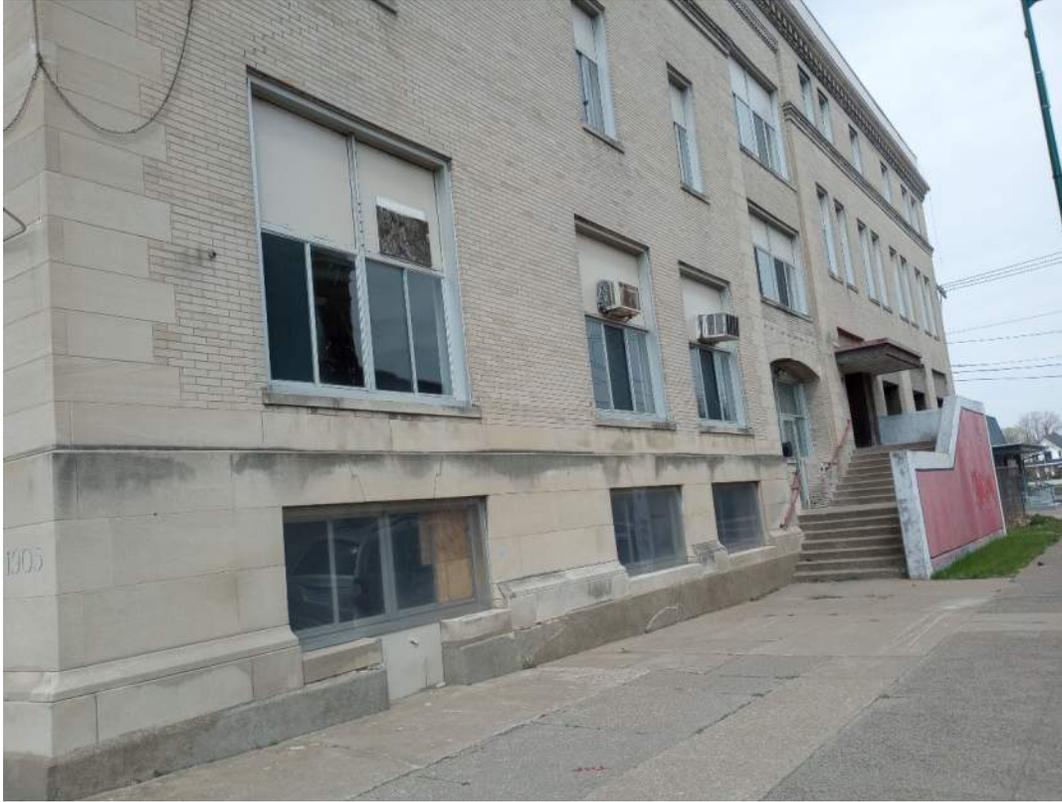
Exterior of Building A

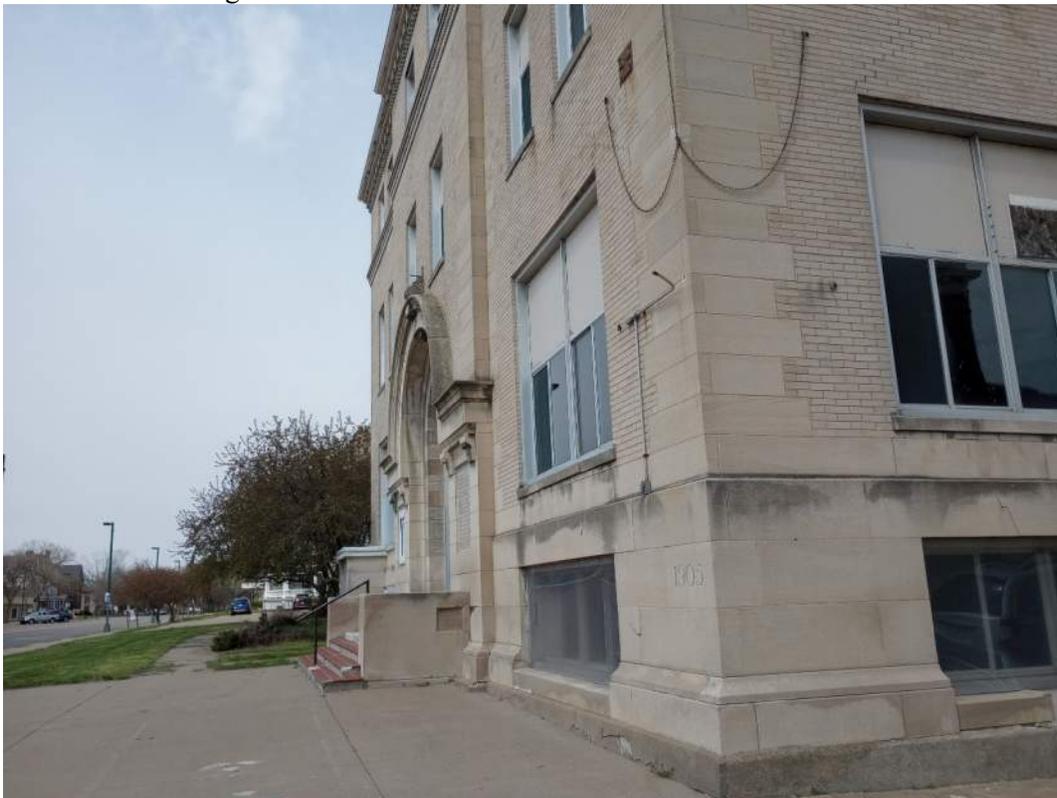
Exterior of Building A

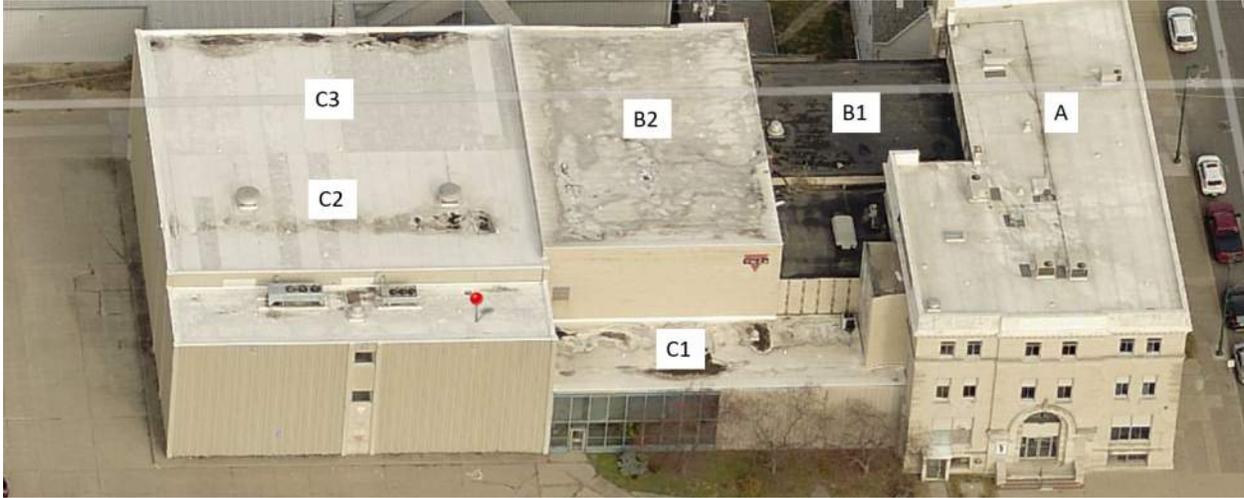
Building B1 is an addition which houses the Woman's Locker Room, the boiler room and some offices on the second story.

It is the opinion of Select Structural Engineering that this Building is not salvageable. The roof of this building was not successful at keeping water out and the level of moisture in the building envelope was/is significant. The structural framing such as the steel is a complete loss and will not be certified by any licensed structural engineer. This is in addition to the mold and potential asbestos which presents a significant risk to occupants including contractors who would need to work inside the building.

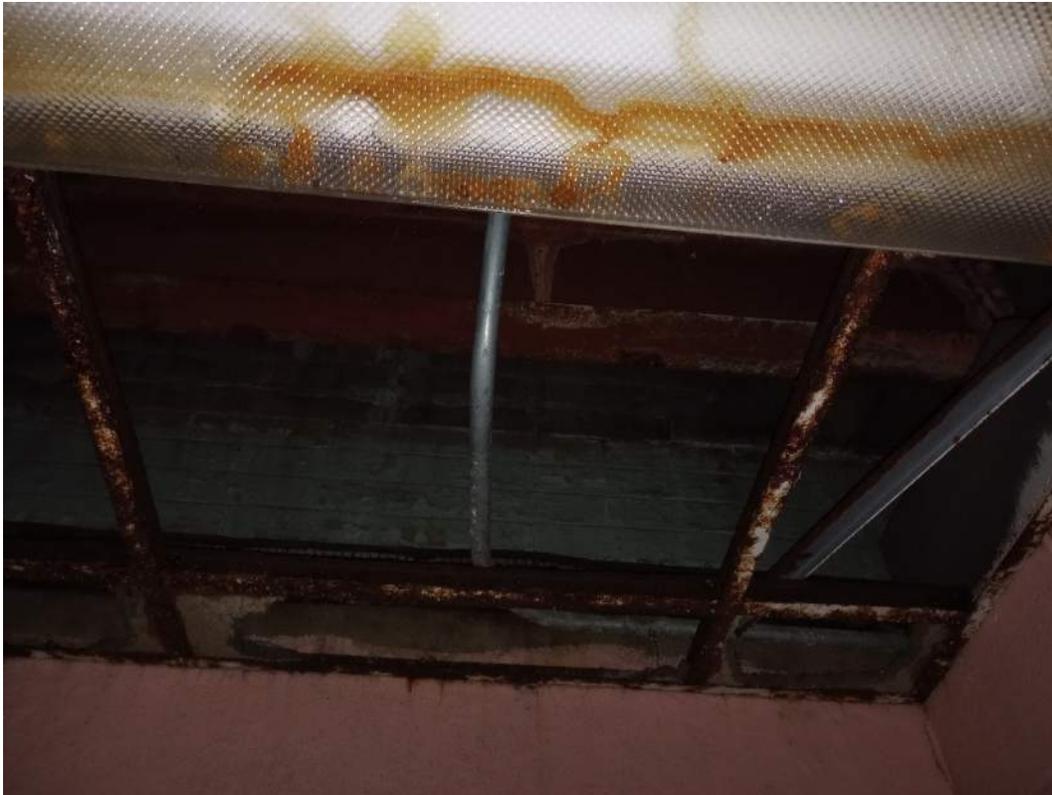
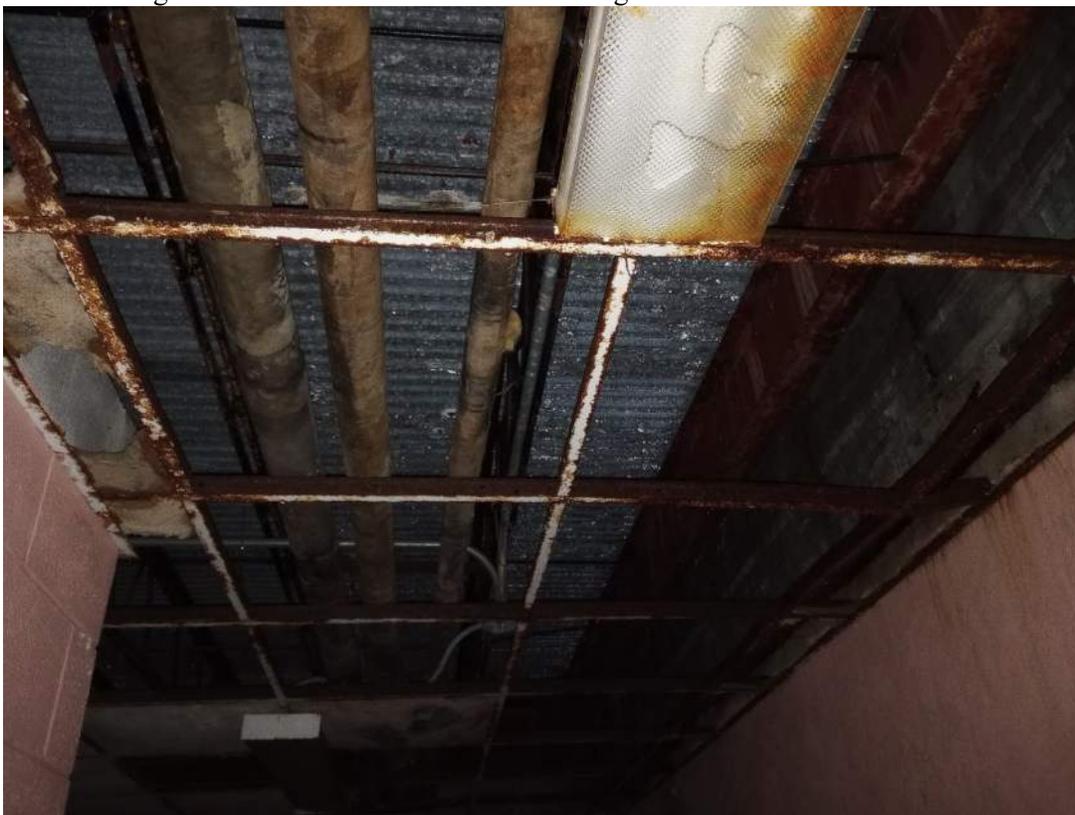
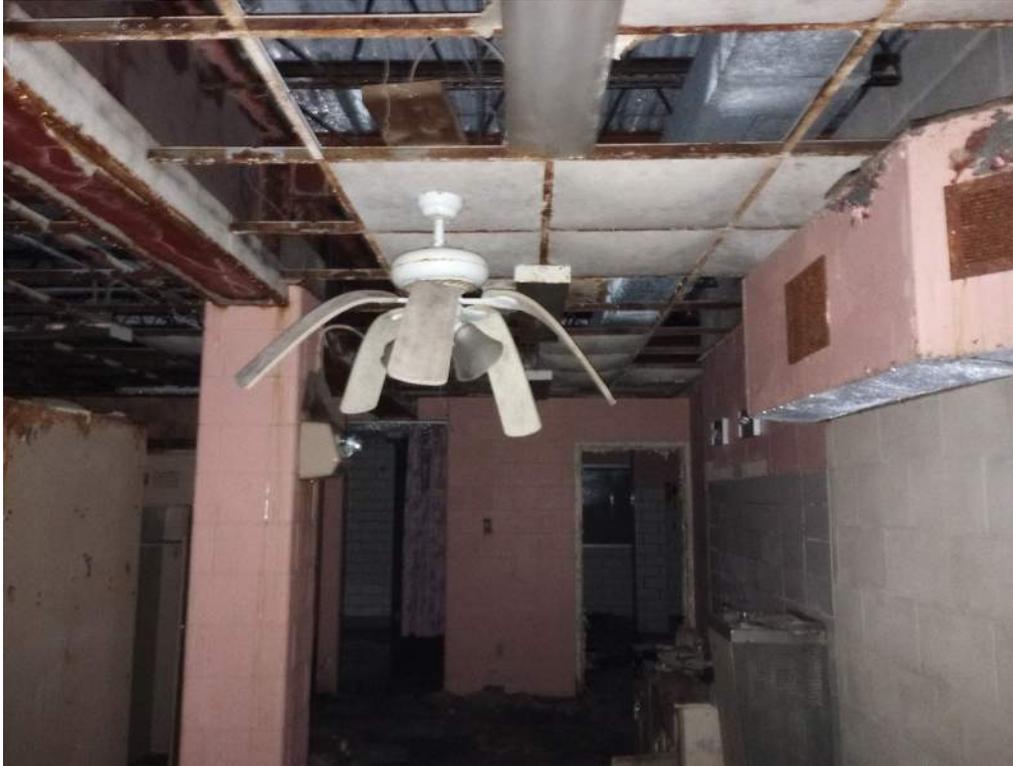
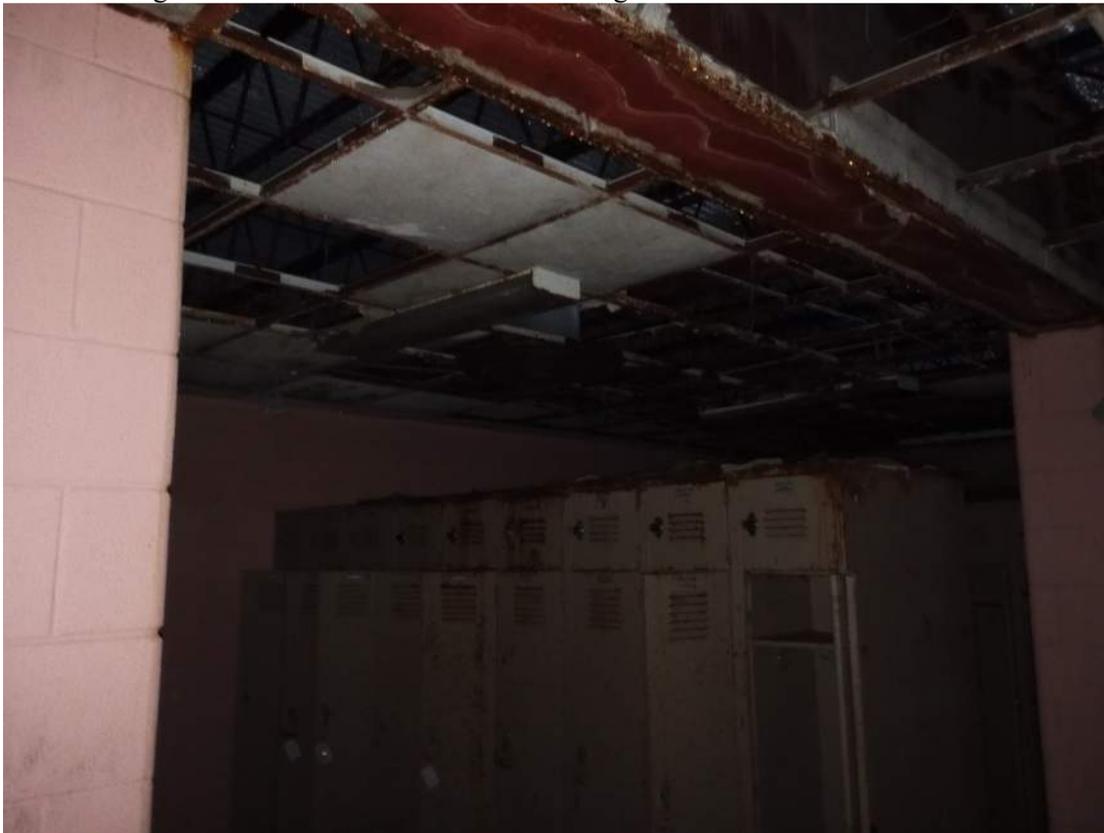
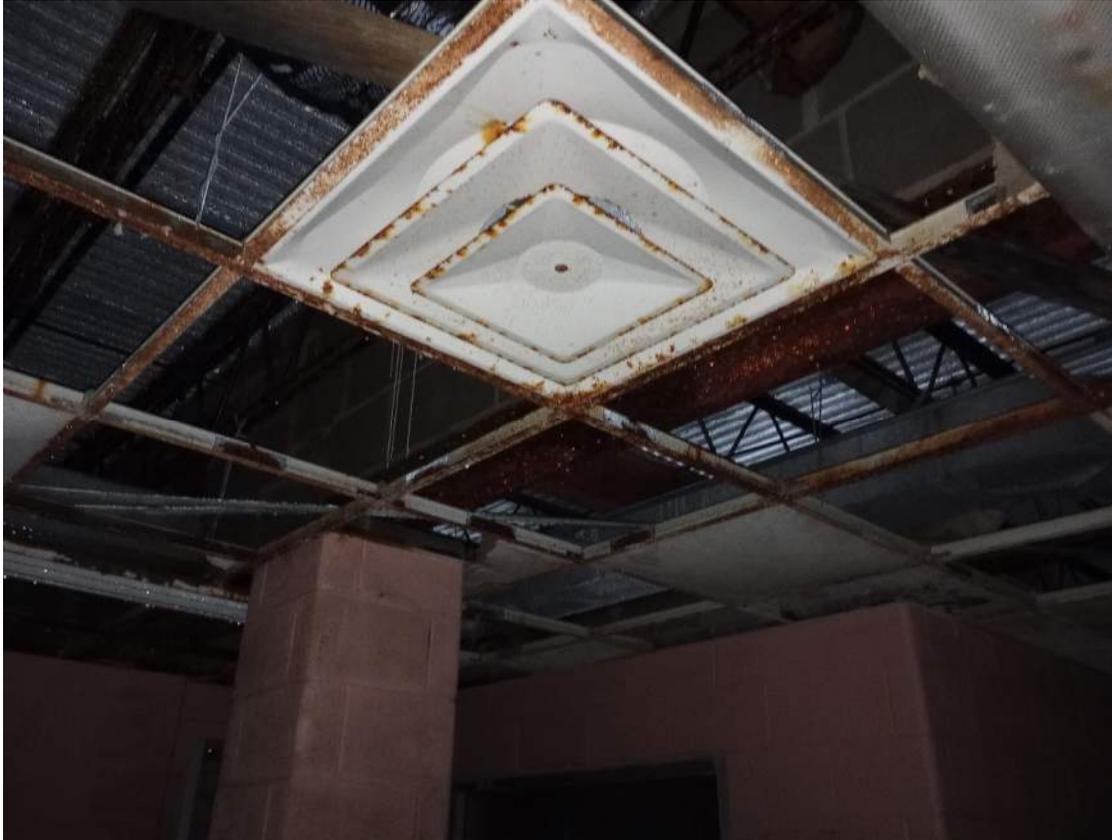
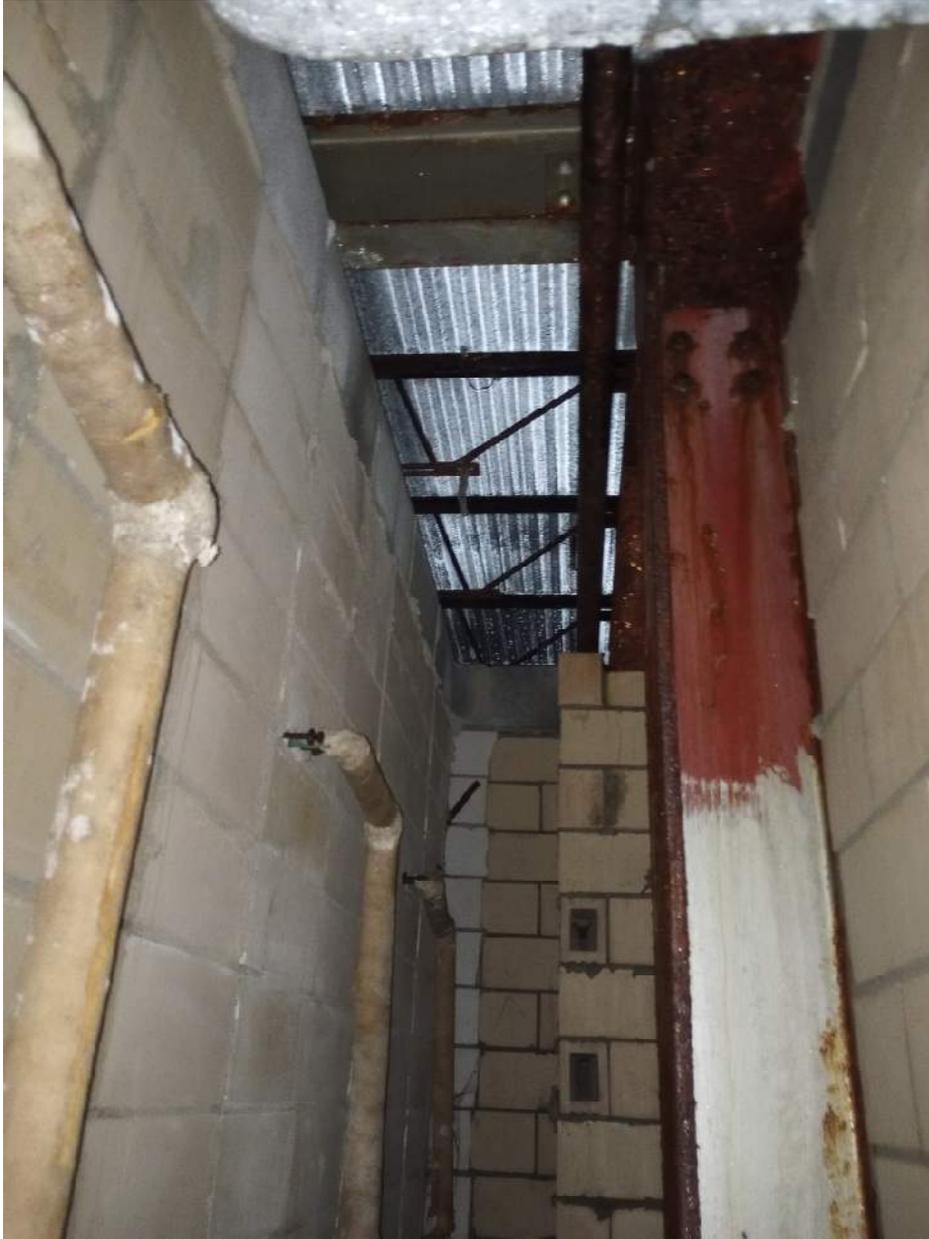
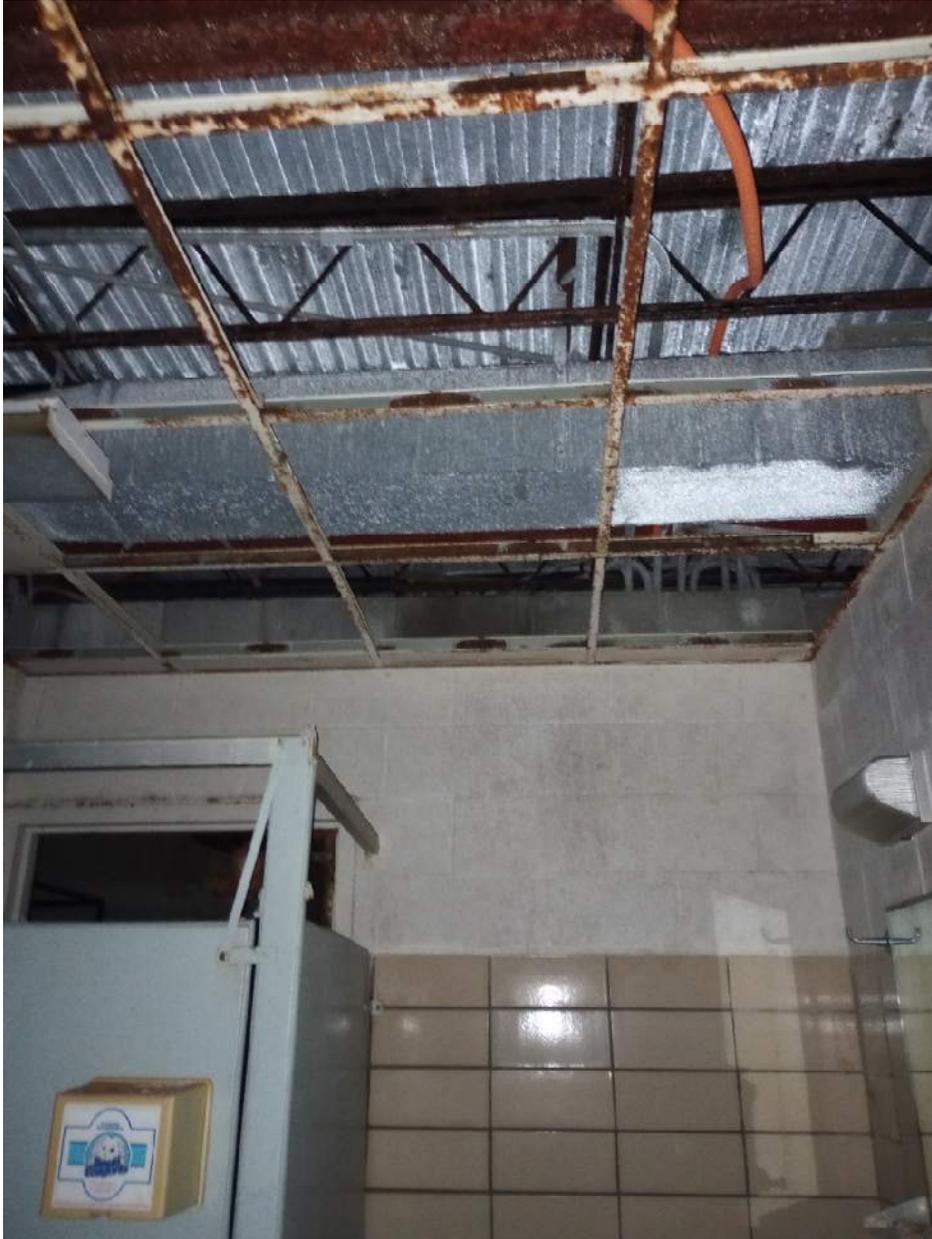
Steel Framing in Woman's Locker Room of Building B1

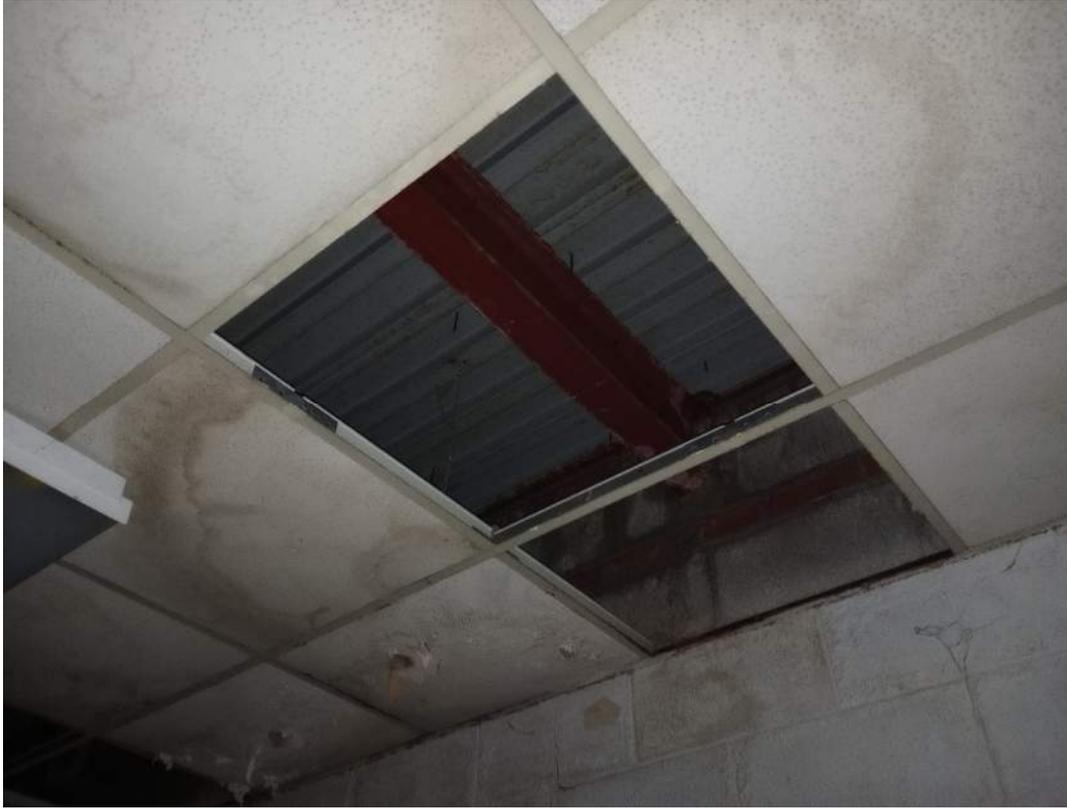
Steel Frame in Building B1
