# Analysis of Brownfield Cleanup Alternatives

480 S. 3rd Street  
Clinton, Clinton County, Iowa 52732

Terracon Project No. 07207086; Task 22/32.4

**Re: Analysis of Brownfield Cleanup Alternatives**  
Clinton YMCA - 480 S. 3rd Street  
Clinton, Clinton County, Iowa 52732  
Terracon Project No. 07207086 T22/32.4  
Brownfields Assessment Grant: BF97782001

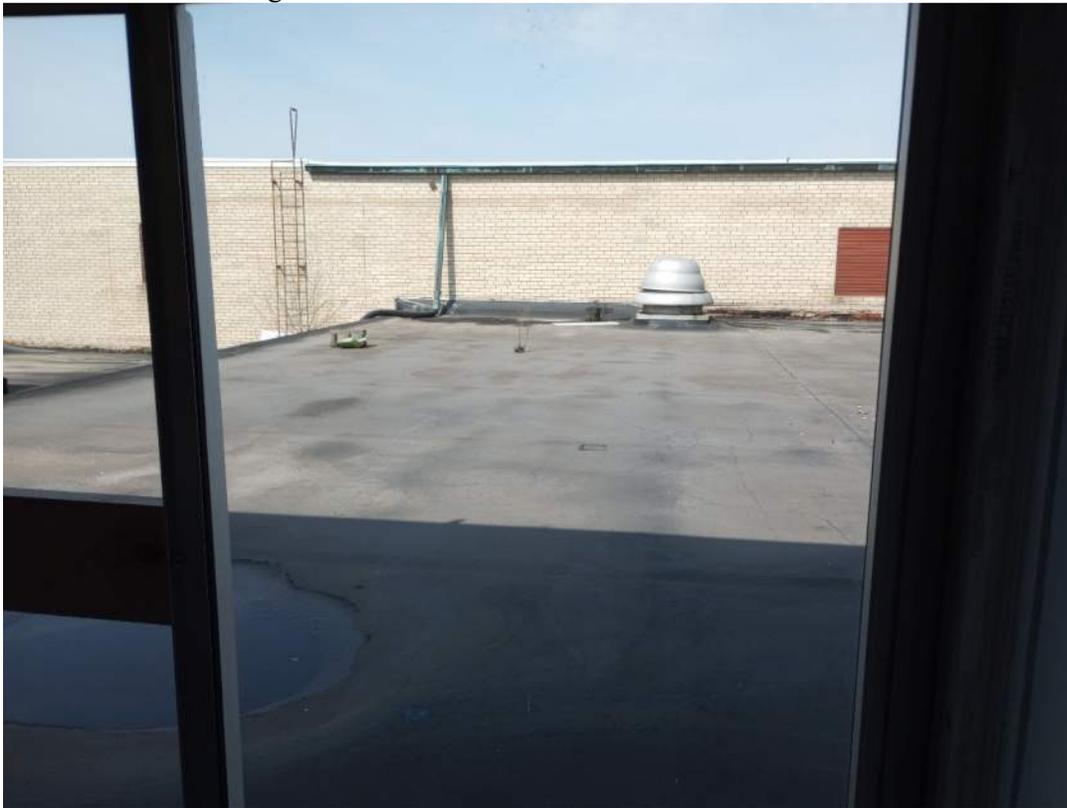
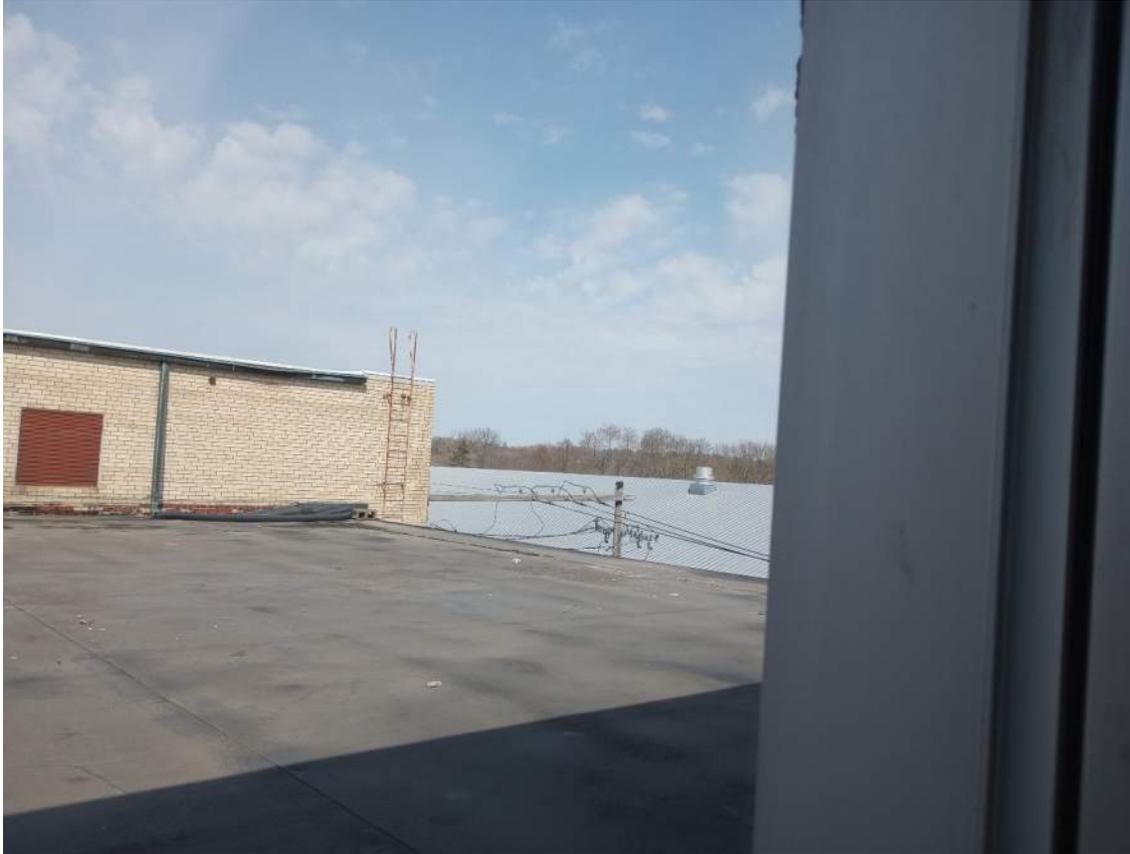
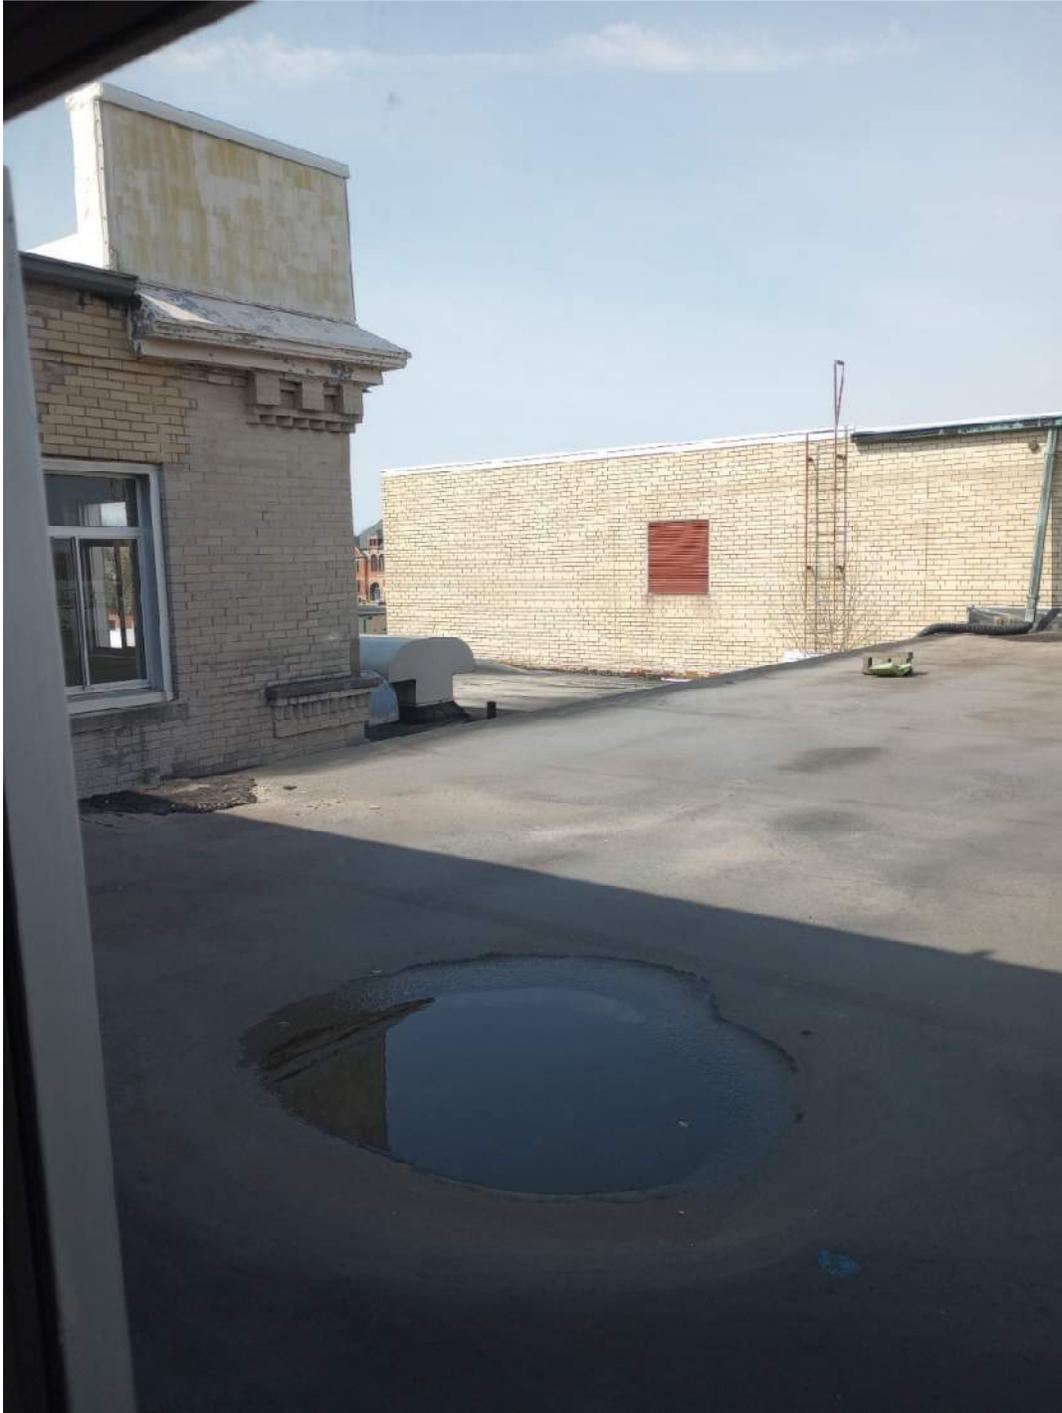
Roof of Building B1

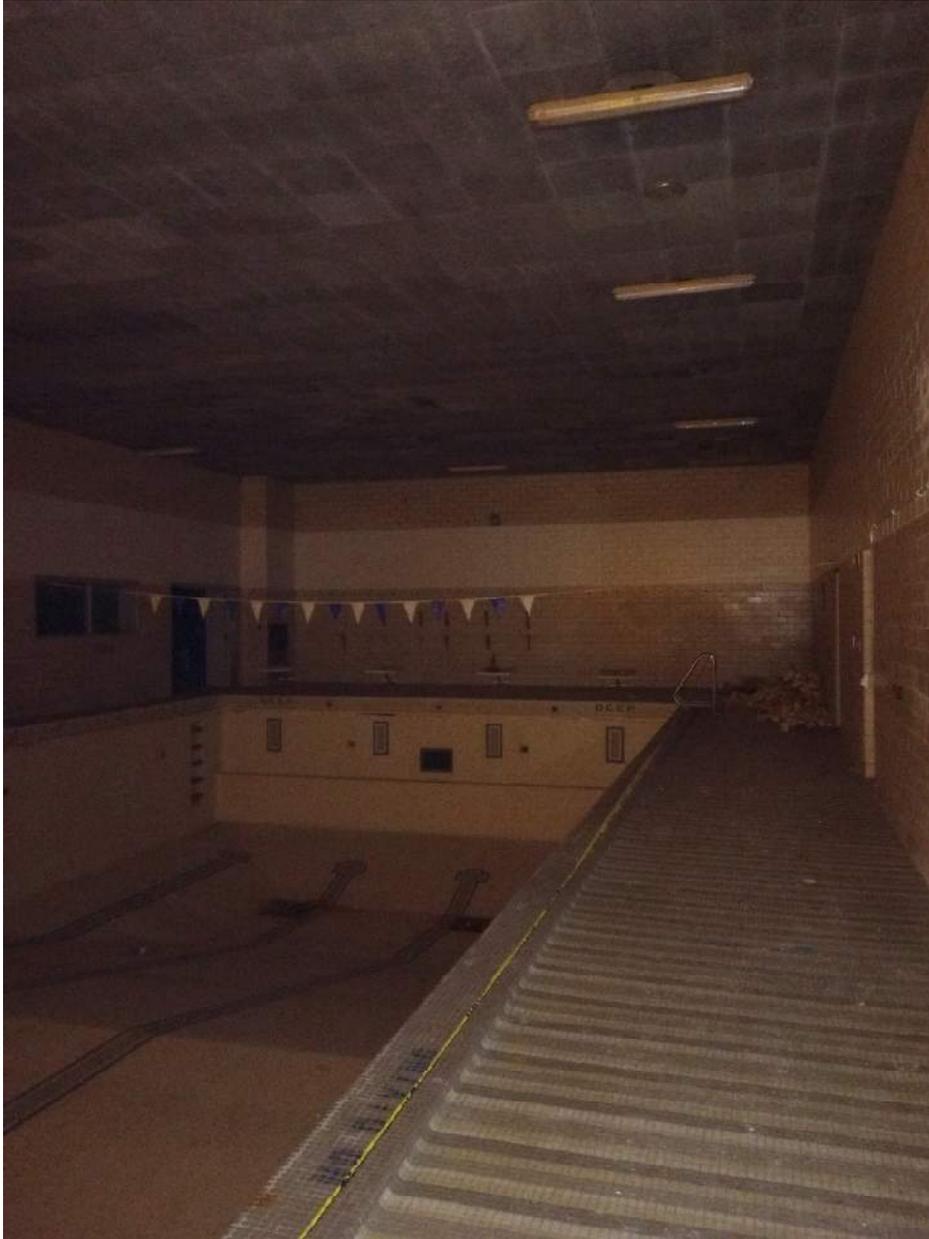
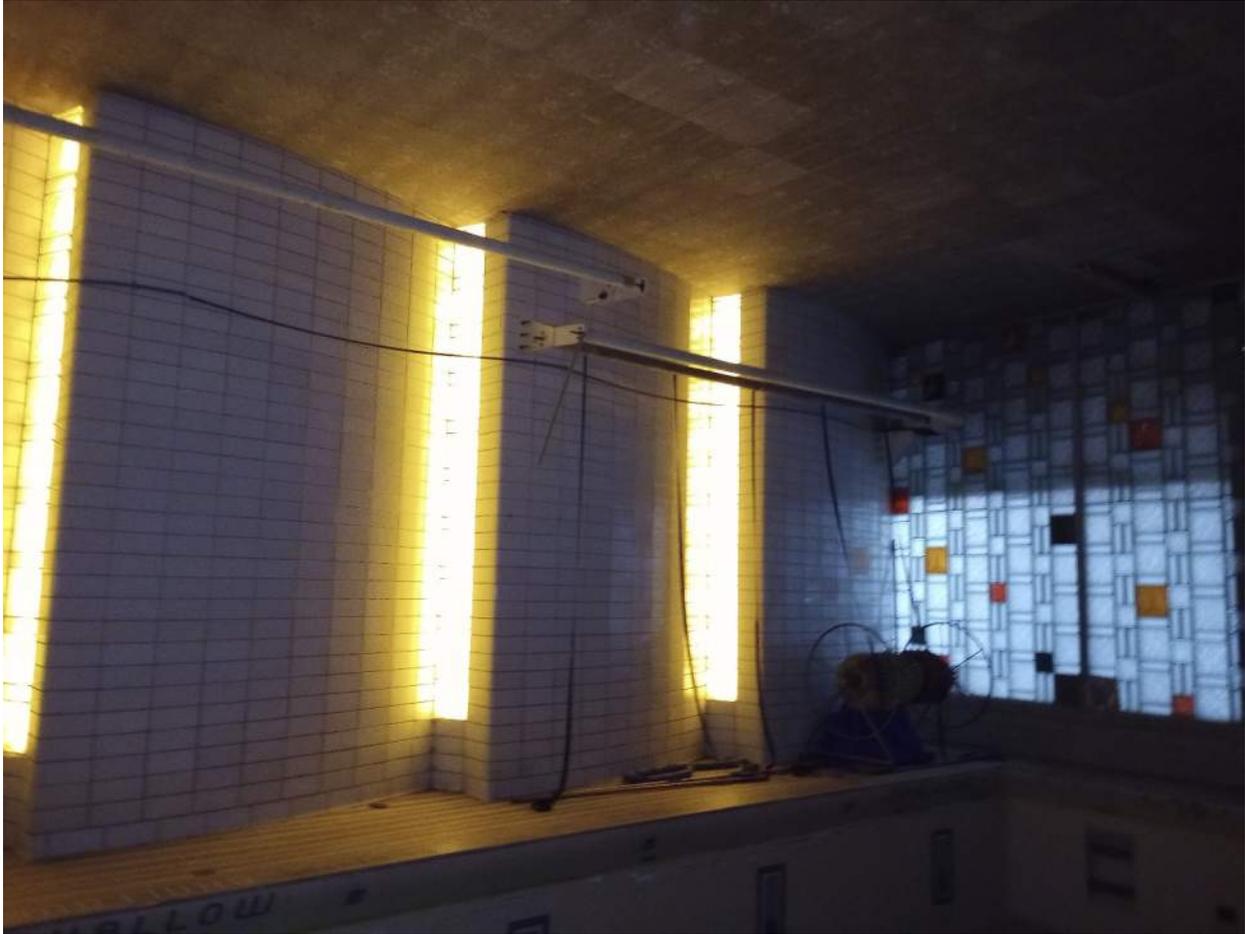
This section of building did receive water damage but it is not as severe as in Building B1. It is possible that the roof in this building was not compromised but the moisture from Building B1 made its way over in the form of humidity.

Swimming Pool on Lower Level of Building B2

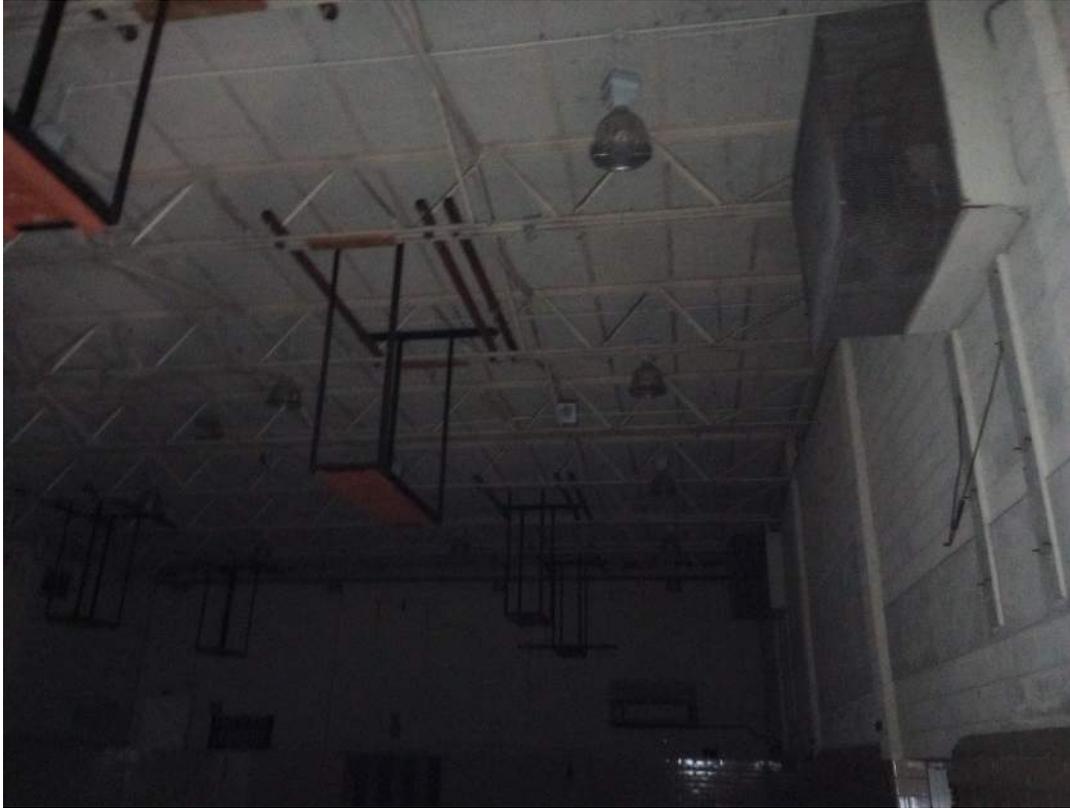
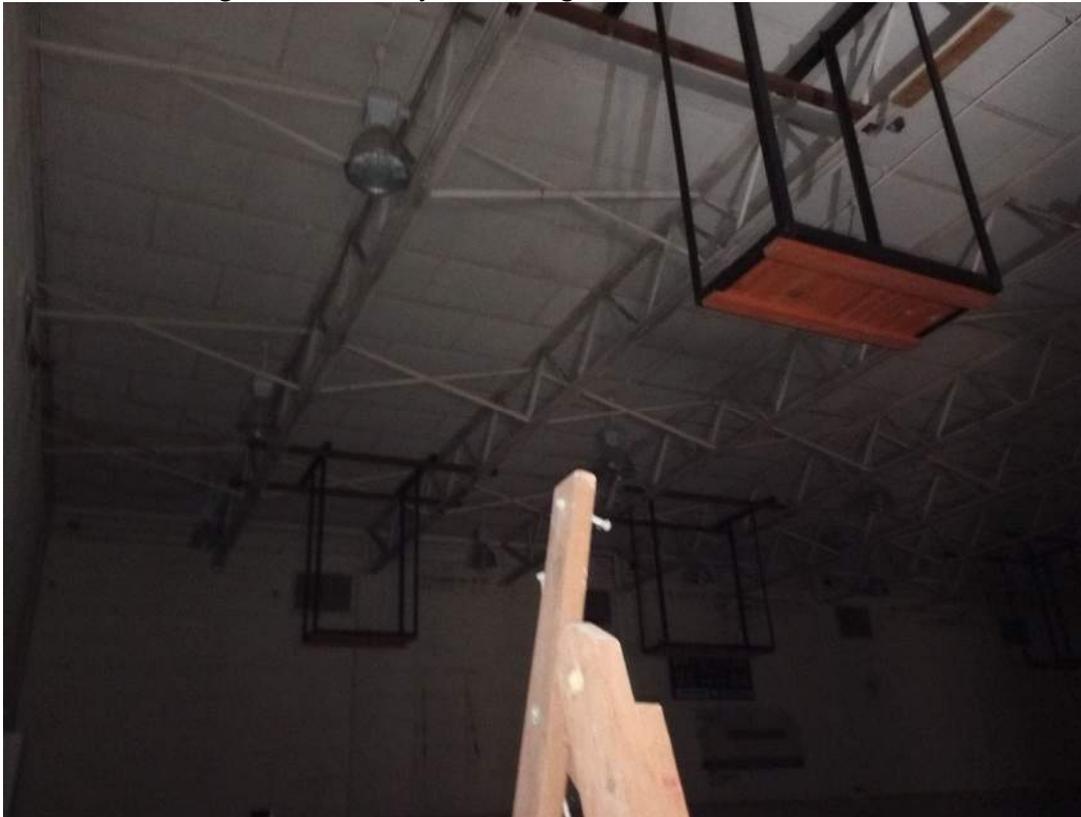
The steel roof structure appears to be intact and probably can be salvageable with some retrofit of the members on a case by case evaluation. Similarly, the concrete floor supporting the basketball court appears to be in good condition however there might need to be some repair in areas.

Steel Roof Framing on Second Story of Building B2

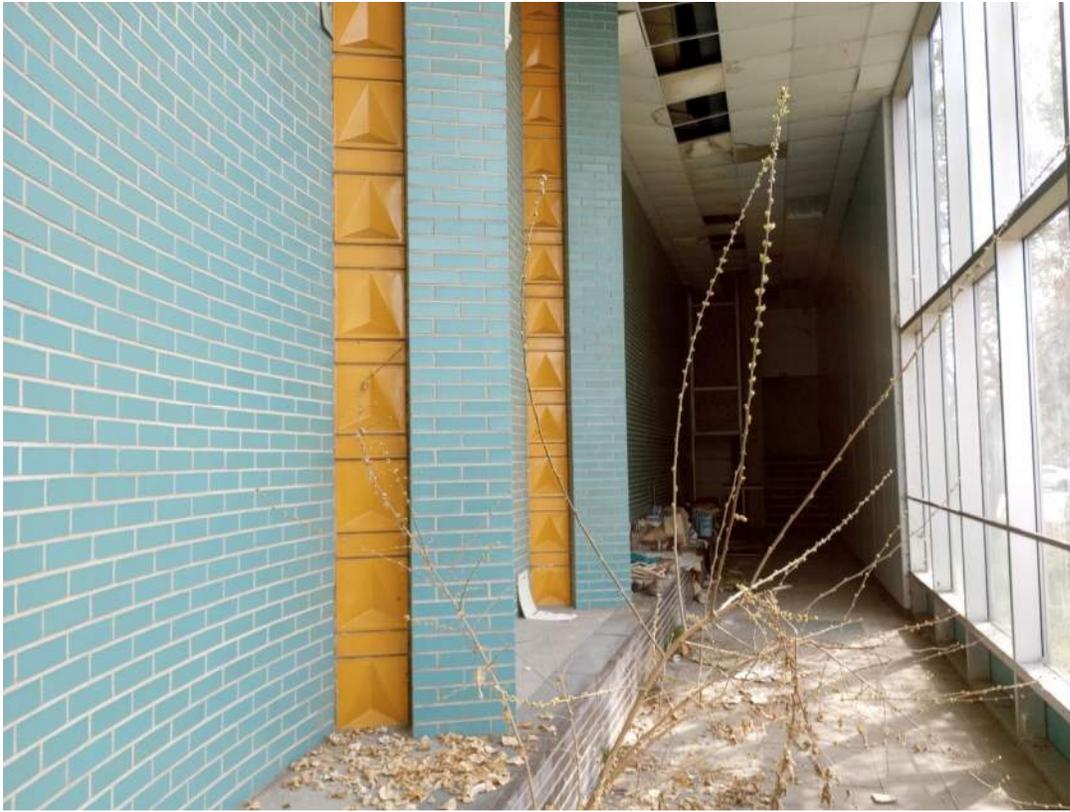
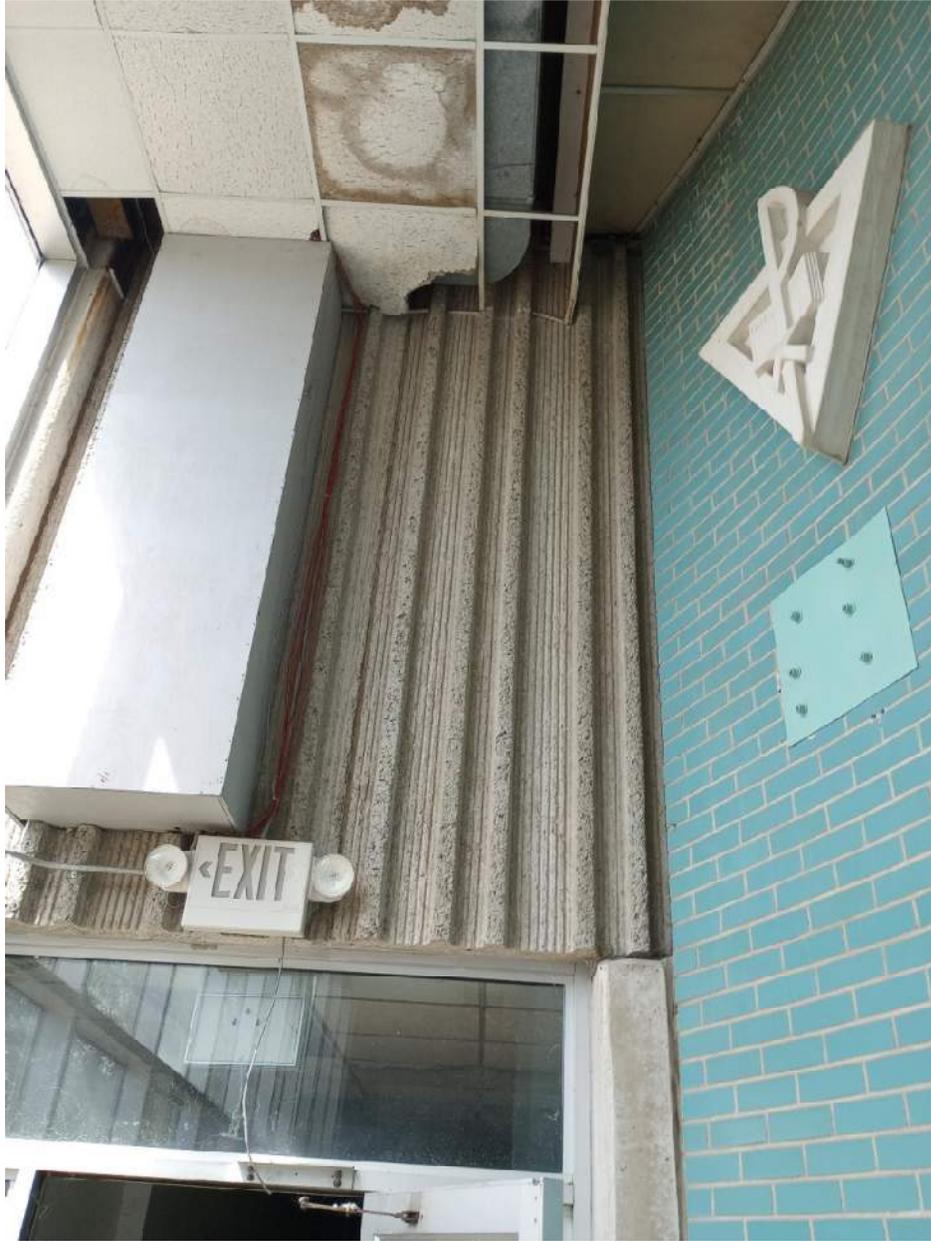
Building C1 is structurally in good condition. While the roof framing was not visible during the site visit, it did not appear to be in distress. The exterior wood/window framed wall looked to be in good condition. The interior blue brick also appeared to be in good condition which was actually the original exterior façade to Building B2.

Interior of Building C1 Looking Toward Building A1

Interior of Building C1 Looking Toward Building C2/3

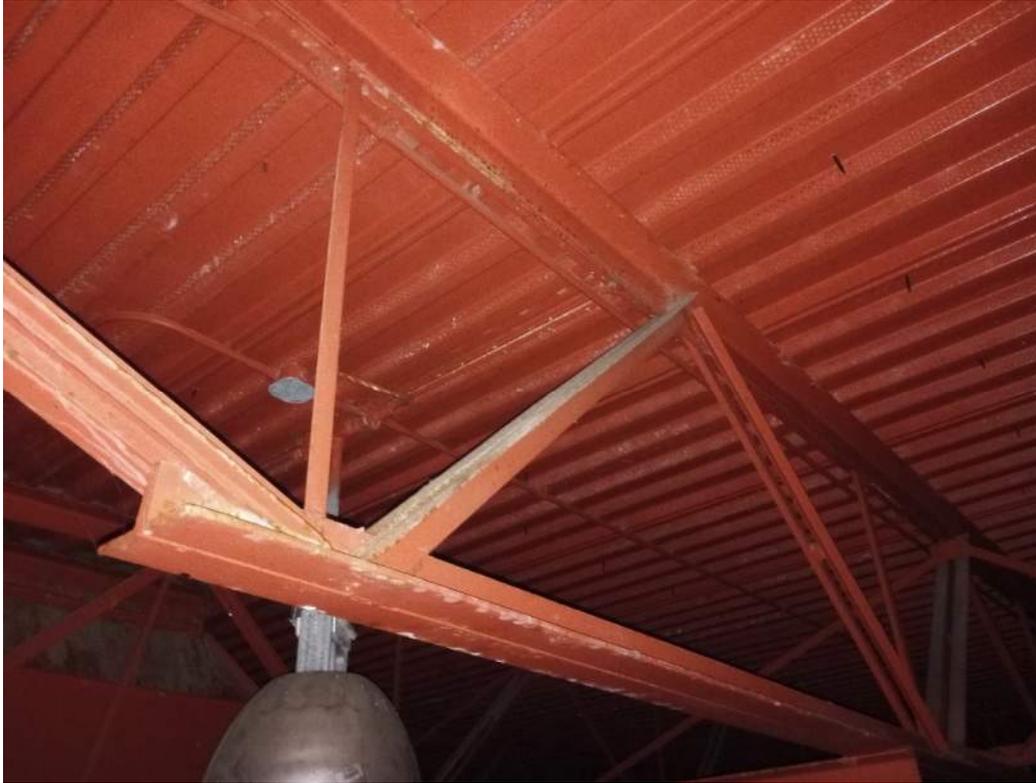
The open web joists supporting the roof appear to be protected by paint and did actually stand up to the test of time and moisture. These steel joists will probably require some maintenance but might not have to be completely replaced. The track should probably be deconstructed as the condition of the suspension members is unknown.

Painted Steel Roof Joists at Gym Area

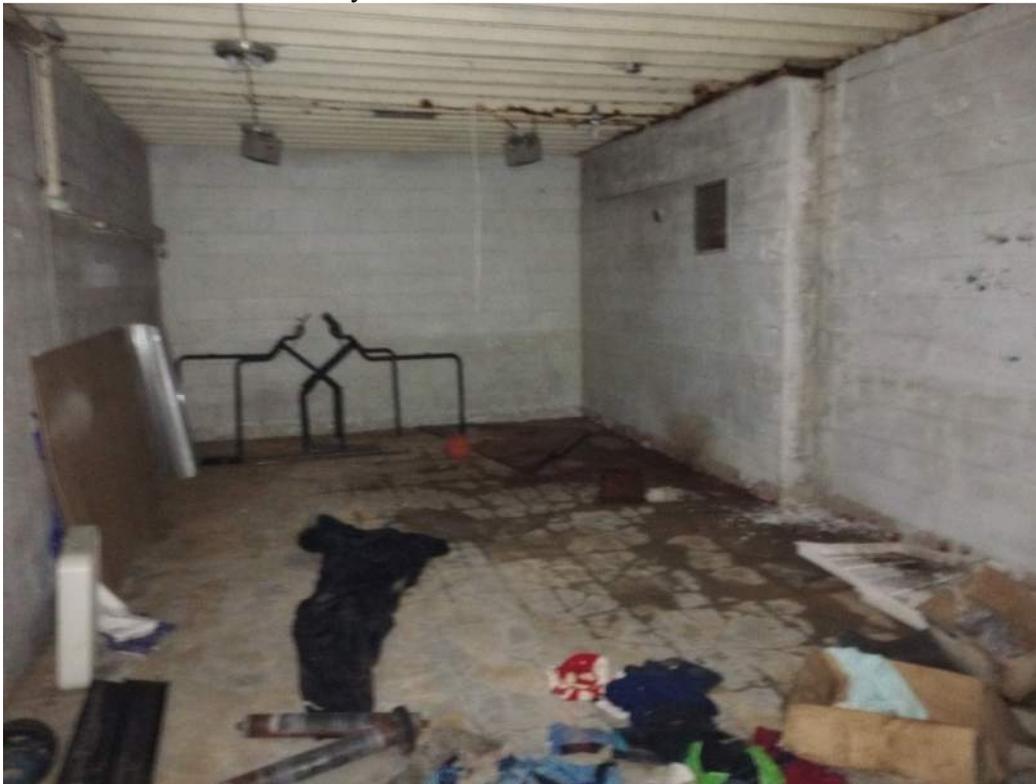
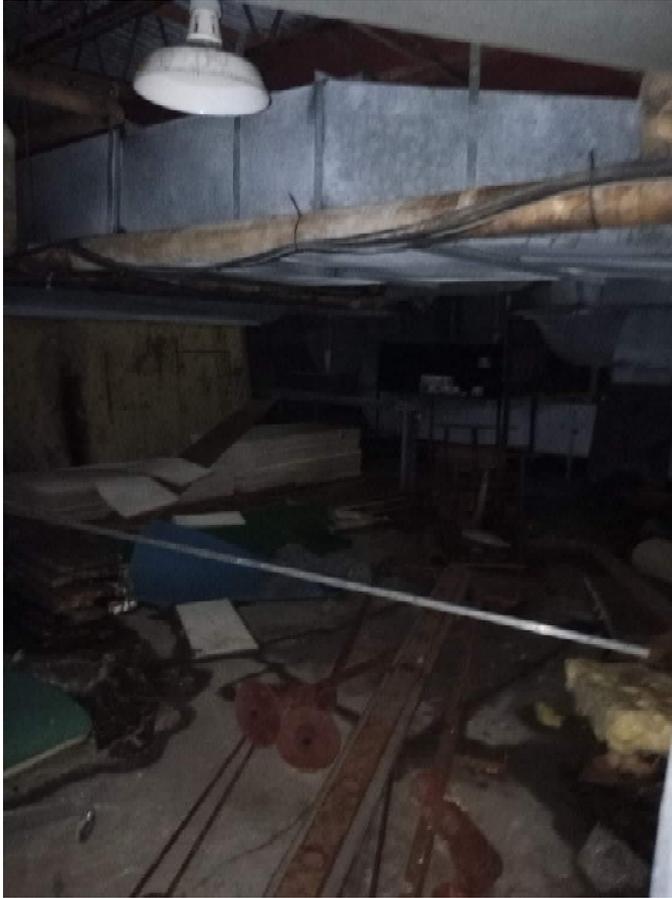
The exterior wall panels appear to be in good condition and will require minimal retrofit in order to bring the walls up to the required condition. It should be noted that the interior of the locker rooms is very moist and that there is a lot of mold in this area. This is a non-structural issue but will require a specialist to figure out how/if it can be abated.

Men's Locker Room on First Floor
